GEOTECHNICAL INVESTIGATION REPORT

**Slope Stabilization at Entradero Basin
City of Torrance, Los Angeles County, California**

November 20, 2012

GEI Project No. 172-52

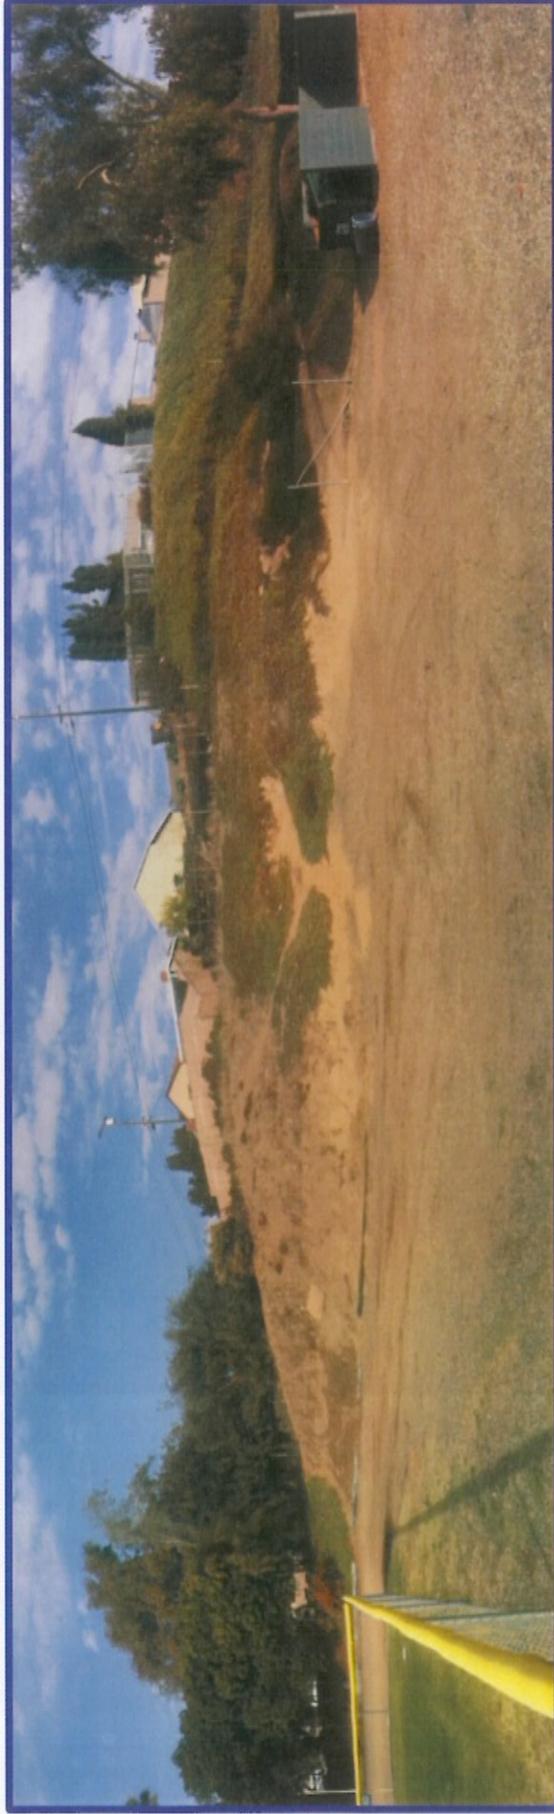
We believe that the observed eroded and slumped areas of the slope (See Panoramic View 1 & 2) have not in any way compromised the gross stability of the slope; however, mitigation measures should be taken as soon as practical to prevent further slippage of the surficial soils towards the baseball fields and the snack bar. In order to repair the damaged portions of the slope, the original slope inclinations of these areas should be restored. The slope restoration should involve re-grading the damaged areas of the slope following the recommendations provided below:

Panoramic View 1: Picture showing slope located on the northeast corner of the baseball fields located on the northeast corner of Entradero Basin. The slope shows signs of erosion, slumping, and surface degradation by some unknown human activity.

- The restoration of the damaged areas of the slope will require the re-grading of the disturbed areas. Before the placement of the engineered fill as described below, the disturbed areas will require cleaning and removal of all existing vegetation and debris to expose competent soil material approved by GEI's Soils Engineer or his representative.

- During the excavation of materials in the areas designated for restoration, the adjacent slopes should be protected.
- The compacted fill should be placed on a series of level benches as shown on the Construction Plan (Figure 3). At the base of the fill area, a slightly larger bench should be excavated in order to create a keyway for the fill. As shown in the Construction Plan (Figure 3), the fill benches should be approximately the size of the slope failure in width, excavated into competent soil material approved by GEI's Soils Engineer or his representative, and tilted back into the slope at a minimum gradient of two (2) percent.

- The fill materials should be placed in 8 to 10-inch lifts, watered or aerated as necessary to achieve near-optimum moisture conditions, and then compacted in place to a minimum relative compaction of 95 percent as determined from ASTM D 1557-12 Testing Procedures. If import material is needed for restoring the slope areas, then the imported soils should meet the specifications provided in Figure 3. The import material should be approved by GEI's Soils Engineer or his representative prior to importation.

- After restoration, the slope should be landscaped with deep-rooted plant material requiring minimal cultivation and irrigation in order to thrive. The existing irrigation system should be connected with the repaired area to ensure plant growth; however, over watering and subsequent saturation of the slope surface should be avoided. The completed graded slope should be landscaped as soon as practical after completion of the repairs. If permanent landscaping cannot be provided within a reasonable period of time, either jute matting or a spray-on product designed to seal the slope surface should be considered as a temporary measure to inhibit surficial erosion.

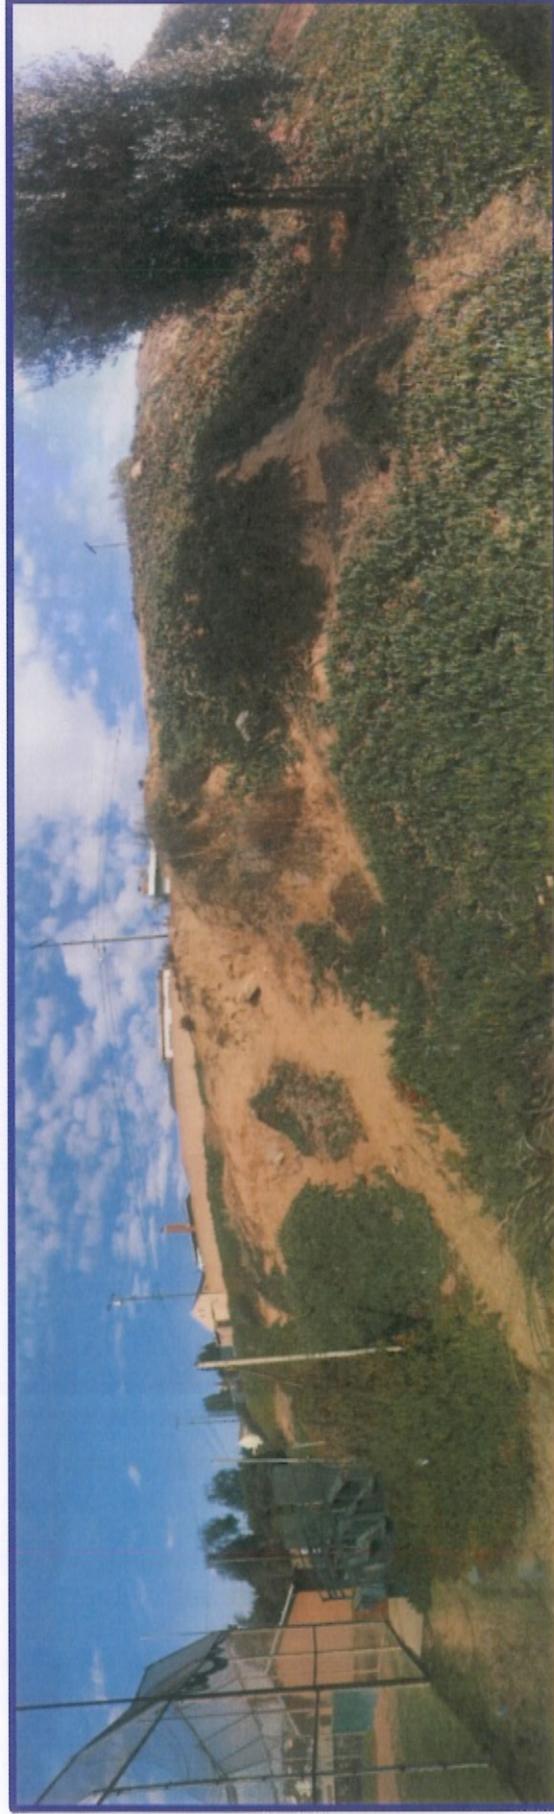
Panoramic View 2: Picture showing slope located on the east side of the baseball fields located on the northeast corner of Entradero Basin where the slope has eroded and slumped due to some unknown human activity.
