**Root Cause Analysis Report
PBF Energy Torrance Refinery
February 22, 2019 Propane Release Incident**

Summary of Incident:

On the morning of February 22, 2019, during the removal of safety valve 52SV41 located in the South Oil Movements Area #52 of the refinery, a release of an estimated 2600 lbs. of propane occurred, resulting in an injury to the craft person performing the valve removal. The injury involved propane burns to the hands and arms of the crafts person. The crafts person was treated at a nearby hospital and returned to work with restrictions.

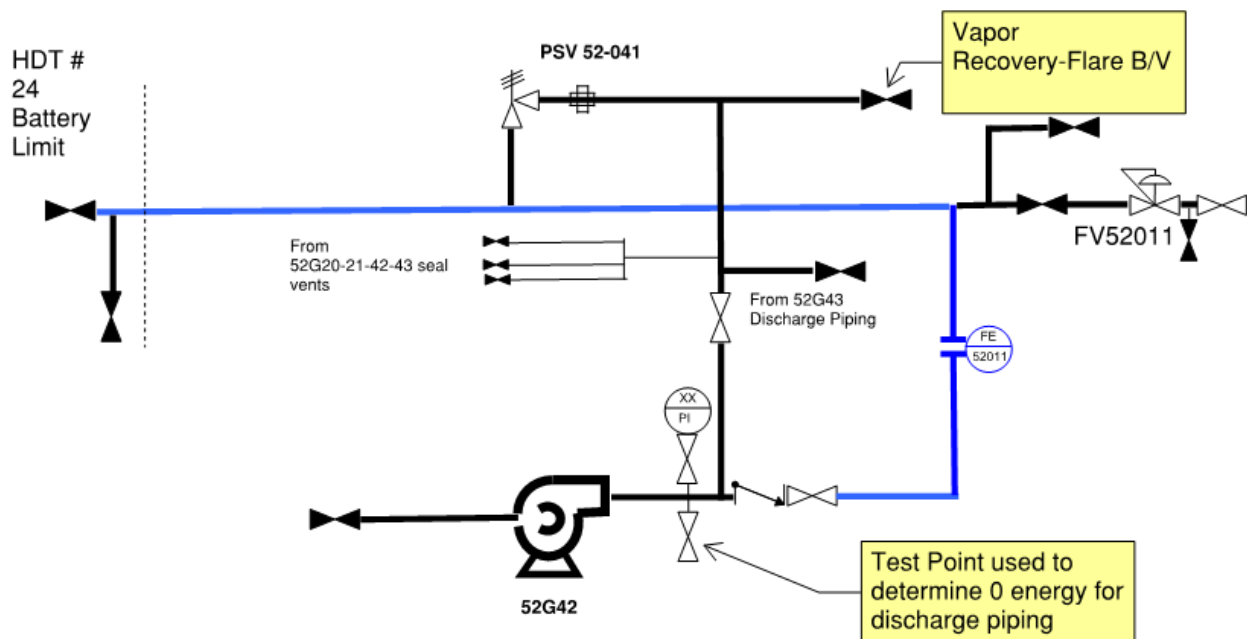
Drawing # 1

52SV41 is the safety valve located on the discharge piping for 52G42 pump. This pump provides propane to a vaporizer located in the Hydrotreater (HDT) unit # 24. See attached Drawing # 1).

The investigation found that the discharge piping contained residual propane because the preparation plan was less than adequate. Specifically, a wafer check valve on the discharge of the pump prevented the piping from being completely emptied to the flare header through the pump suction piping. This issue was not found during the process plan verification step because the Head Operator relied on the operator's experience and knowledge. As a result, the wafer check valve was not identified prior to the job.
