SUBJECT: Torrance Bridge Maintenance and Beautification- Vegetation and Wooden Guardrailing Removal.

Re: Pacific Electric Railroad Bridge
 Recommendation for complete and sustained removal of vines

PACIFIC ELECTRIC RAILROAD BRIDGE
HISTORIC PHOTOS COURTESY OF TORRANCE HISTORICAL SOCIETY

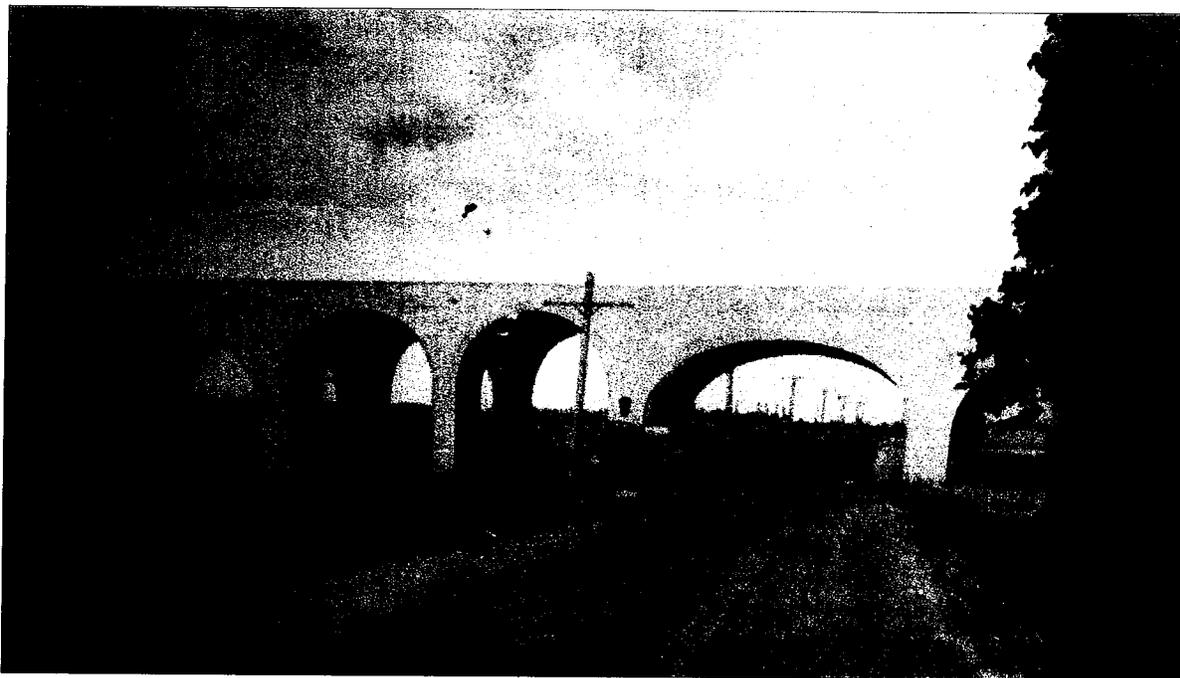
Figure 1: Bridge, note absence of wood guardrails and lack of vegetation on bridge (soon after construction)

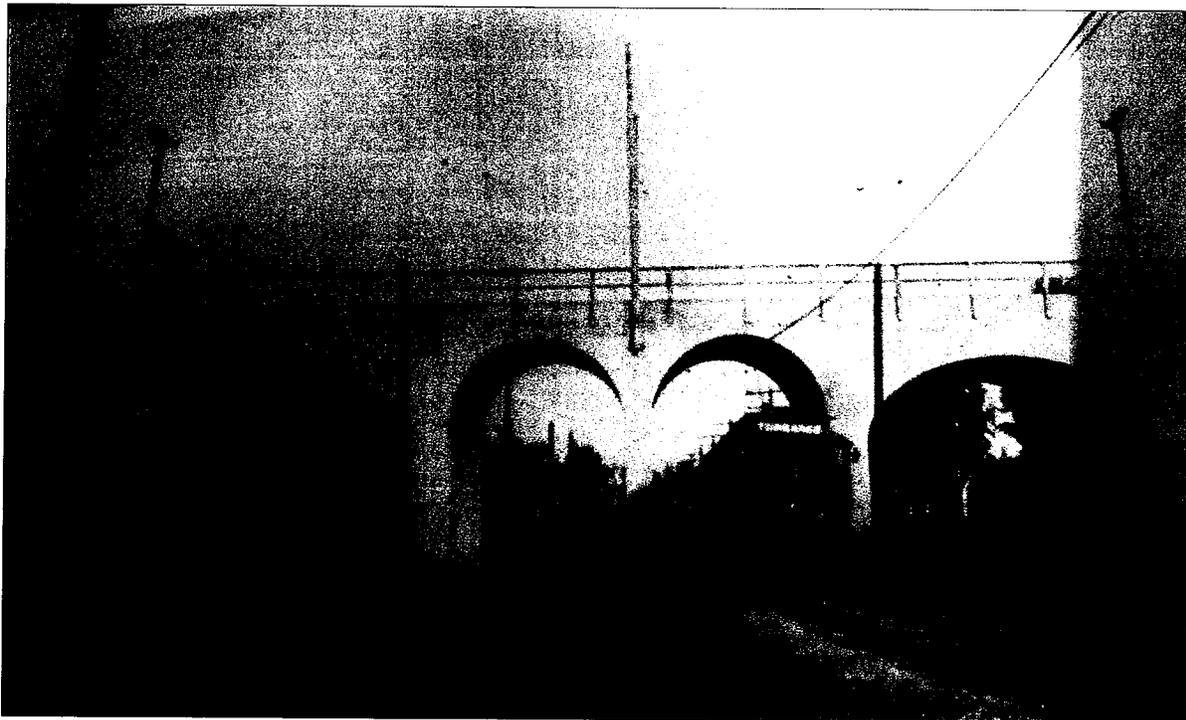
In addition to the vegetation, it was discovered that the wooden guardrails, which were added sometime after 1920, were not part of the original design and are not a contributing feature to the bridge. Additionally, some of the cracking to be repaired on the concrete face of the bridge originates from the bolts that attach the guardrail to the structure. Our thoughts regarding the railings are to remove them permanently, along with the vegetation, to provide a more complete bridge repair and beautification.

Figure 4: Bridge, note addition of wood guardrails and poles supporting overhead catenary and telephone wires (bolts in bridge east and west elevations associated with center poles are still extant), note lack of vegetation on bridge (1940)

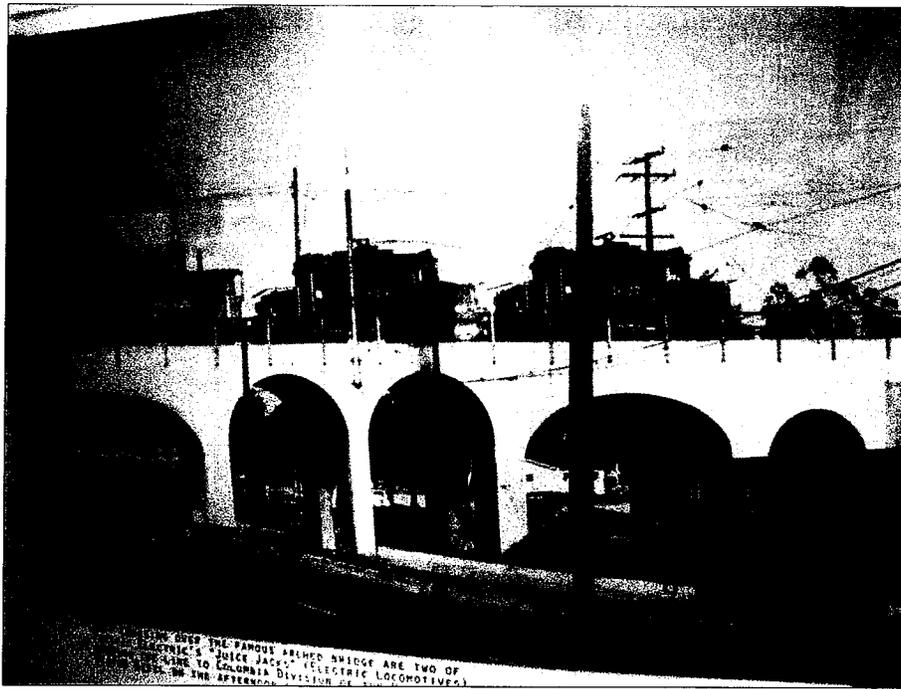
Figure 5: Bridge, note lack of vegetation on bridge (1953)

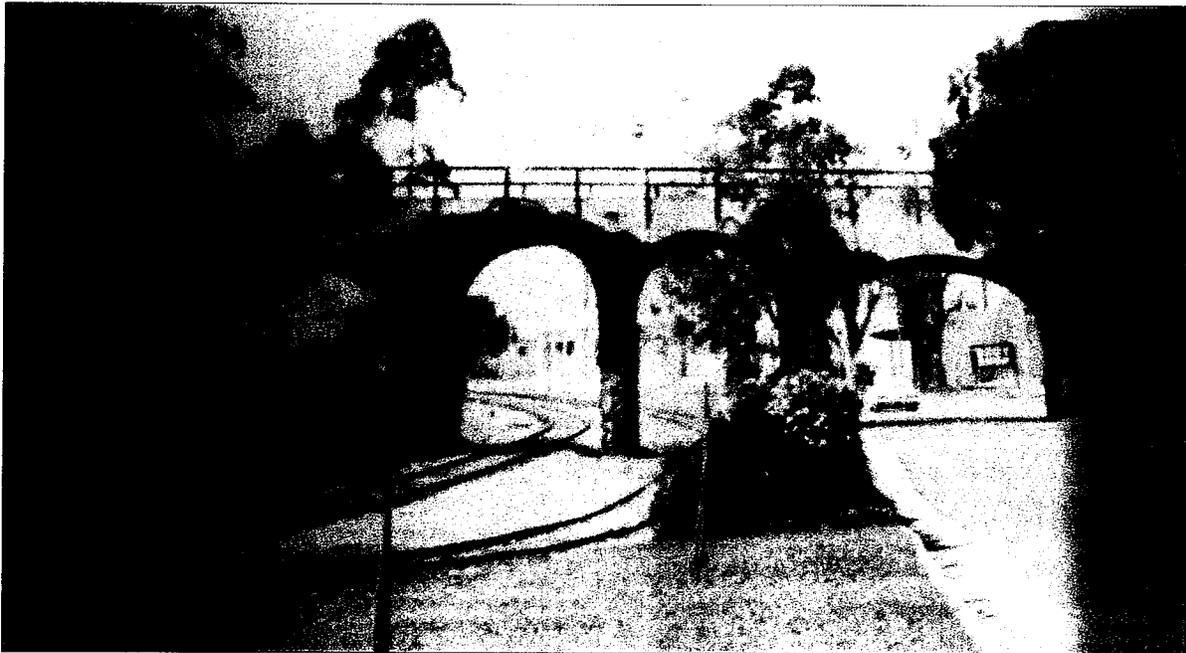
Figure 6: Bridge, note growth of vegetation on and adjacent to bridge (c1970s)
