# Addendum #1

**RFP No. B2016-38**

**RFP for Engineering Design Services for Anza Ave Rehabilitation (190<sup>th</sup> St to Sepulveda Blvd), I-144**

**City of Torrance, California**

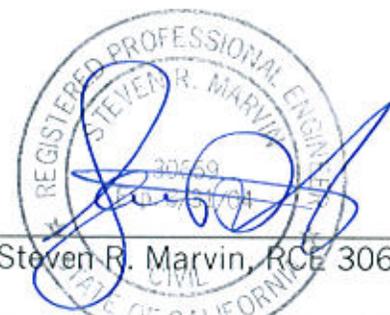
<b>Equilibrium R-Value</b>	<b>71</b> by EXUDATION	Examined & Checked: 3 /7/ 03
REMARKS:	G <sub>f</sub> = 1.25

Steven R. Marvin, PCE 30659
	0.0% Retained on the	
	3/4" Sieve.

The data above is based upon processing and testing samples as received from the field. Test procedures in accordance with latest revisions to Department of Transportation, State of California, Materials & Research Test Method No. 301.

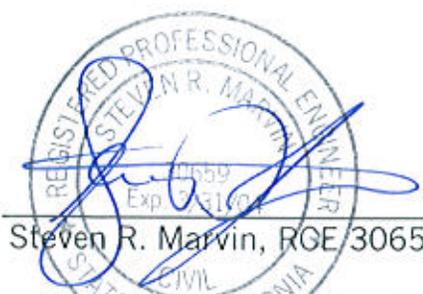
<b>Equilibrium R-Value</b>	<b>71</b> by EXUDATION	Examined & Checked: 3 /7/ 03
REMARKS:	Gf = 1.25

0.0% Retained on the	
	3/4" Sieve.	
	Partial Free Drainage.

The data above is based upon processing and testing samples as received from the field. Test procedures in accordance with latest revisions to Department of Transportation, State of California, Materials & Research Test Method No. 301.
