**TECHNICAL BACKGROUND REPORT to the
SAFETY ELEMENT of the GENERAL PLAN
for the CITY of TORRANCE,
LOS ANGELES COUNTY, CALIFORNIA**

**SEISMIC HAZARDS
GEOLOGIC HAZARDS
FLOODING HAZARDS
FIRE HAZARDS
HAZARDOUS MATERIALS MANAGEMENT
AVIATION HAZARDS**

August 2005

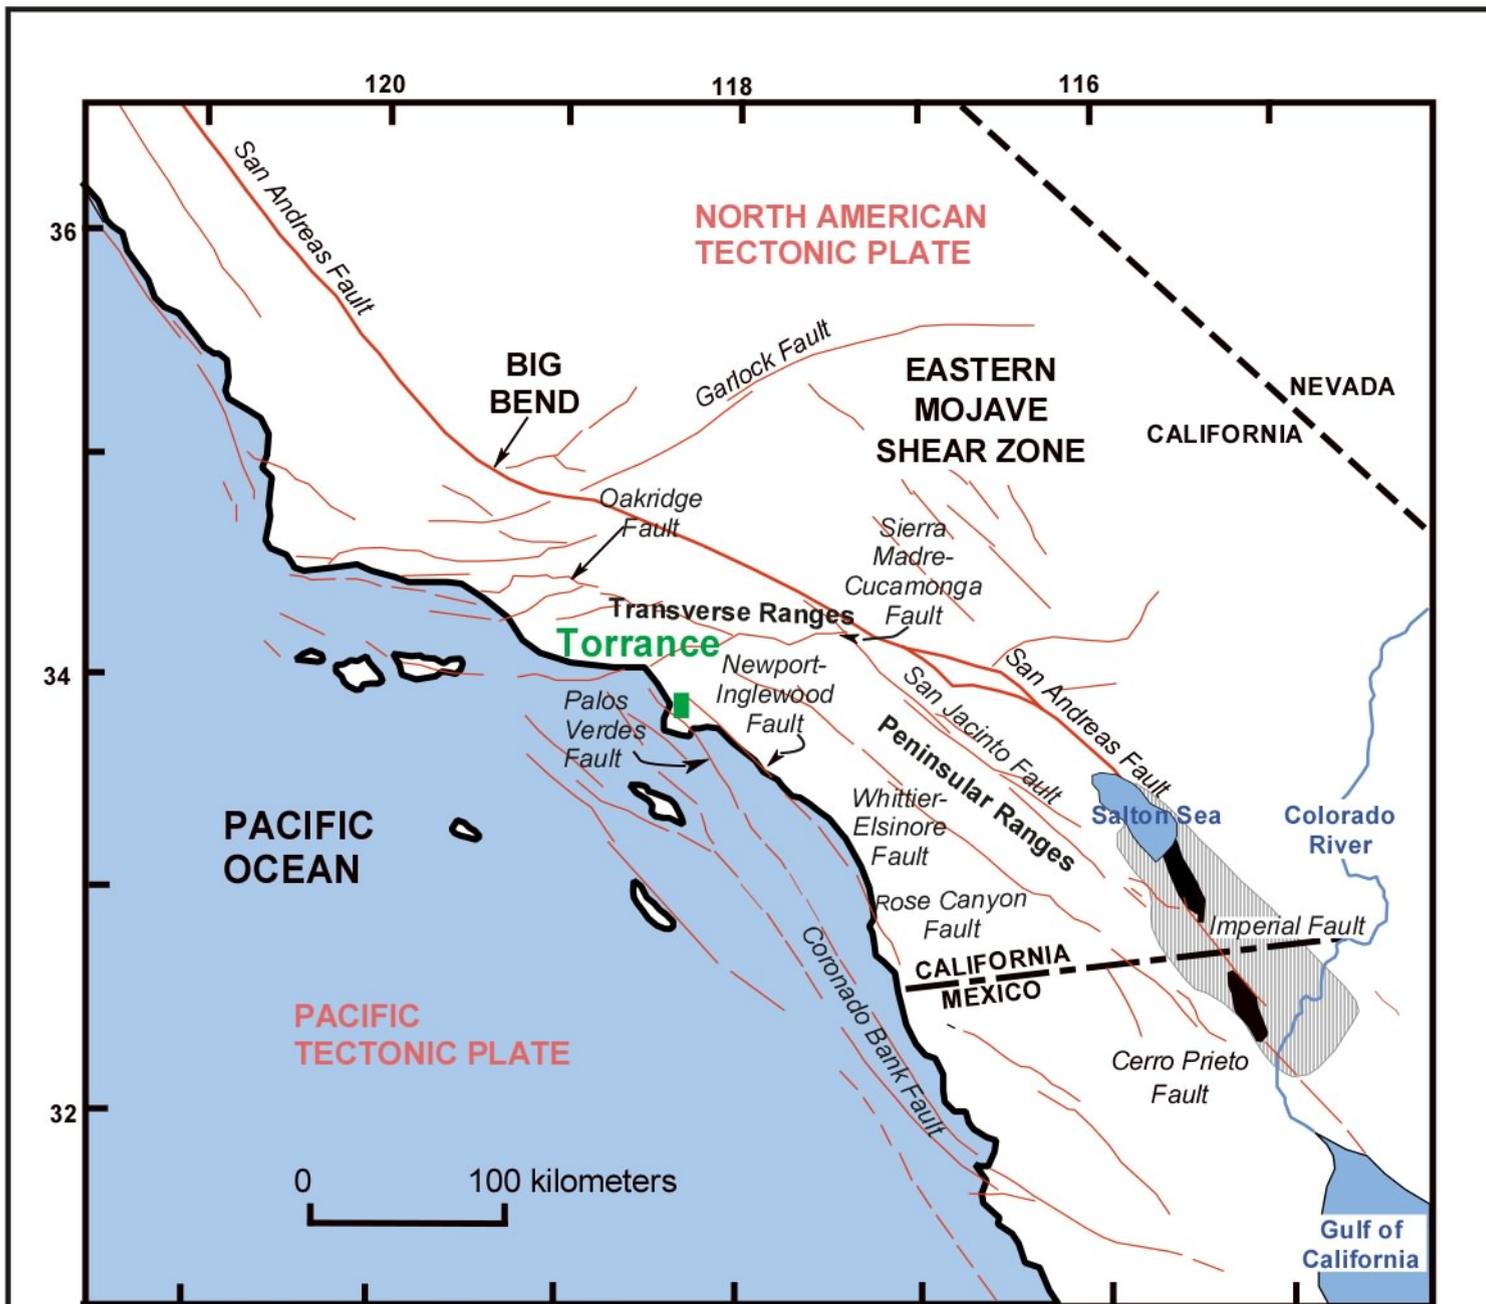
Figure
1-1

Source: Modified from Fuis and Mooney, 1990

However, there is a kink in the San Andreas fault commonly referred to as the "Big Bend." The northwest corner of the Big Bend is located about 75 miles north of Torrance (Figure 1-1). Near the Big Bend, the two plates do not slide past each other. Instead, they collide, causing localized compression, which results in folding and thrust faulting. Thrust faults meet the surface of the Earth at a low angle, dipping 25 to 35 degrees from horizontal. Thrusts are a type of dip-slip fault where rocks on opposite sides of the fault move up or down relative to each other. When a thrust fault ruptures, the top block of rock moves up and over the rock on the opposite side of the fault.

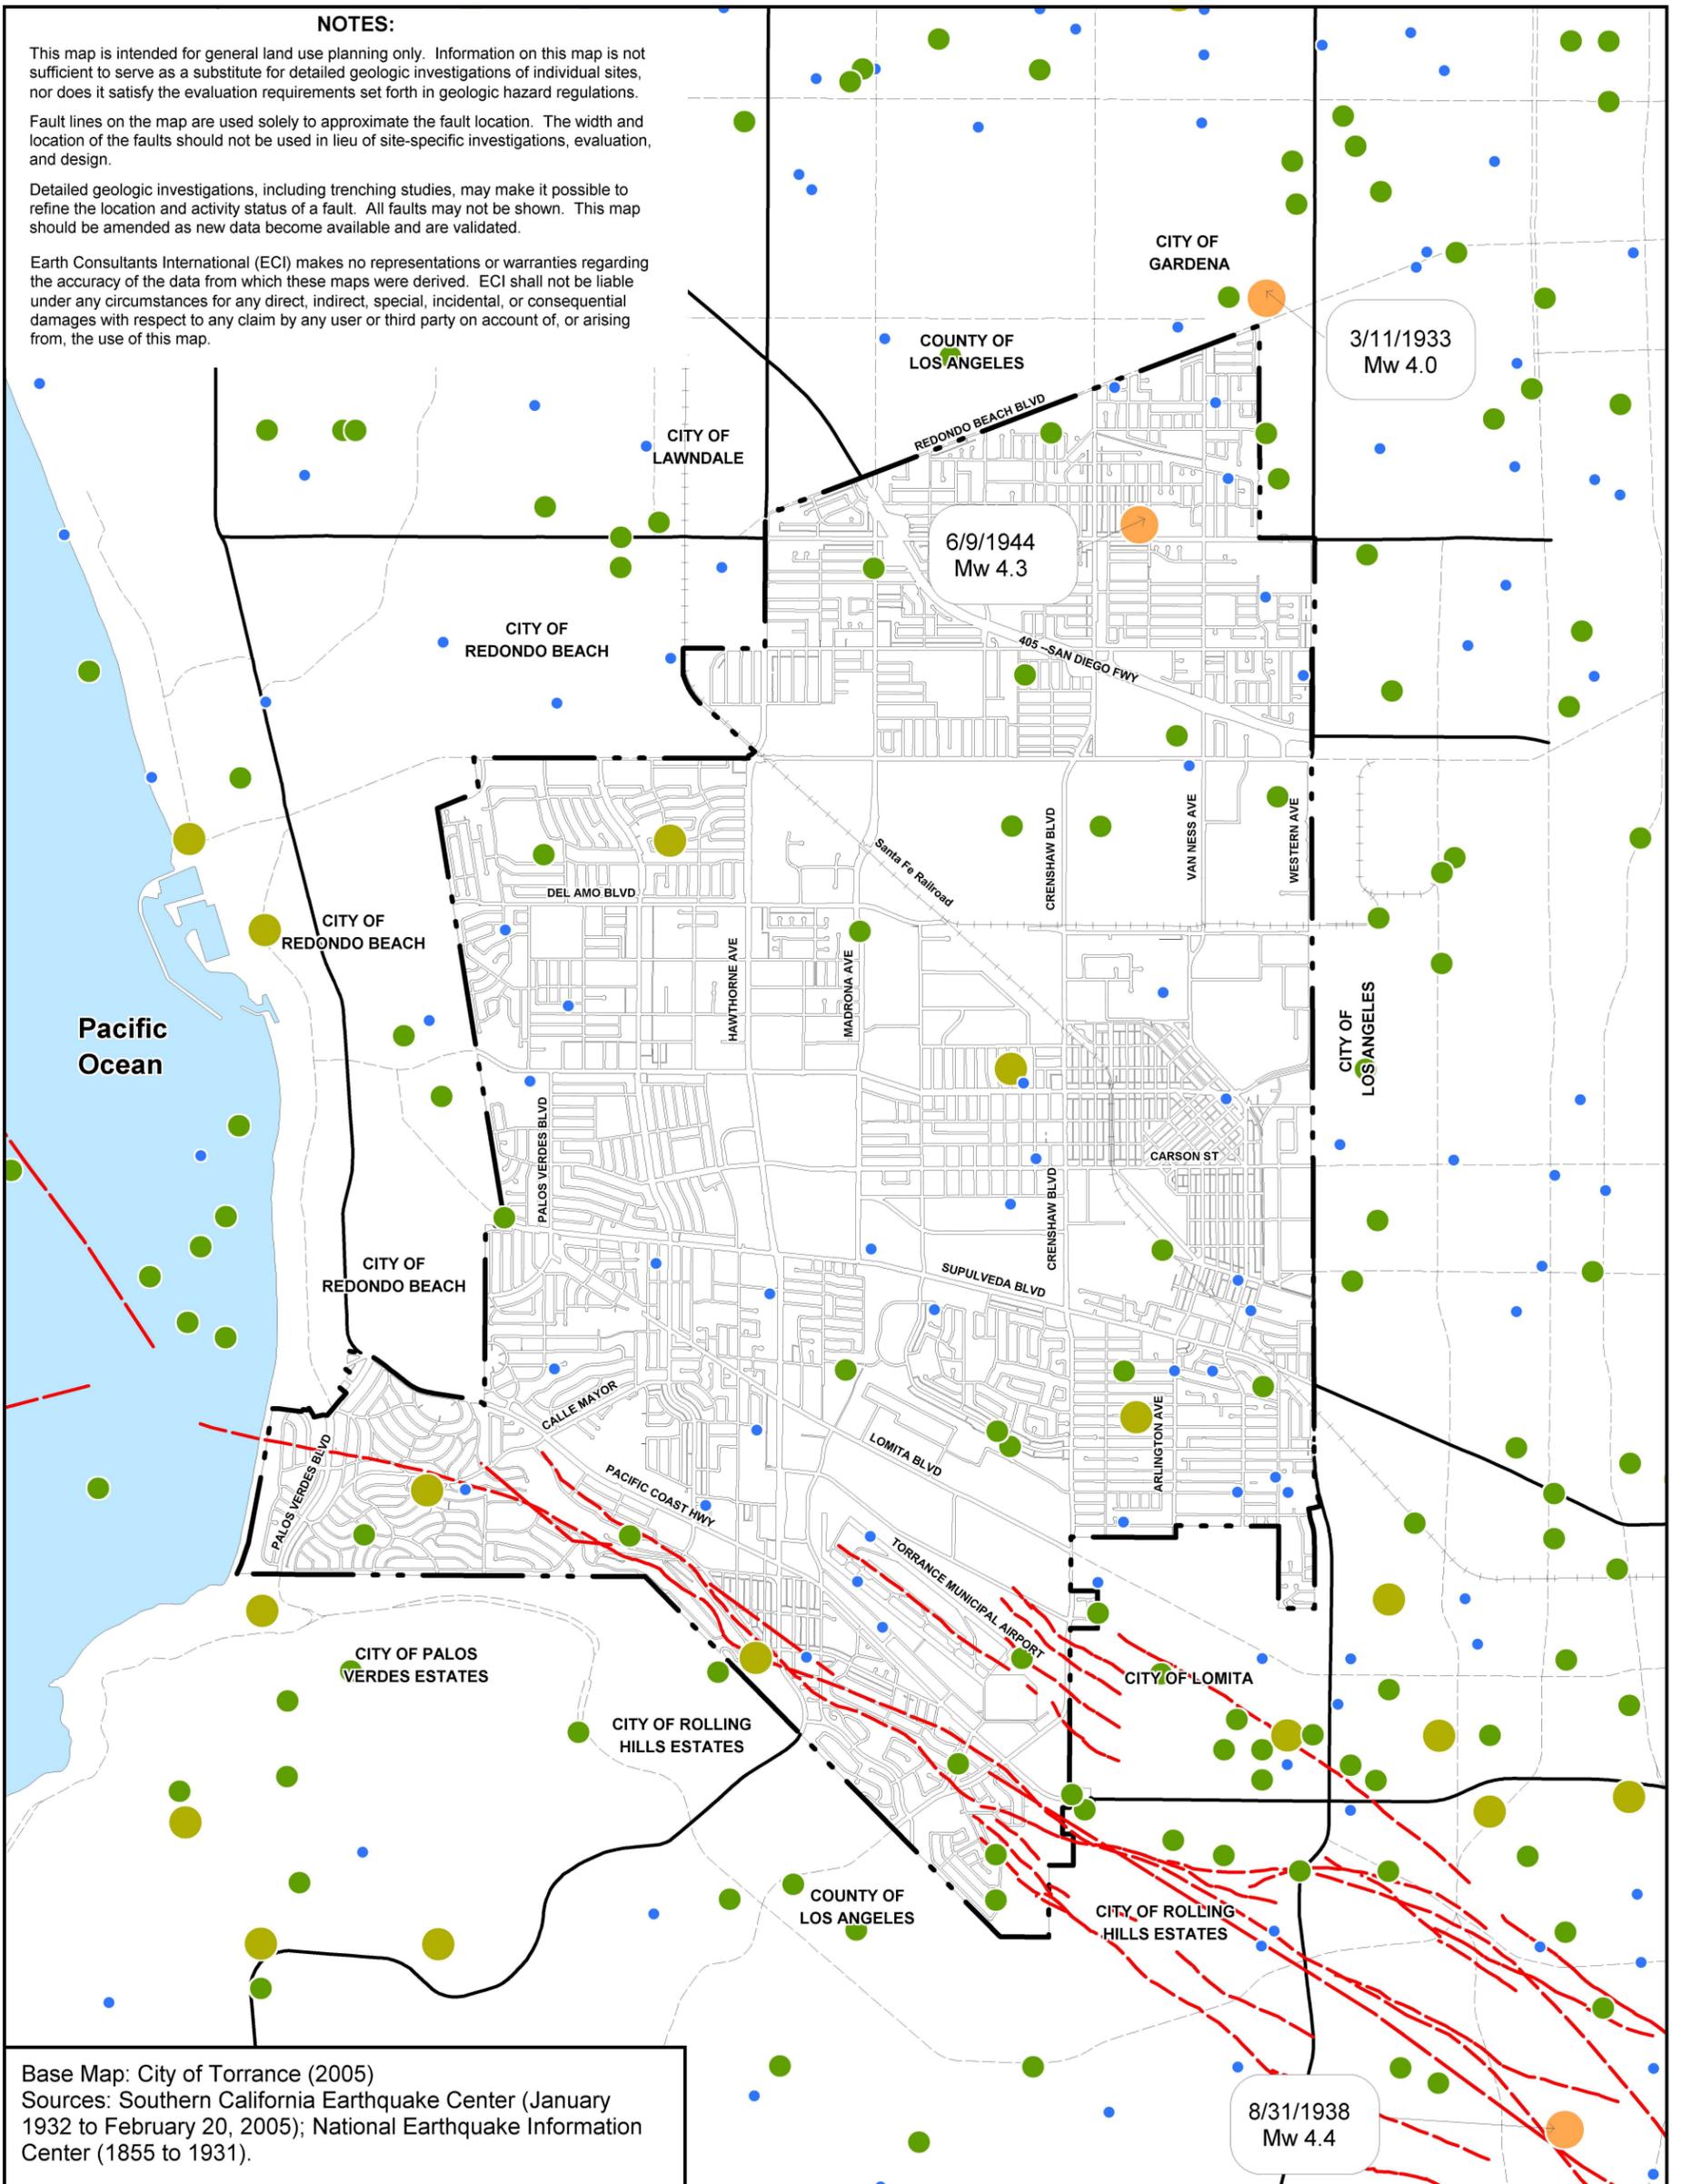
**Plate
 1-1**

Base Map: City of Torrance (2005)
 Sources: Southern California Earthquake Center (January 1932 to February 20, 2005); National Earthquake Information Center (1855 to 1931).

Figure 1-3 shows the approximate epicenters of some of the earthquakes that have resulted in significant ground shaking in the southern California area, including Torrance, since at least the 1800s. The most significant of these events are described below. Plate 1-1 shows the approximate epicentral locations of historical earthquakes in and around the city. Please note that the locations and magnitudes of pre-1932 earthquakes are approximate since there were no instruments available to measure these parameters before 1932.

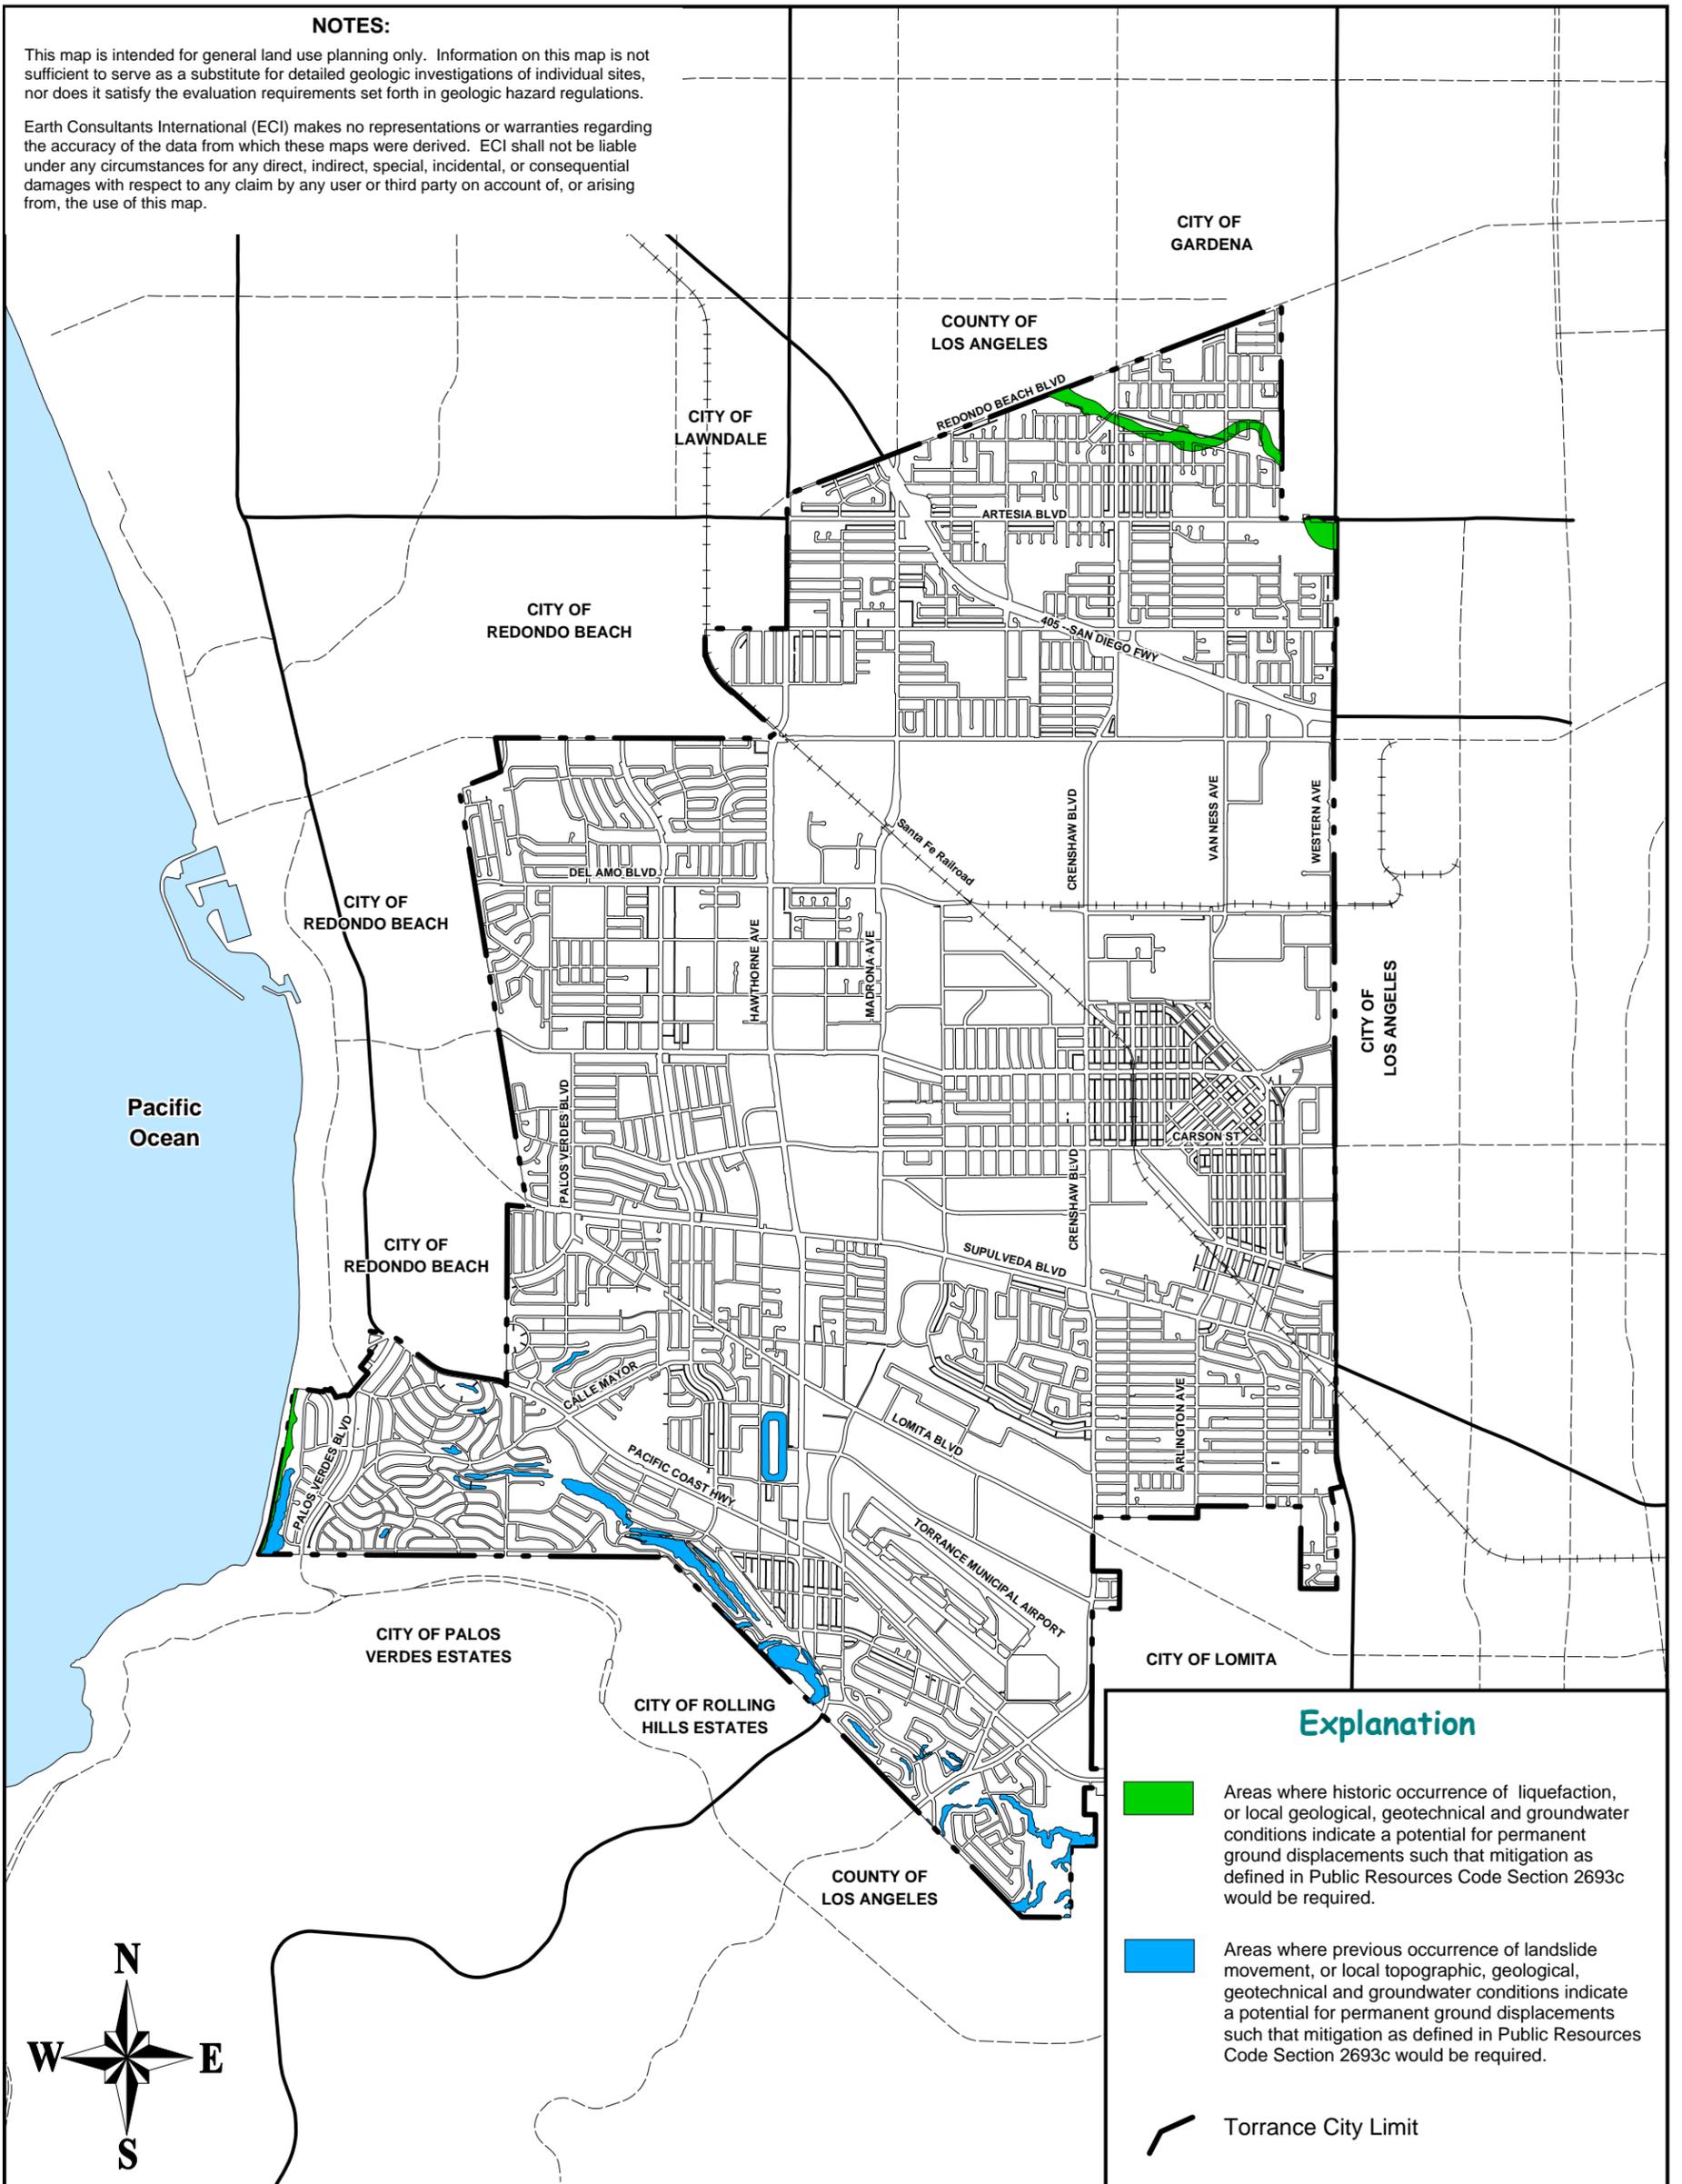
- Areas where historic occurrence of liquefaction, or local geological, geotechnical and groundwater conditions indicate a potential for permanent ground displacements such that mitigation as defined in Public Resources Code Section 2693c would be required.
- Areas where previous occurrence of landslide movement, or local topographic, geological, geotechnical and groundwater conditions indicate a potential for permanent ground displacements such that mitigation as defined in Public Resources Code Section 2693c would be required.
- Torrance City Limit

Base Map: City of Torrance (2005).
Sources: California Division of Mines and Geology, 1998; (Inglewood, Redondo Beach, and Torrance Quadrangles)

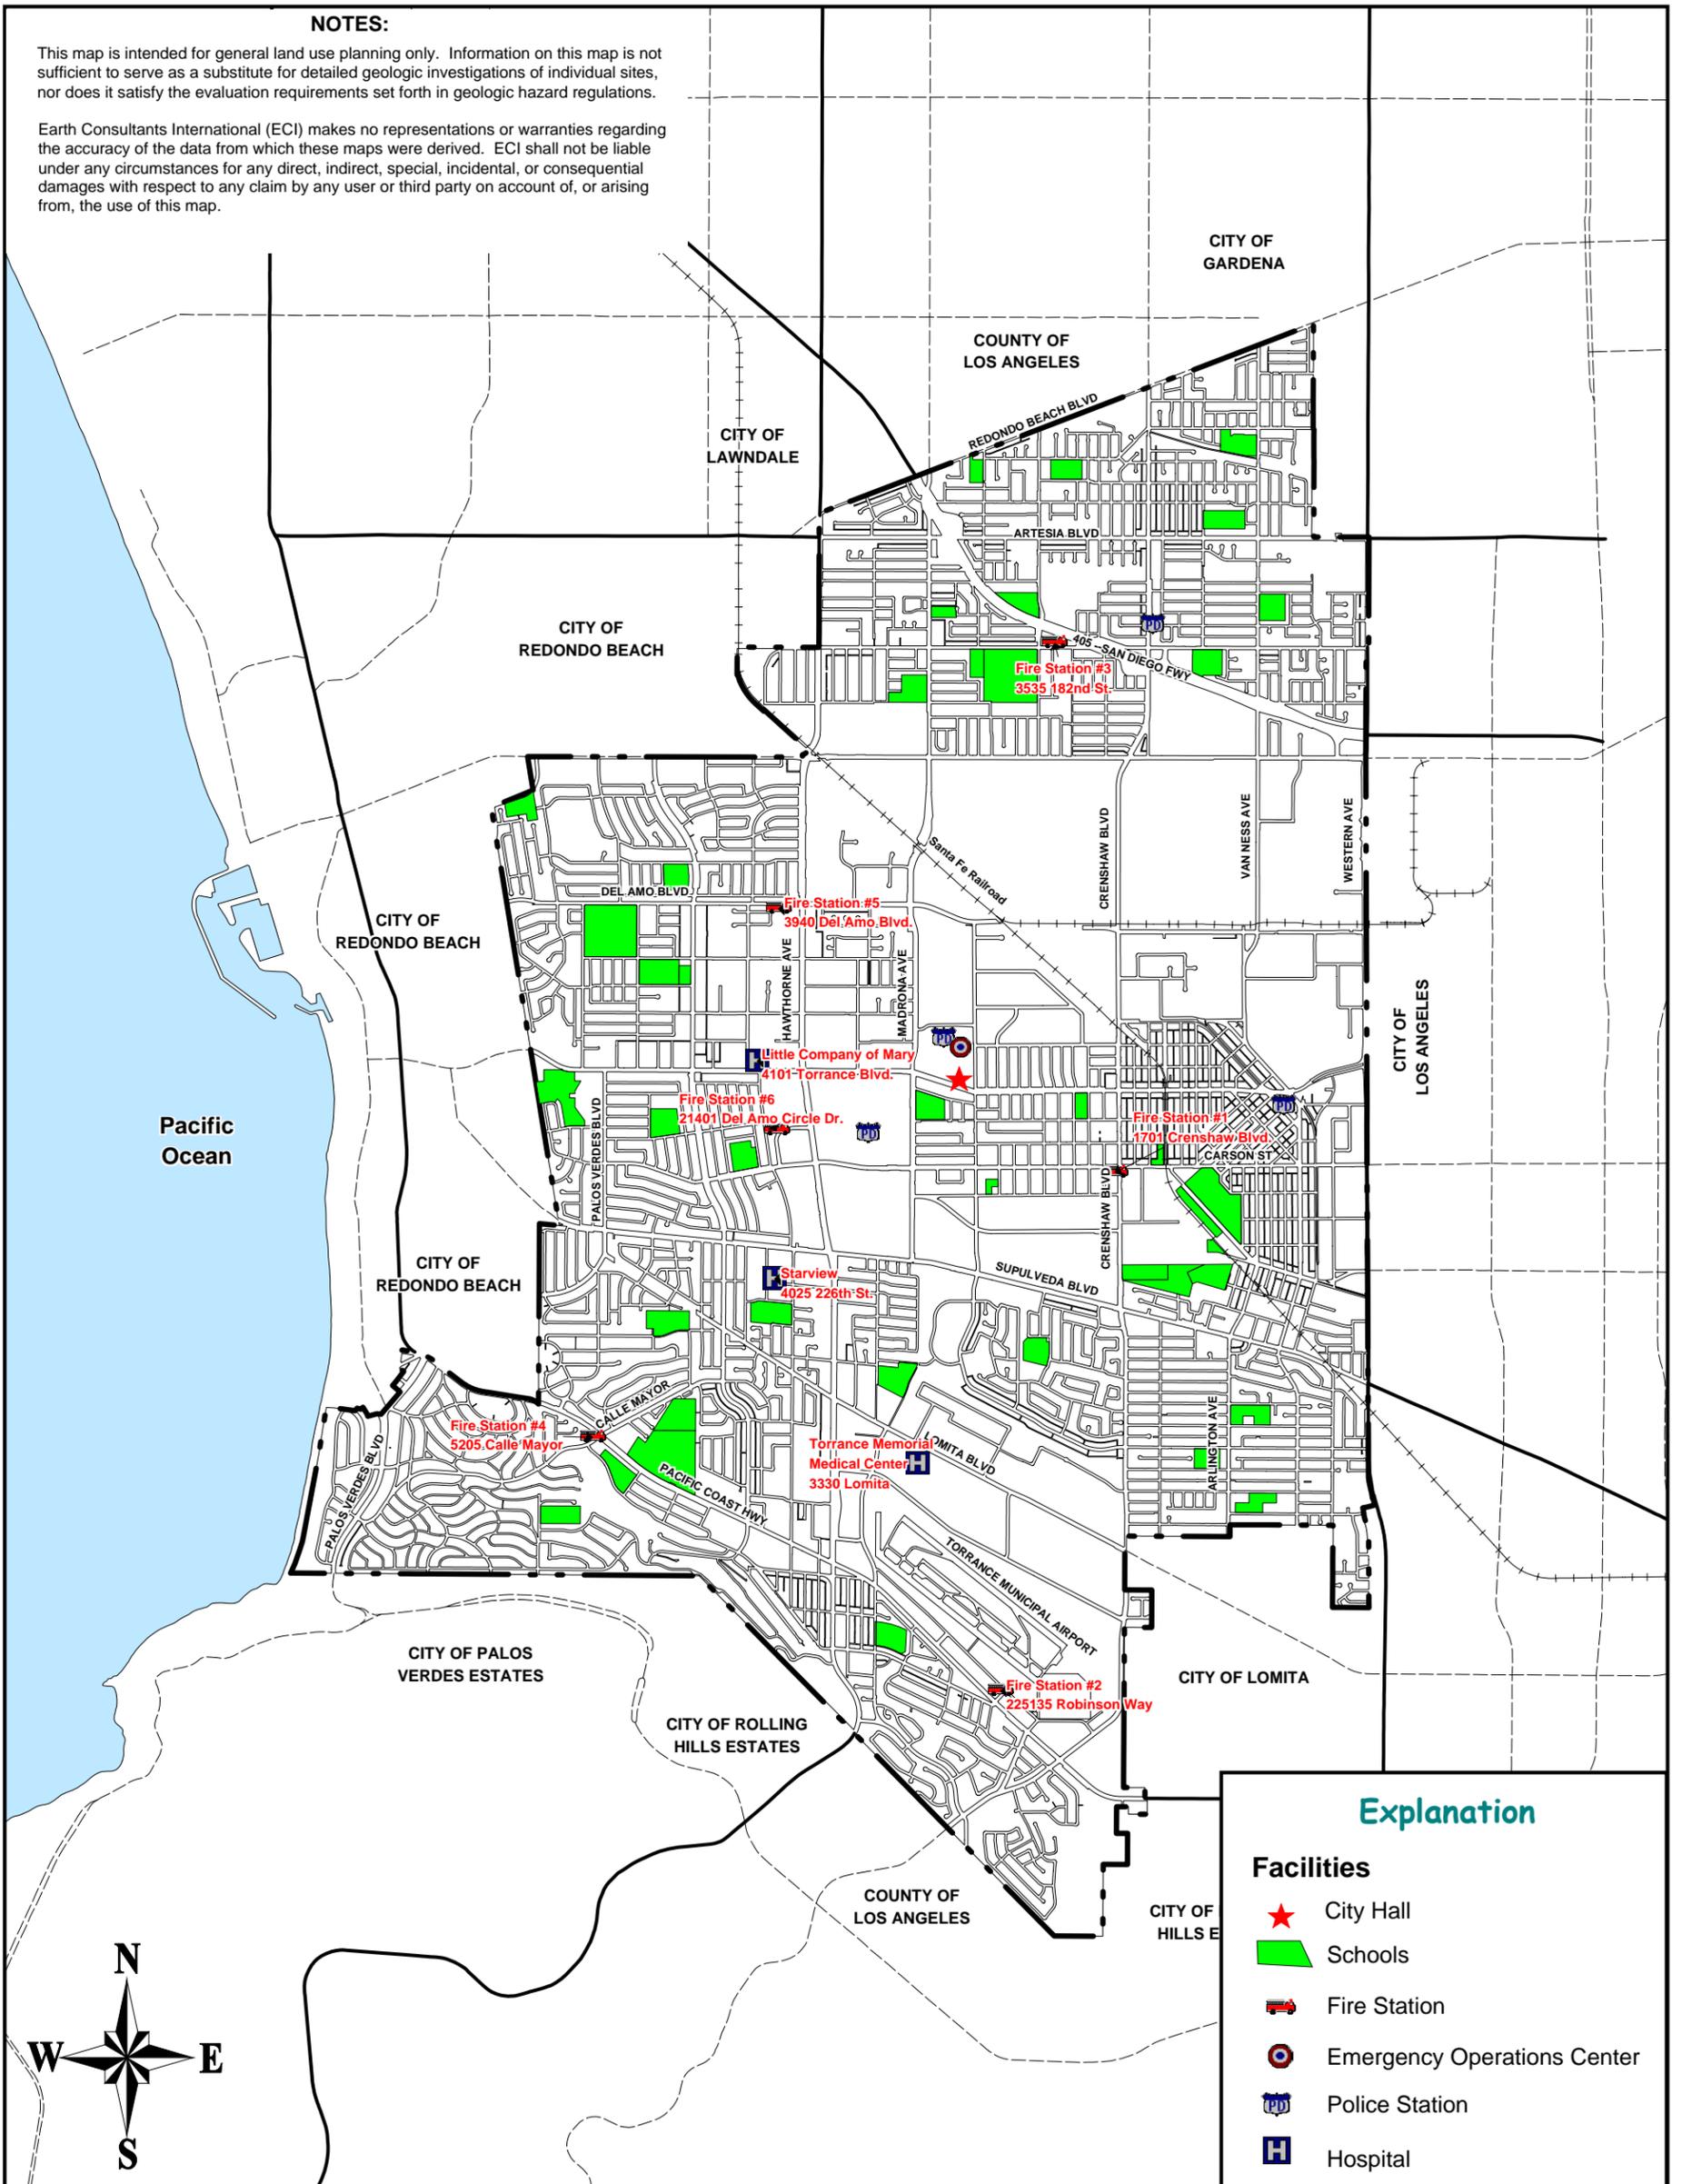
- City Hall
- Schools
- Fire Station
- Emergency Operations Center
- Police Station
- Hospital

Base Map: City of Torrance
Source: Essential Facilities, City of Torrance

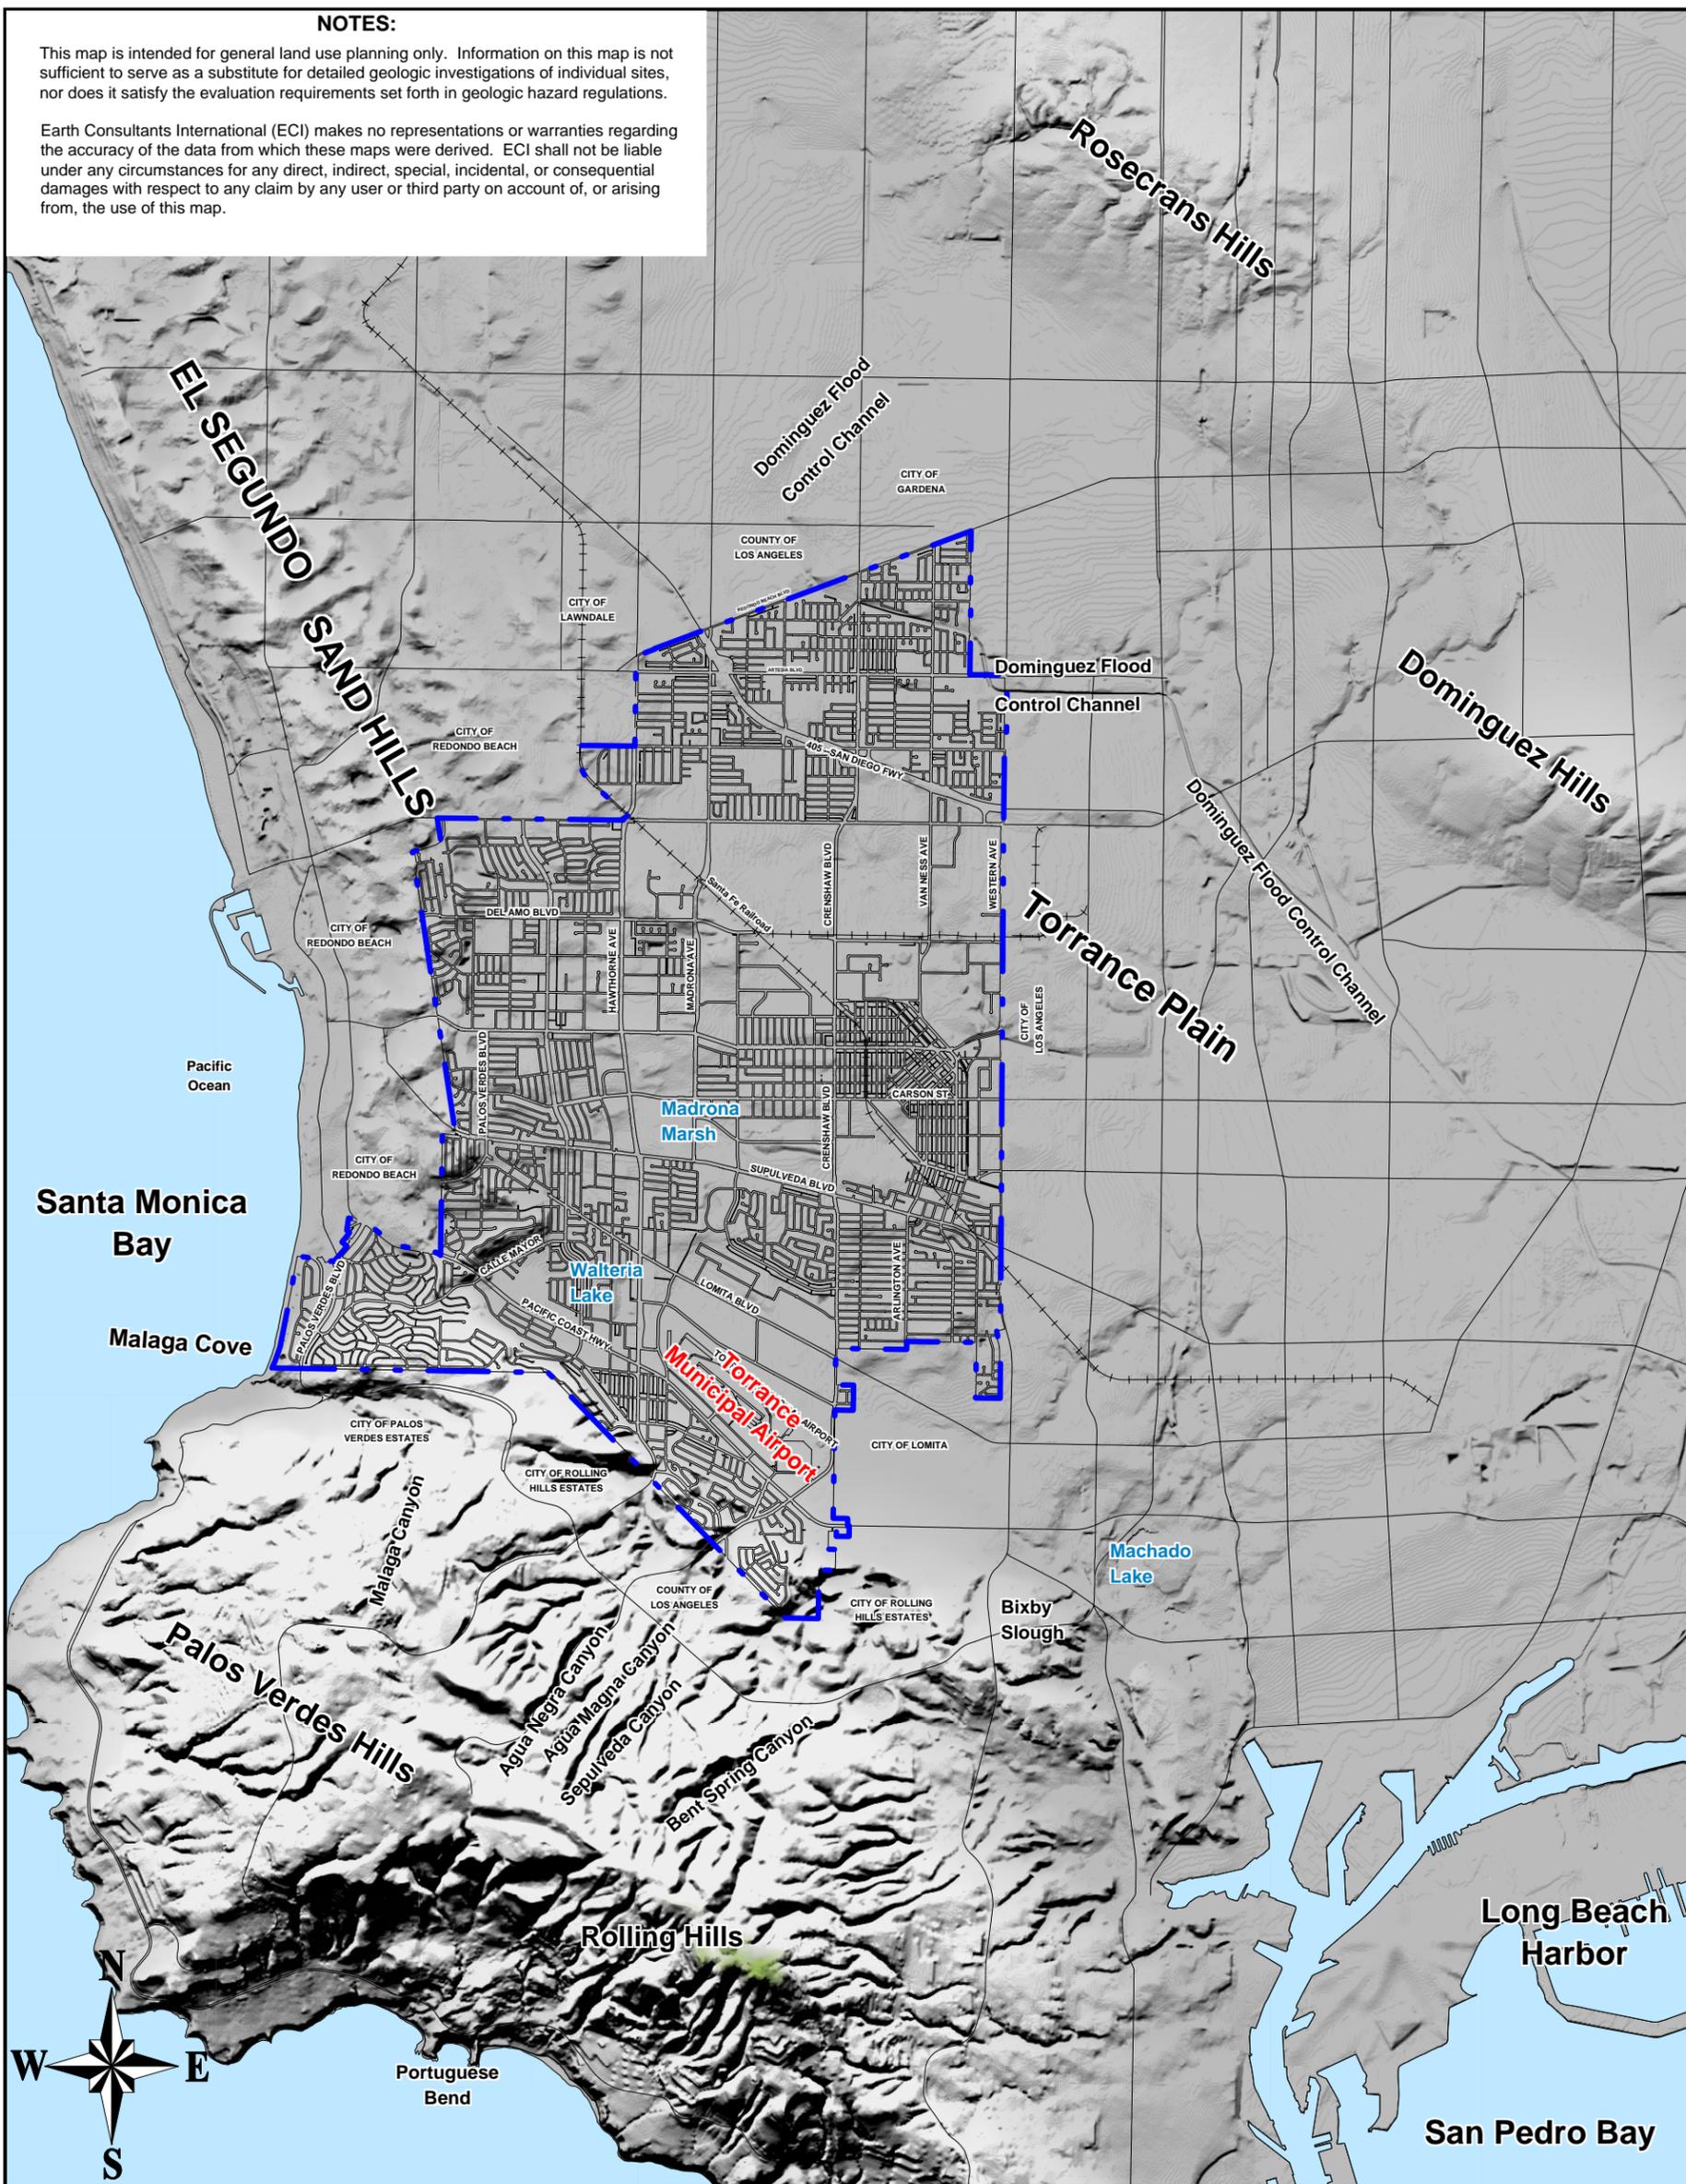
Plate 2-1

Physiographic Map of Torrance, California and Surrounding Areas

The landscape within the city can best be described by physiographic area, each reflective of its distinct topographic features (see Plate 2-1). The central and western portions of the city encompass the southern part of an area once known as the El Segundo Sand Hills (also known as the El Segundo Sand Dunes). Prior to development, this area consisted of ancient and modern sand dunes that extended from the sea to about four miles inland, with dunes rising to almost 200 feet above sea level, creating a landscape of shallow hills and closed depressions. The northeastern part of the city, as well as the relatively flat area between Lomita Boulevard and Pacific Coast Highway in the south, is part of a physiographic area known as the Torrance Plain. This plain, which parallels the Newport-Inglewood uplift from the Ballona Gap to Wilmington, is a prehistoric flood plain that was intermittently inundated by the sea. Its history of emergence and submergence has been revealed in excavations that have yielded fresh-water fossils, extinct land mammals, and marine fossils (California Department of Water Resources - DWR, 1961). Today, this area is slightly elevated above the modern flood plain, and has been gently dissected by local streams. Hillside areas within the city are confined to coastal bluffs and, at its southern margin, the base of the Palos Verdes Hills. During the last 80 years, the city's natural landscape has been largely altered by dense urban development. Lowland portions of city, including the area of the El Segundo Sand Hills, are now at elevations ranging from about 60 to 100 feet above sea level. The Palos Verdes Hills rise to an elevation of about 1,480 feet; however, the portions of the hills within city limits reach only to about 400 feet above sea level.

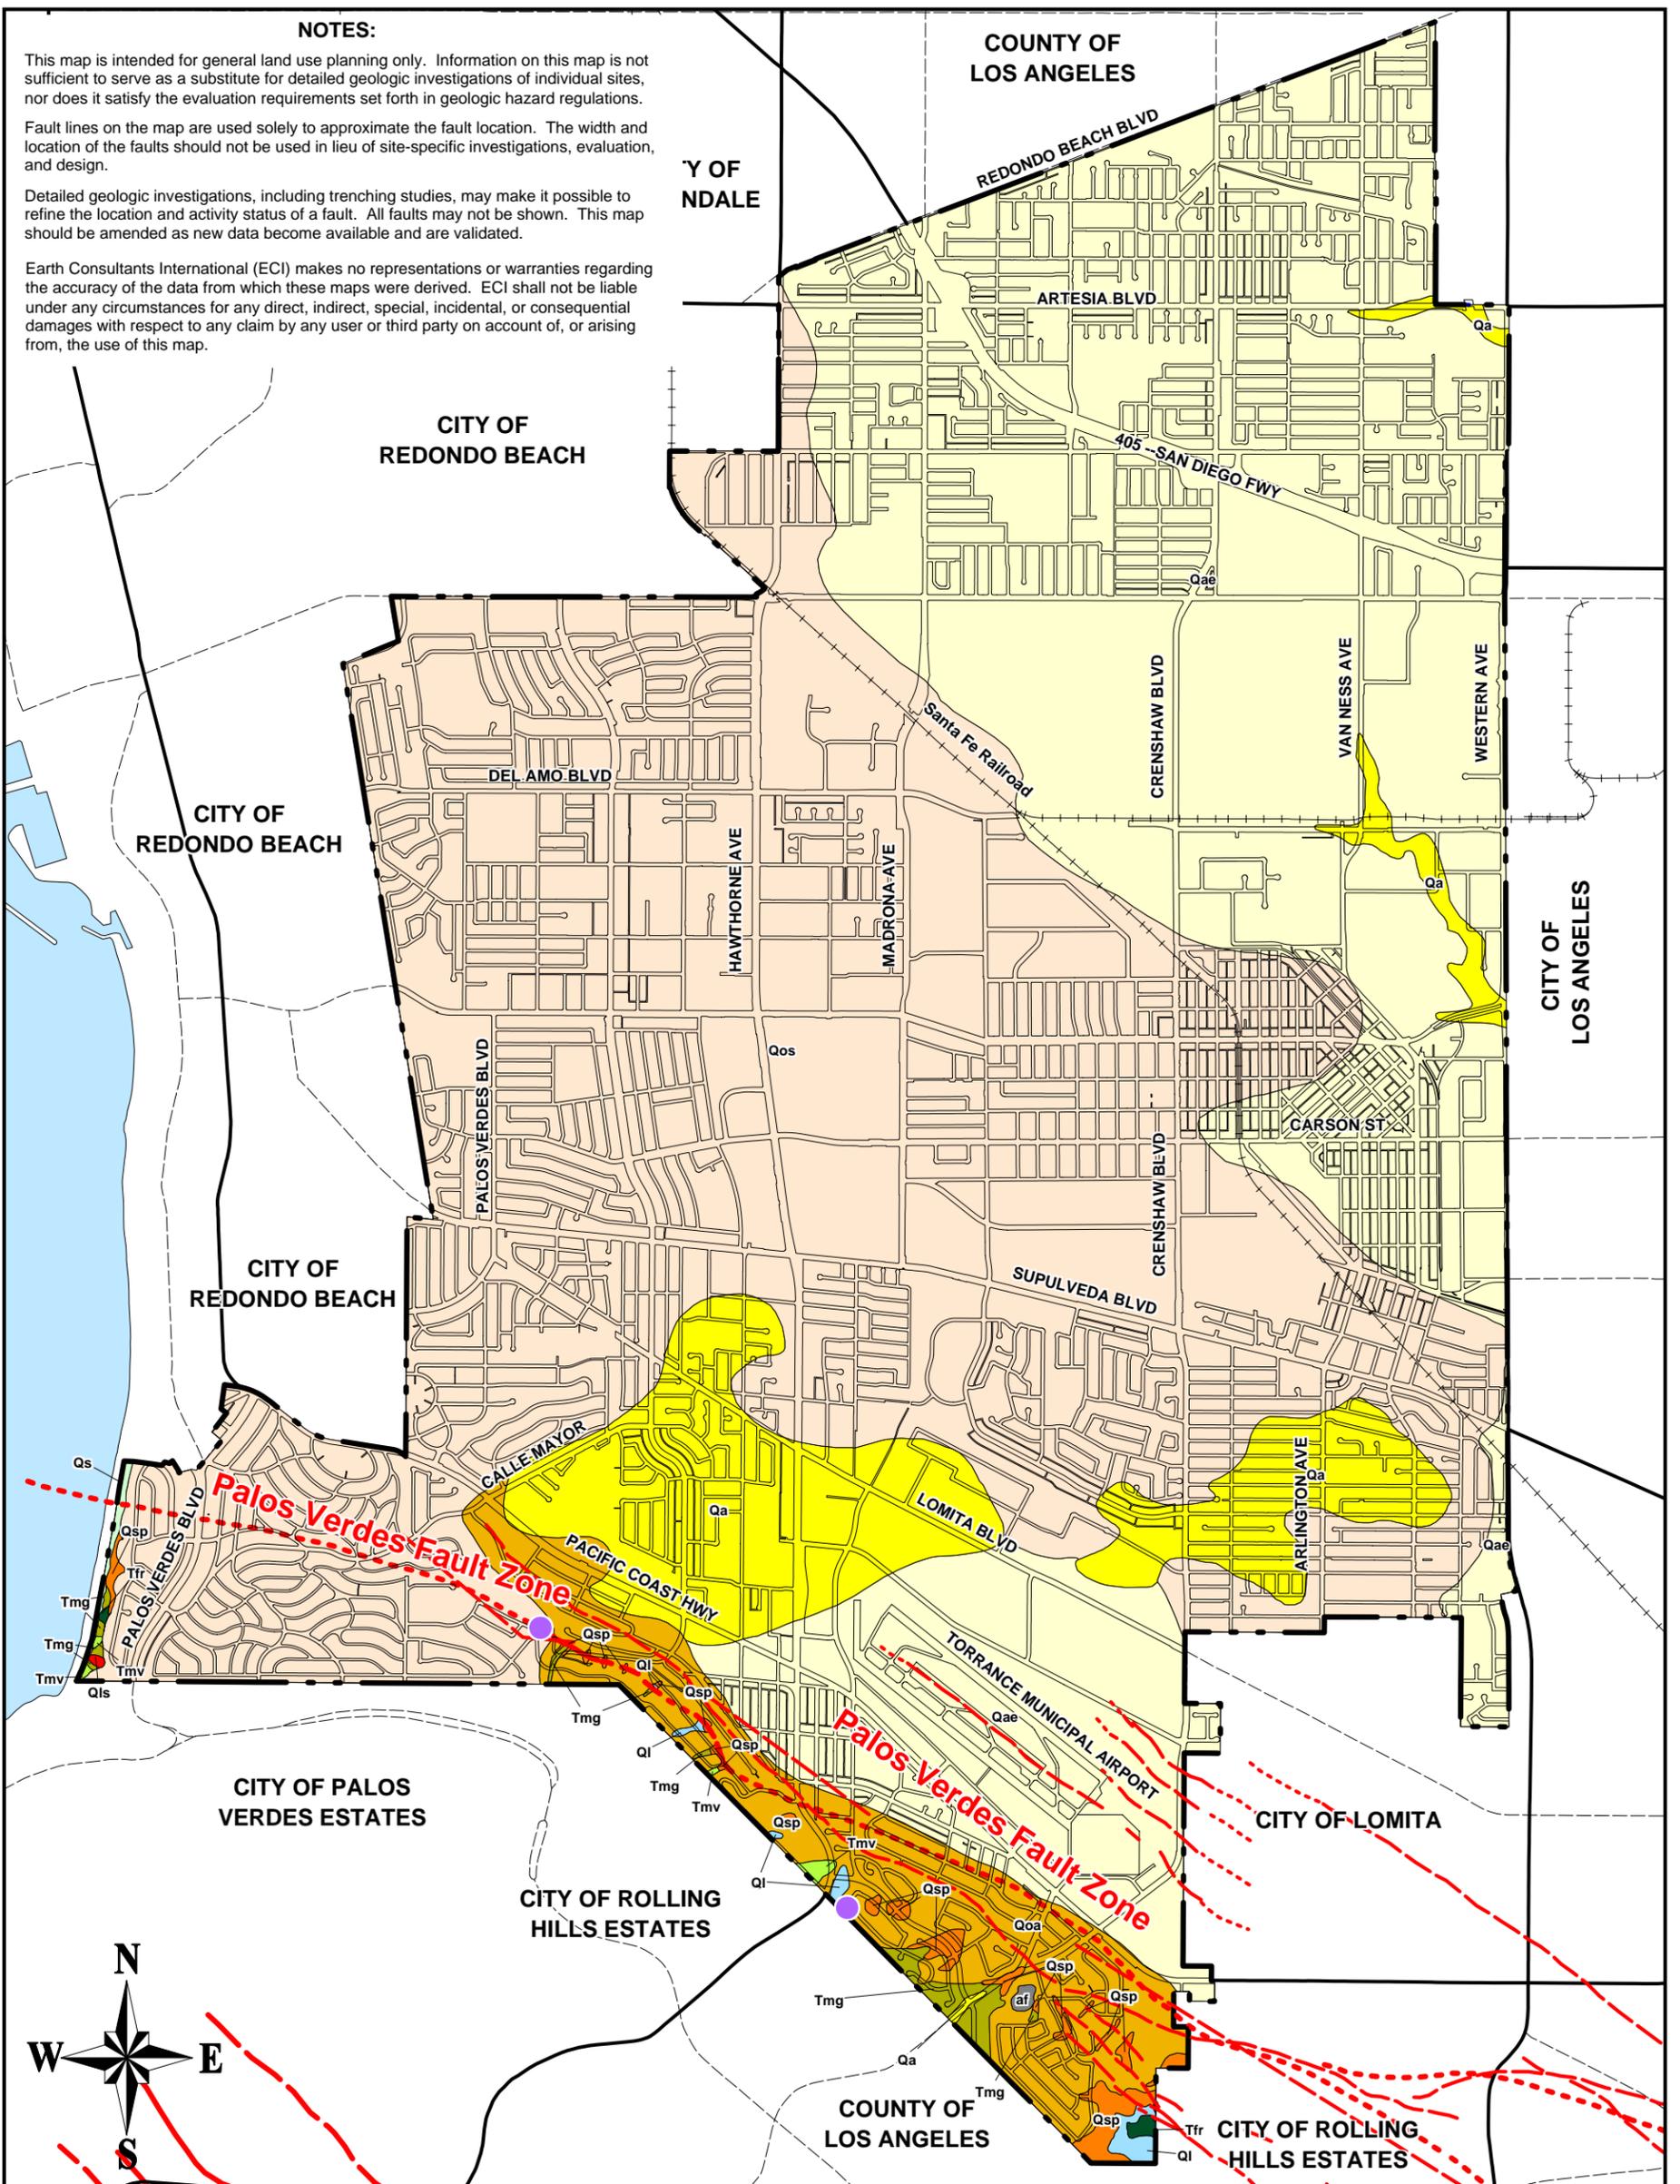
Base Map: City of Torrance (2005).
Sources: Faults and Geology, Dibblee (1999).

For the key to map symbols and Geologic Descriptions, See Plate 2-2a.

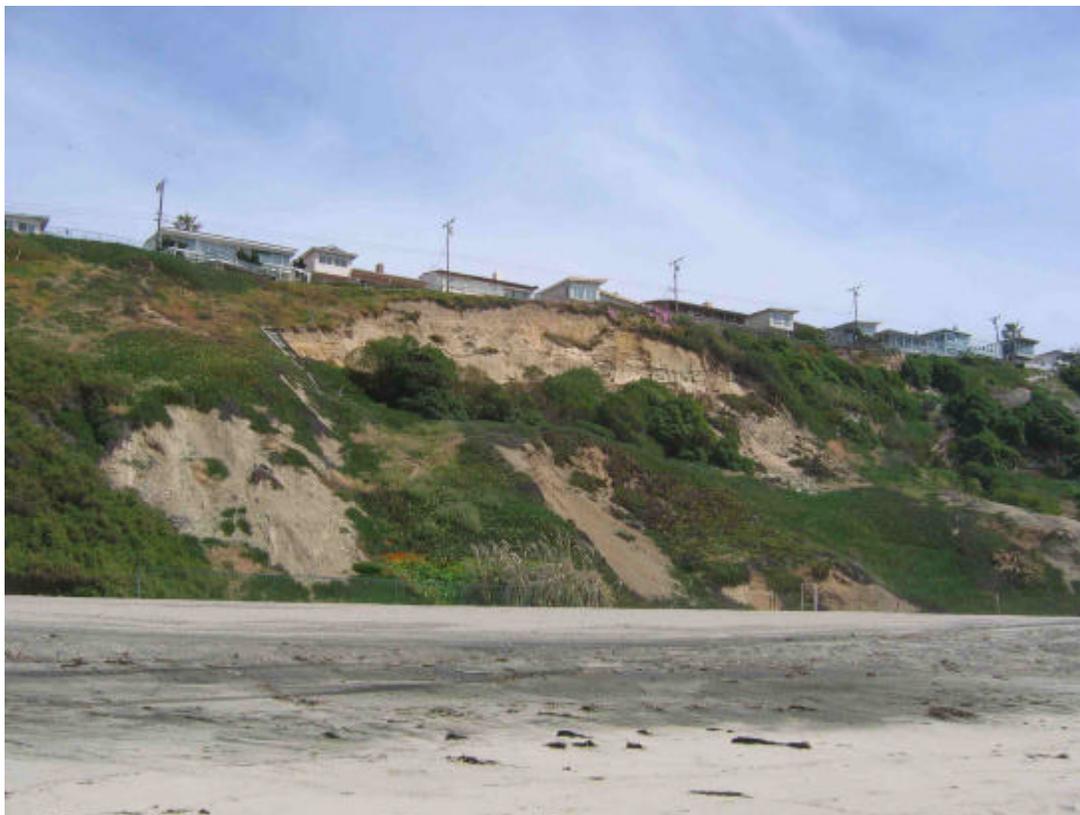
Figure 2-1: Sea Cliff Above Torrance Beach Showing Signs of Past Slope Instability.

Note the hummocky topography and steep scarp below the homes.
