**TECHNICAL BACKGROUND REPORT to the
SAFETY ELEMENT of the GENERAL PLAN
for the CITY of TORRANCE,
LOS ANGELES COUNTY, CALIFORNIA**

**SEISMIC HAZARDS
GEOLOGIC HAZARDS
FLOODING HAZARDS
FIRE HAZARDS
HAZARDOUS MATERIALS MANAGEMENT
AVIATION HAZARDS**

August 2005

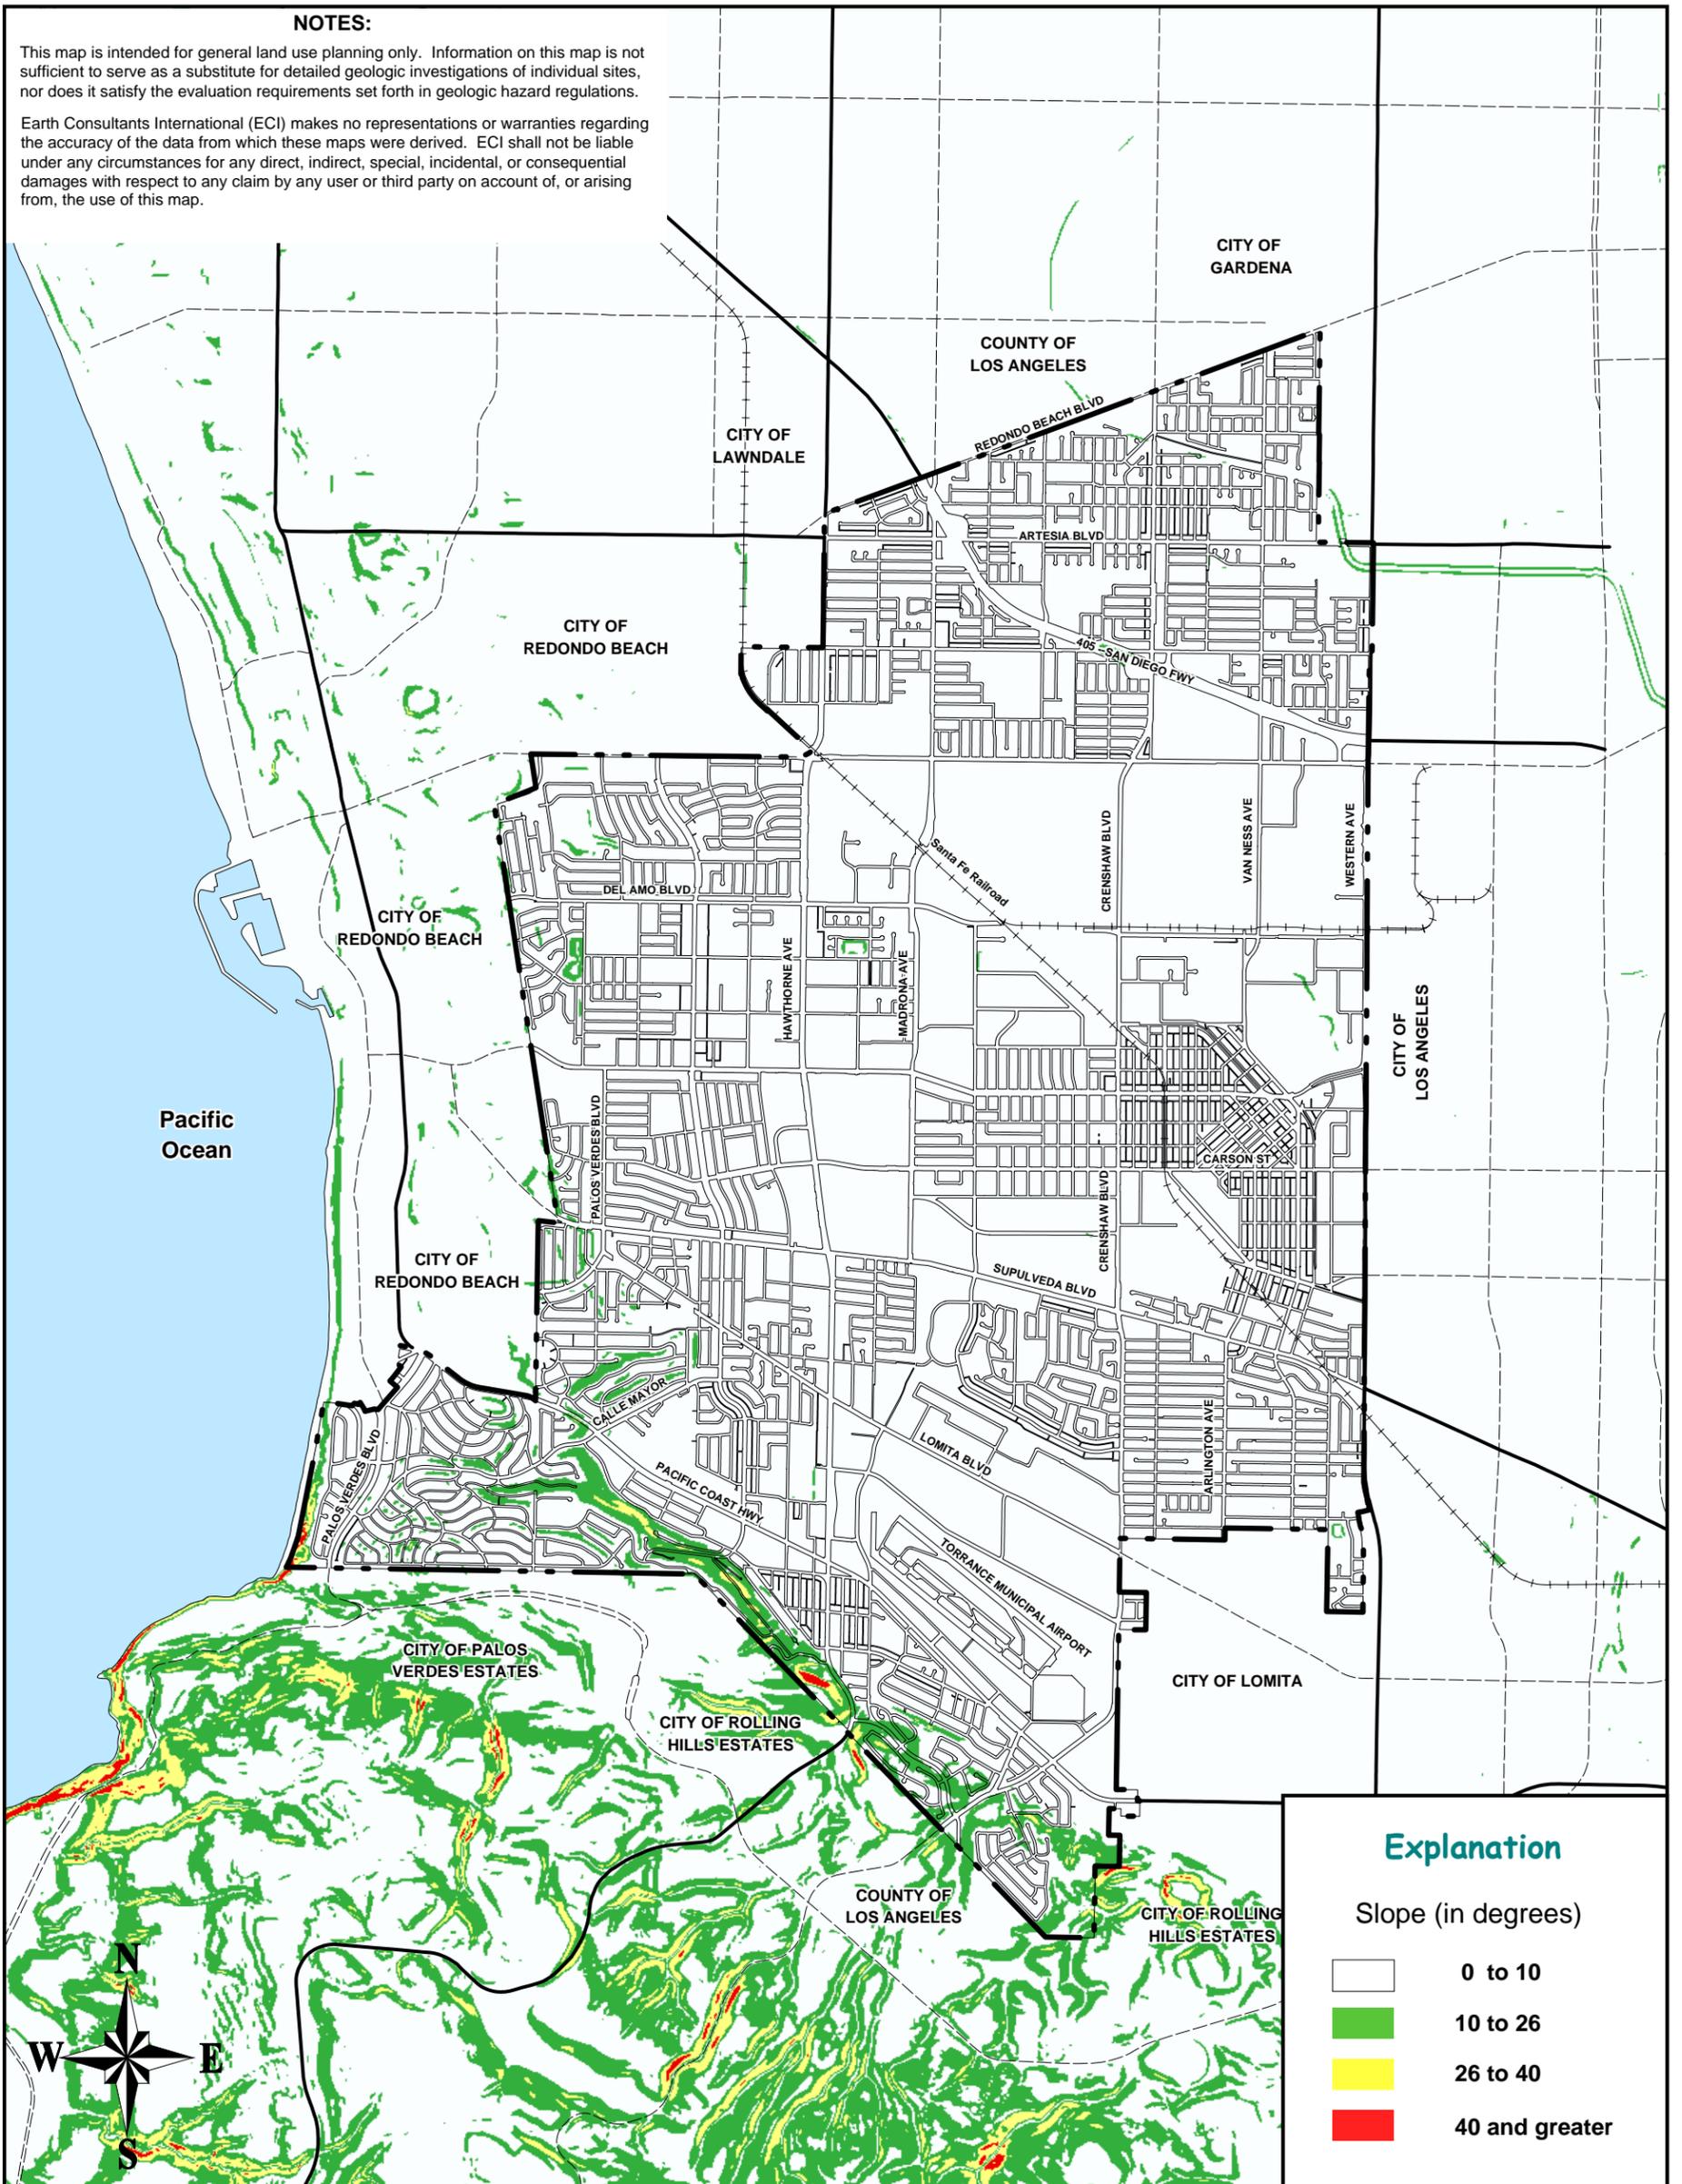
Plate
2-3

Slope (in degrees)

Table 2-1 below is a summary of the geologic conditions in various parts of the city that provide the environment for slope instability to occur. These conditions usually include such factors as terrain steepness, rock or soil type, condition of the rock (such as degree of fracturing and weathering), internal structures within the rock (such as bedding, foliation, faults) and the prior occurrence of slope failures. Catalysts that ultimately allow slope failures to occur in vulnerable terrain are most often water (heavy and prolonged rainfall), erosion and undercutting by streams, man-made alterations to the slope, or seismic shaking. The summary in Table 2-1 was derived from the Geologic Map (Plate 2-2), and the Slope Distribution Map (Plate 2-3).

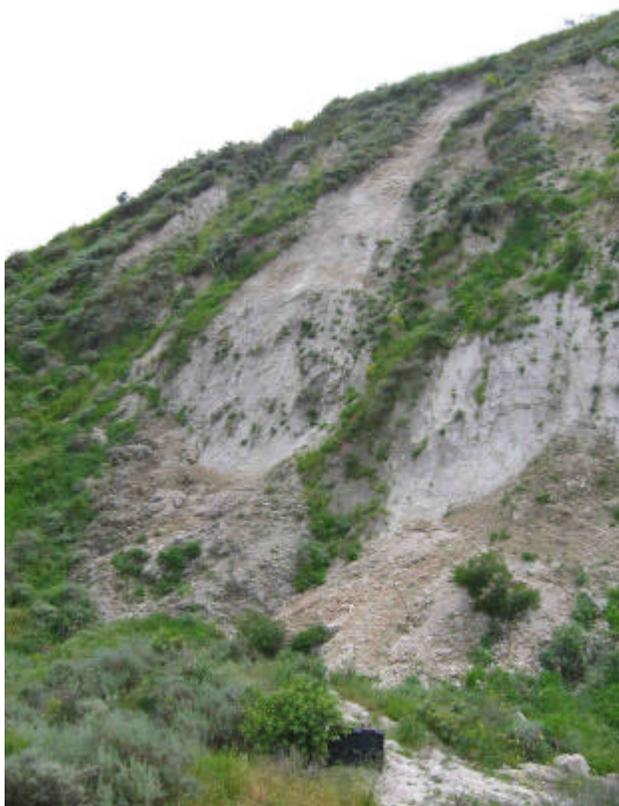
Figure 2-2: Soil Slippage on a Steep Quarry Slope at the Base of the Palos Verdes Hills. Note the accumulation of soil debris at the base of the slope. Such failures during intense winter rains are often the catalyst for dangerous debris flows.

Soil Slip - This type of failure is generated by strong winter storms, and is widespread in the steeper slope areas, particularly after winters with prolonged and/or heavy rainfall. Failure occurs on canyon sideslopes, and in soils that have accumulated in swales, gullies and ravines. Soil slips can also occur on graded slopes, especially older slopes, and those that are poorly maintained. Slope steepness has a strong influence on the development of soil slips, with most slips occurring on slopes with gradients of between about 27 and 56 degrees (Campbell, 1975). More recently, in a study of the Santa Paula area of Ventura County it was found that about 70 percent of the debris flows generated during winter storms occurred on slopes between 20 and 36 degrees (Morton et al., 2003). For slope gradients in the Torrance area, refer to the Slope Distribution Map (Plate 2-3). Figure 2-2 shows recent soil slippage on the steep slopes of an abandoned quarry pit in at the base of the Palos Verdes Hills.

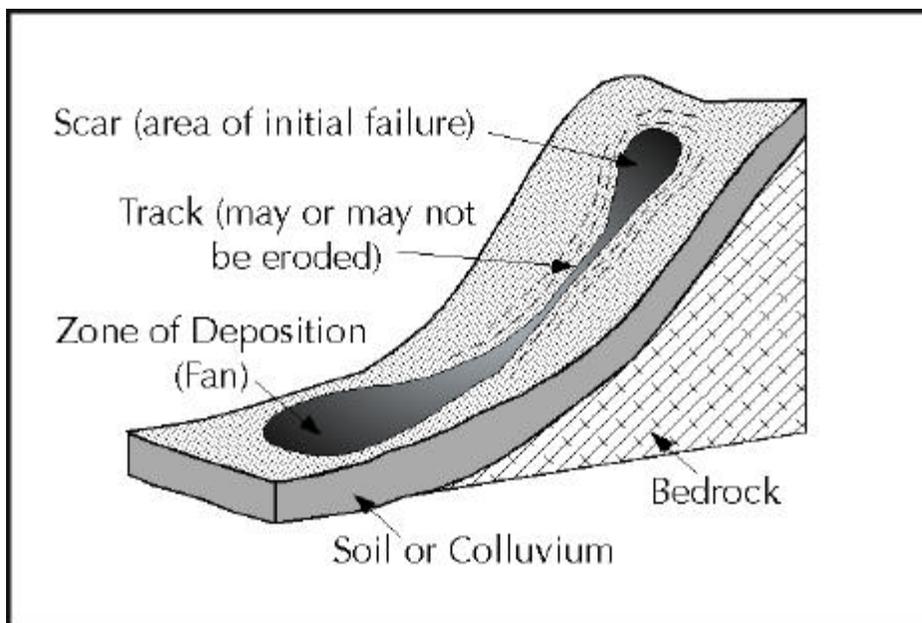
Figure 2-3: Sketch of a Typical Debris Avalanche Scar and Track

Modified from:
http://www.consrv.ca.gov/cgs/information/publications/cgs_notes/note_33/index.htm.
Original sketch by Janet K. Smith

A debris flow most commonly originates as a soil slip in the rounded, soil-filled "hollow" at the head of a drainage swale or ravine (see Figure 2-3). The rigid soil mass is deformed into a viscous fluid that moves down the drainage, incorporating into the flow additional soil and vegetation scoured from the channel. Debris flows also occur on canyon walls, often in soil-filled swales that do not have topographic expression. The velocity of the flow depends on the viscosity, slope gradient, height of the slope, roughness and gradient of the channel, and the baffling effects of vegetation. Even relatively small amounts of debris can cause damage from inundation and/or impact (Ellen and Fleming, 1987; Reneau and Dietrich, 1987). Recognition of this hazard led the Federal Emergency Management

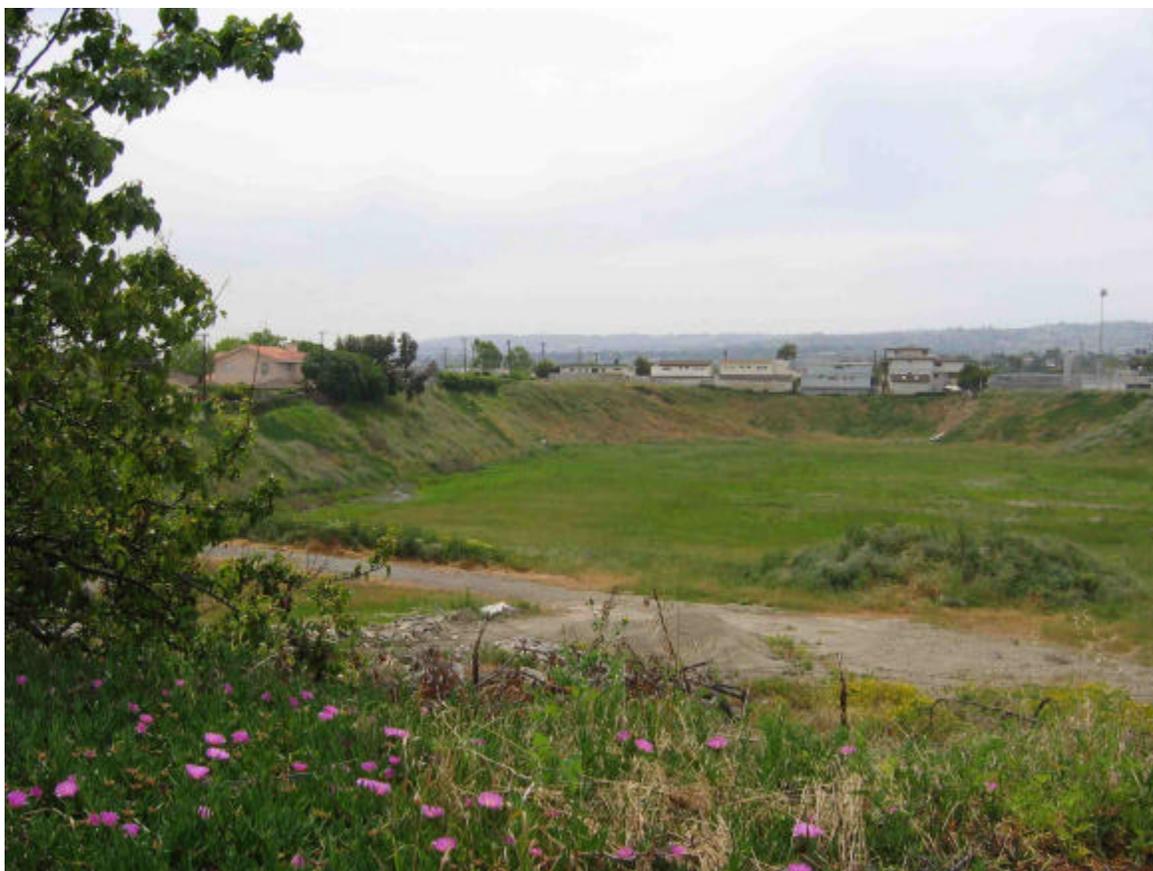
Figure 3.1: Bishop Montgomery Basin Occupies What Was Once Part of a Natural Closed Depression in Dunes of the El Segundo Sand Hills

In the southeastern part of the city, the Wilmington Drain discharges runoff to Machado Lake. In the south-central part of the city, runoff is directed via storm drains to the Walteria Retention Basin (Plates 2-1 and 3-2), where it is dissipated by infiltration and evaporation. Within the El Segundo Sand Hills, local runoff is directed to detention or retention basins scattered throughout the area. Many of these basins occupy what were natural depressions between the dunes.

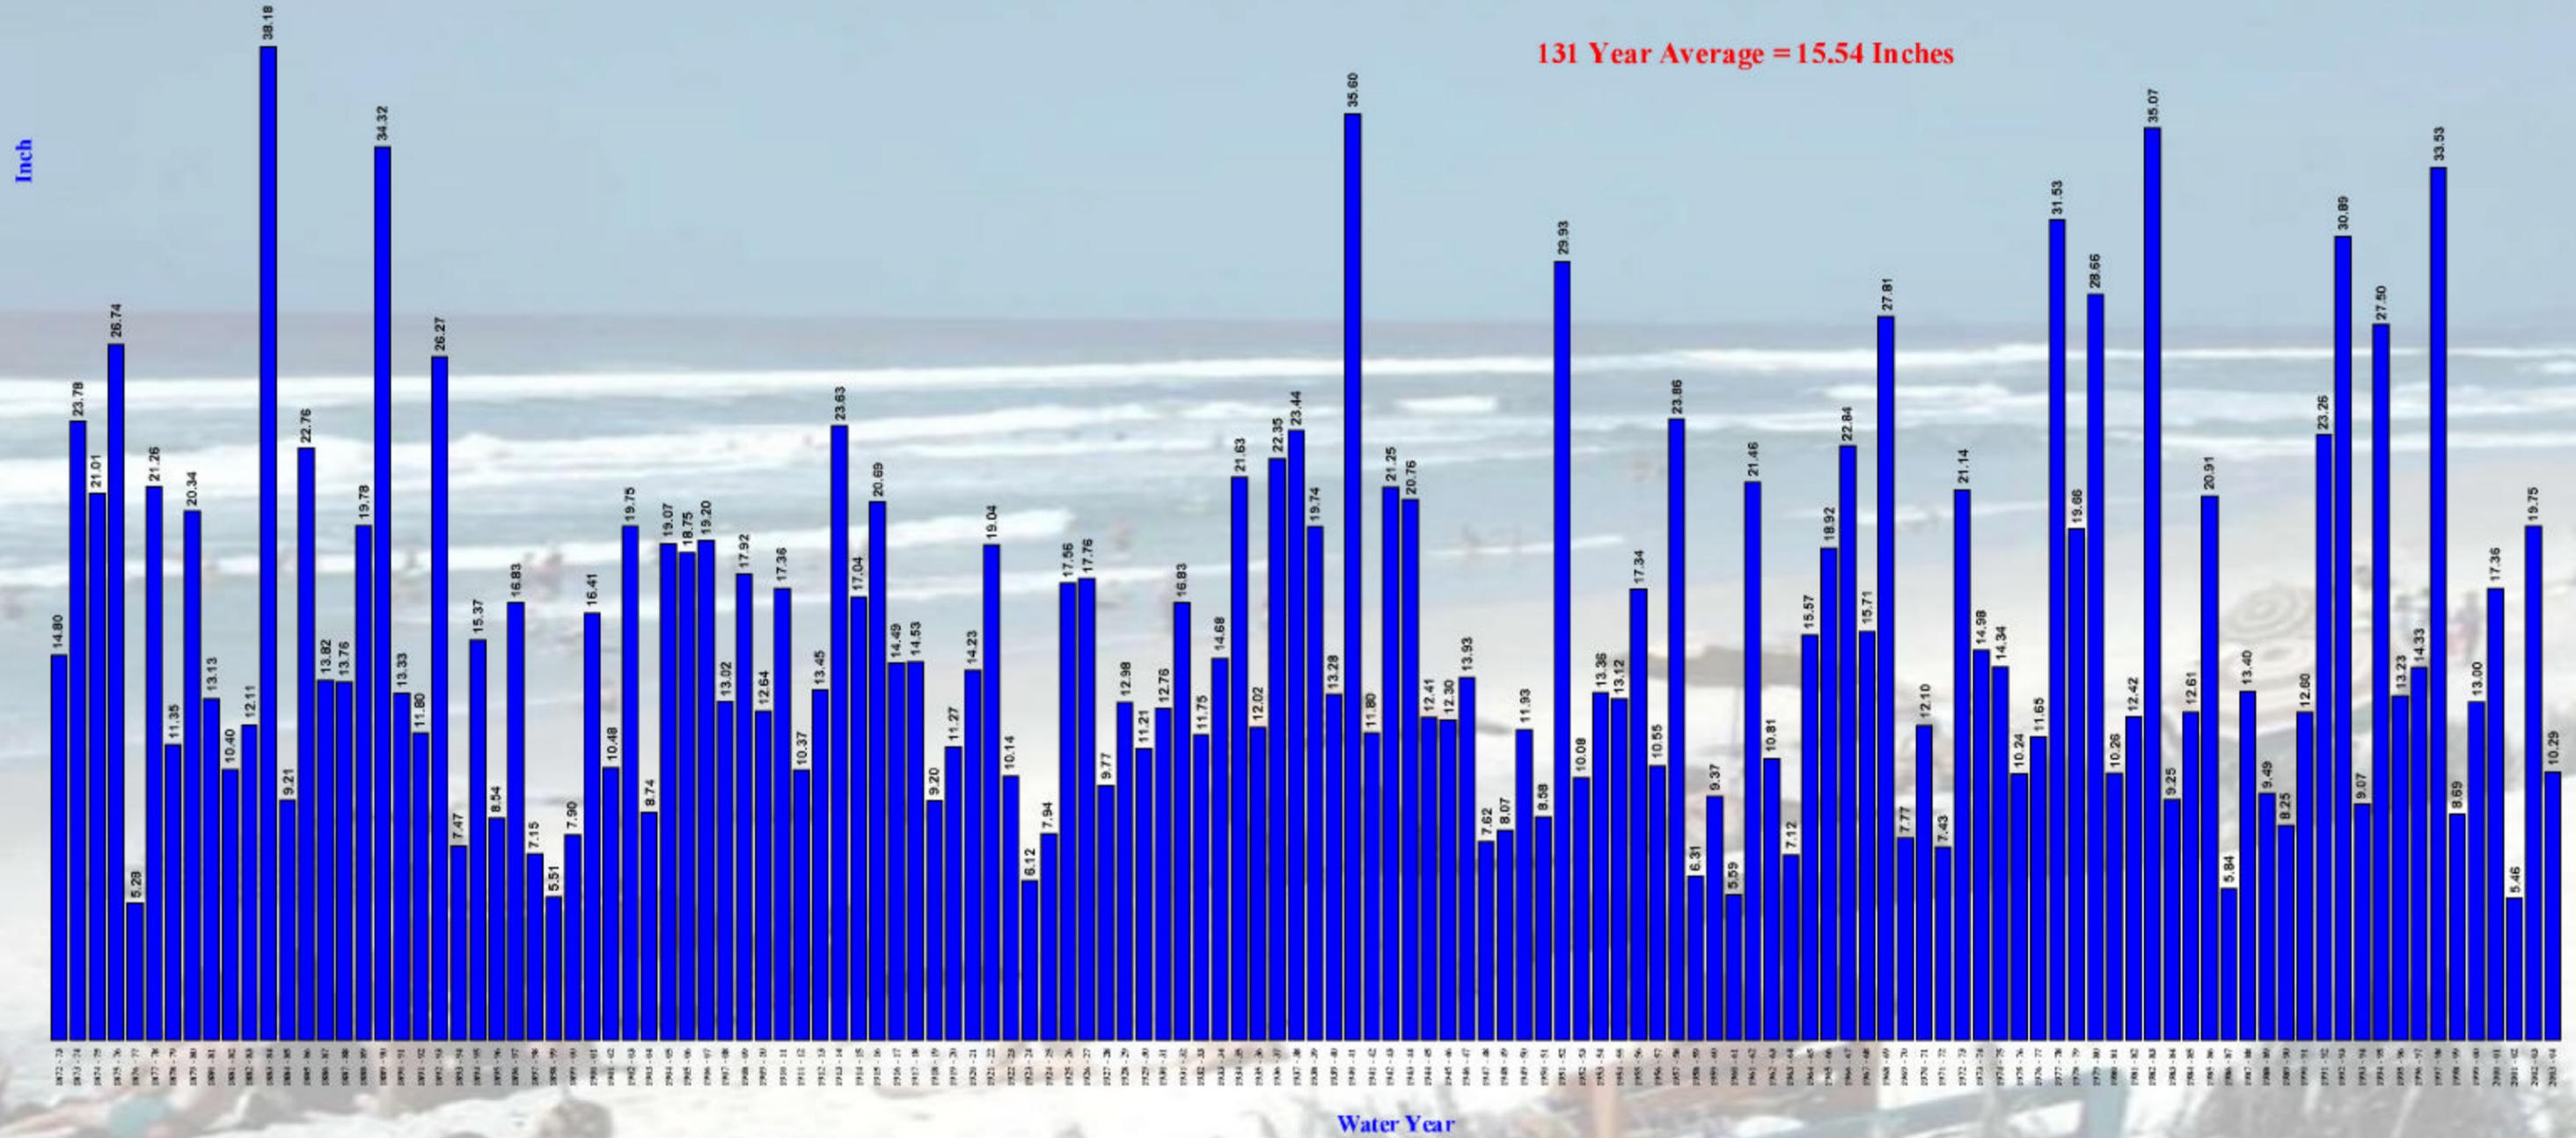
Los Angeles Annual Rainfall 1872 -2004

(Station No. 716, Downtown Los Angeles)

Annual Rainfall in the City of Los Angeles, California for the Period Between 1872 and 2004

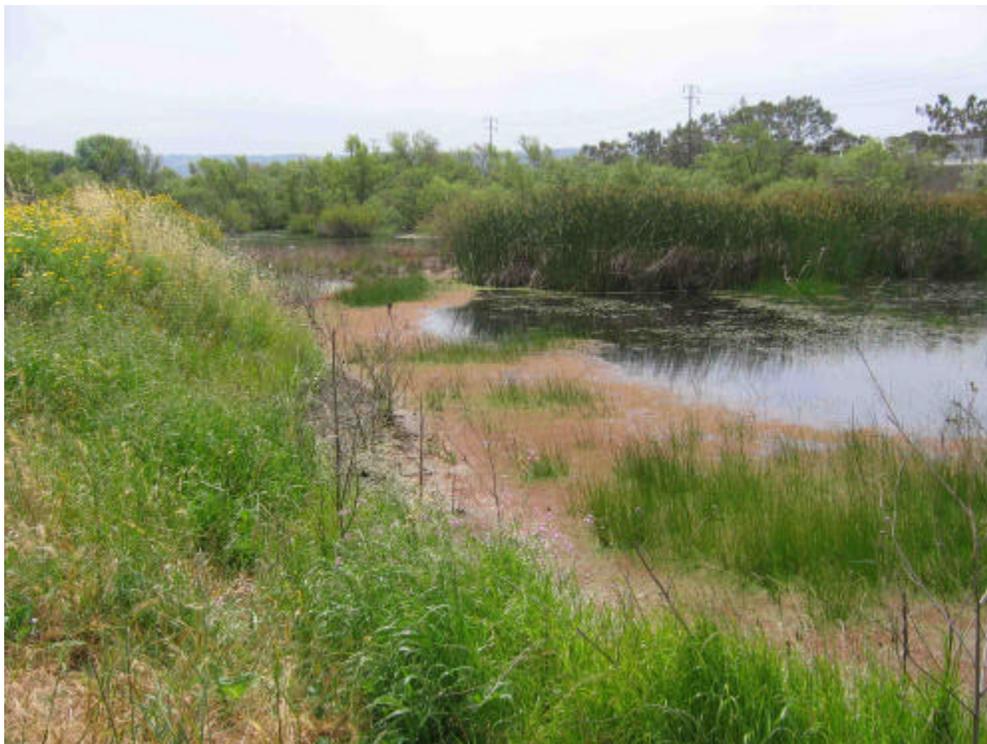
Figure 3.2: Madrona Marsh Nature Preserve, One of the Last Remaining Natural Wetlands in the Highly Urbanized Los Angeles Basin, is included in the Flood Insurance Rate Maps for Torrance as a Special Flood Hazard Zone.

Only a few, small, isolated areas within the City have been mapped as Special Flood Hazard Areas, and these result primarily from ponding of water in shallow depressions or sumps, and not from channel flooding. Several of the SFHAs occupy low points that were once natural closed depressions in the El Segundo Sand Hills. For example, the Madrona Marsh Nature Preserve, the largest SFHA in the city, occupies what was once a large, natural depression. Other SFHAs appear to be man-made depressions or sumps.

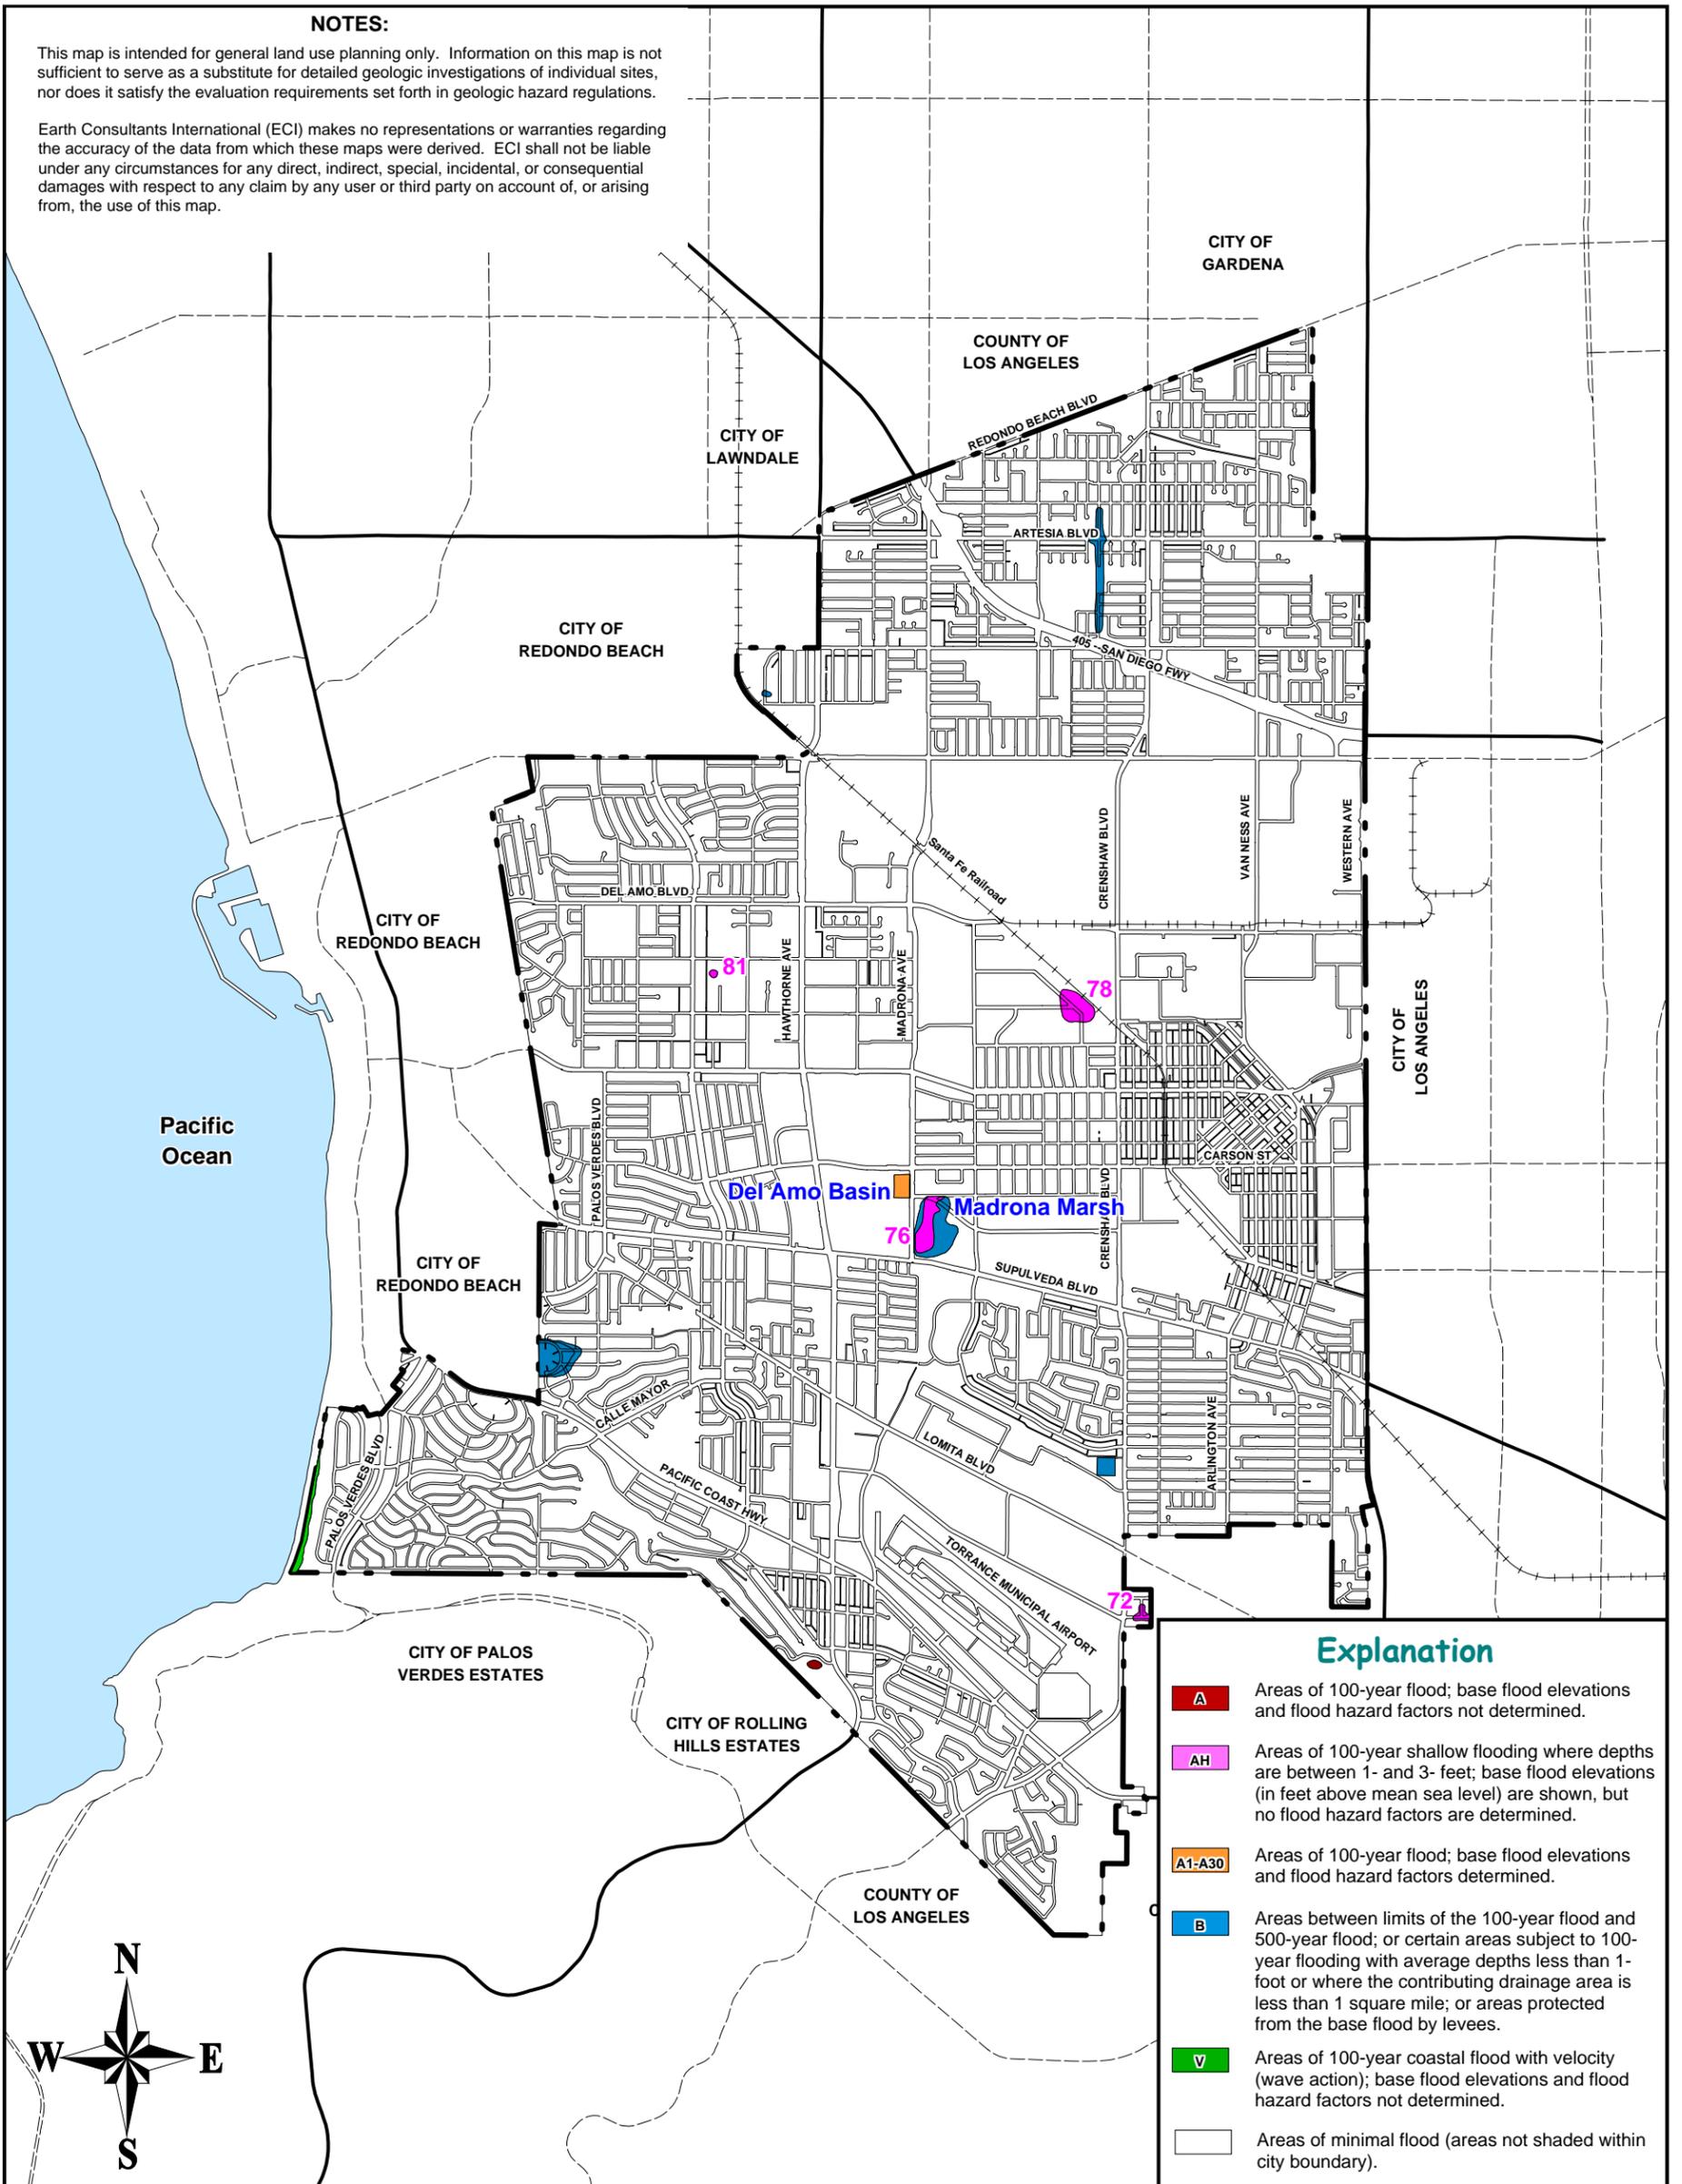
Explanation

- A** Areas of 100-year flood; base flood elevations and flood hazard factors not determined.
- AH** Areas of 100-year shallow flooding where depths are between 1- and 3- feet; base flood elevations (in feet above mean sea level) are shown, but no flood hazard factors are determined.
- A1-A30** Areas of 100-year flood; base flood elevations and flood hazard factors determined.
- B** Areas between limits of the 100-year flood and 500-year flood; or certain areas subject to 100-year flooding with average depths less than 1-foot or where the contributing drainage area is less than 1 square mile; or areas protected from the base flood by levees.
- V** Areas of 100-year coastal flood with velocity (wave action); base flood elevations and flood hazard factors not determined.
- Areas of minimal flood (areas not shaded within city boundary).

Base Map: City of Torrance (2005)
 Source: Federal Emergency Management Agency, 1979, Flood Insurance Rate Map (Panel Numbers: 060165 0001B, 060165 0003B, 060165 0004B, and 060165 0005B)

The FEMA mapping shows that overbank flooding from the major open channels generally does not occur. Persistent flood-prone areas in the Torrance area are generally small and localized, often being associated with low areas having poor drainage and inadequate storm drains (LACDPW, 2004). Localized flooding still occurs along Hawthorne and Sepulveda boulevards, near the Del Amo Fashion Center, but the Los Angeles County Flood Control District is reportedly fixing this problem. In general, street flooding due to storm runoff is no longer perceived as a problem in Torrance (Torrance Public Works Department, personal communication, 2005).

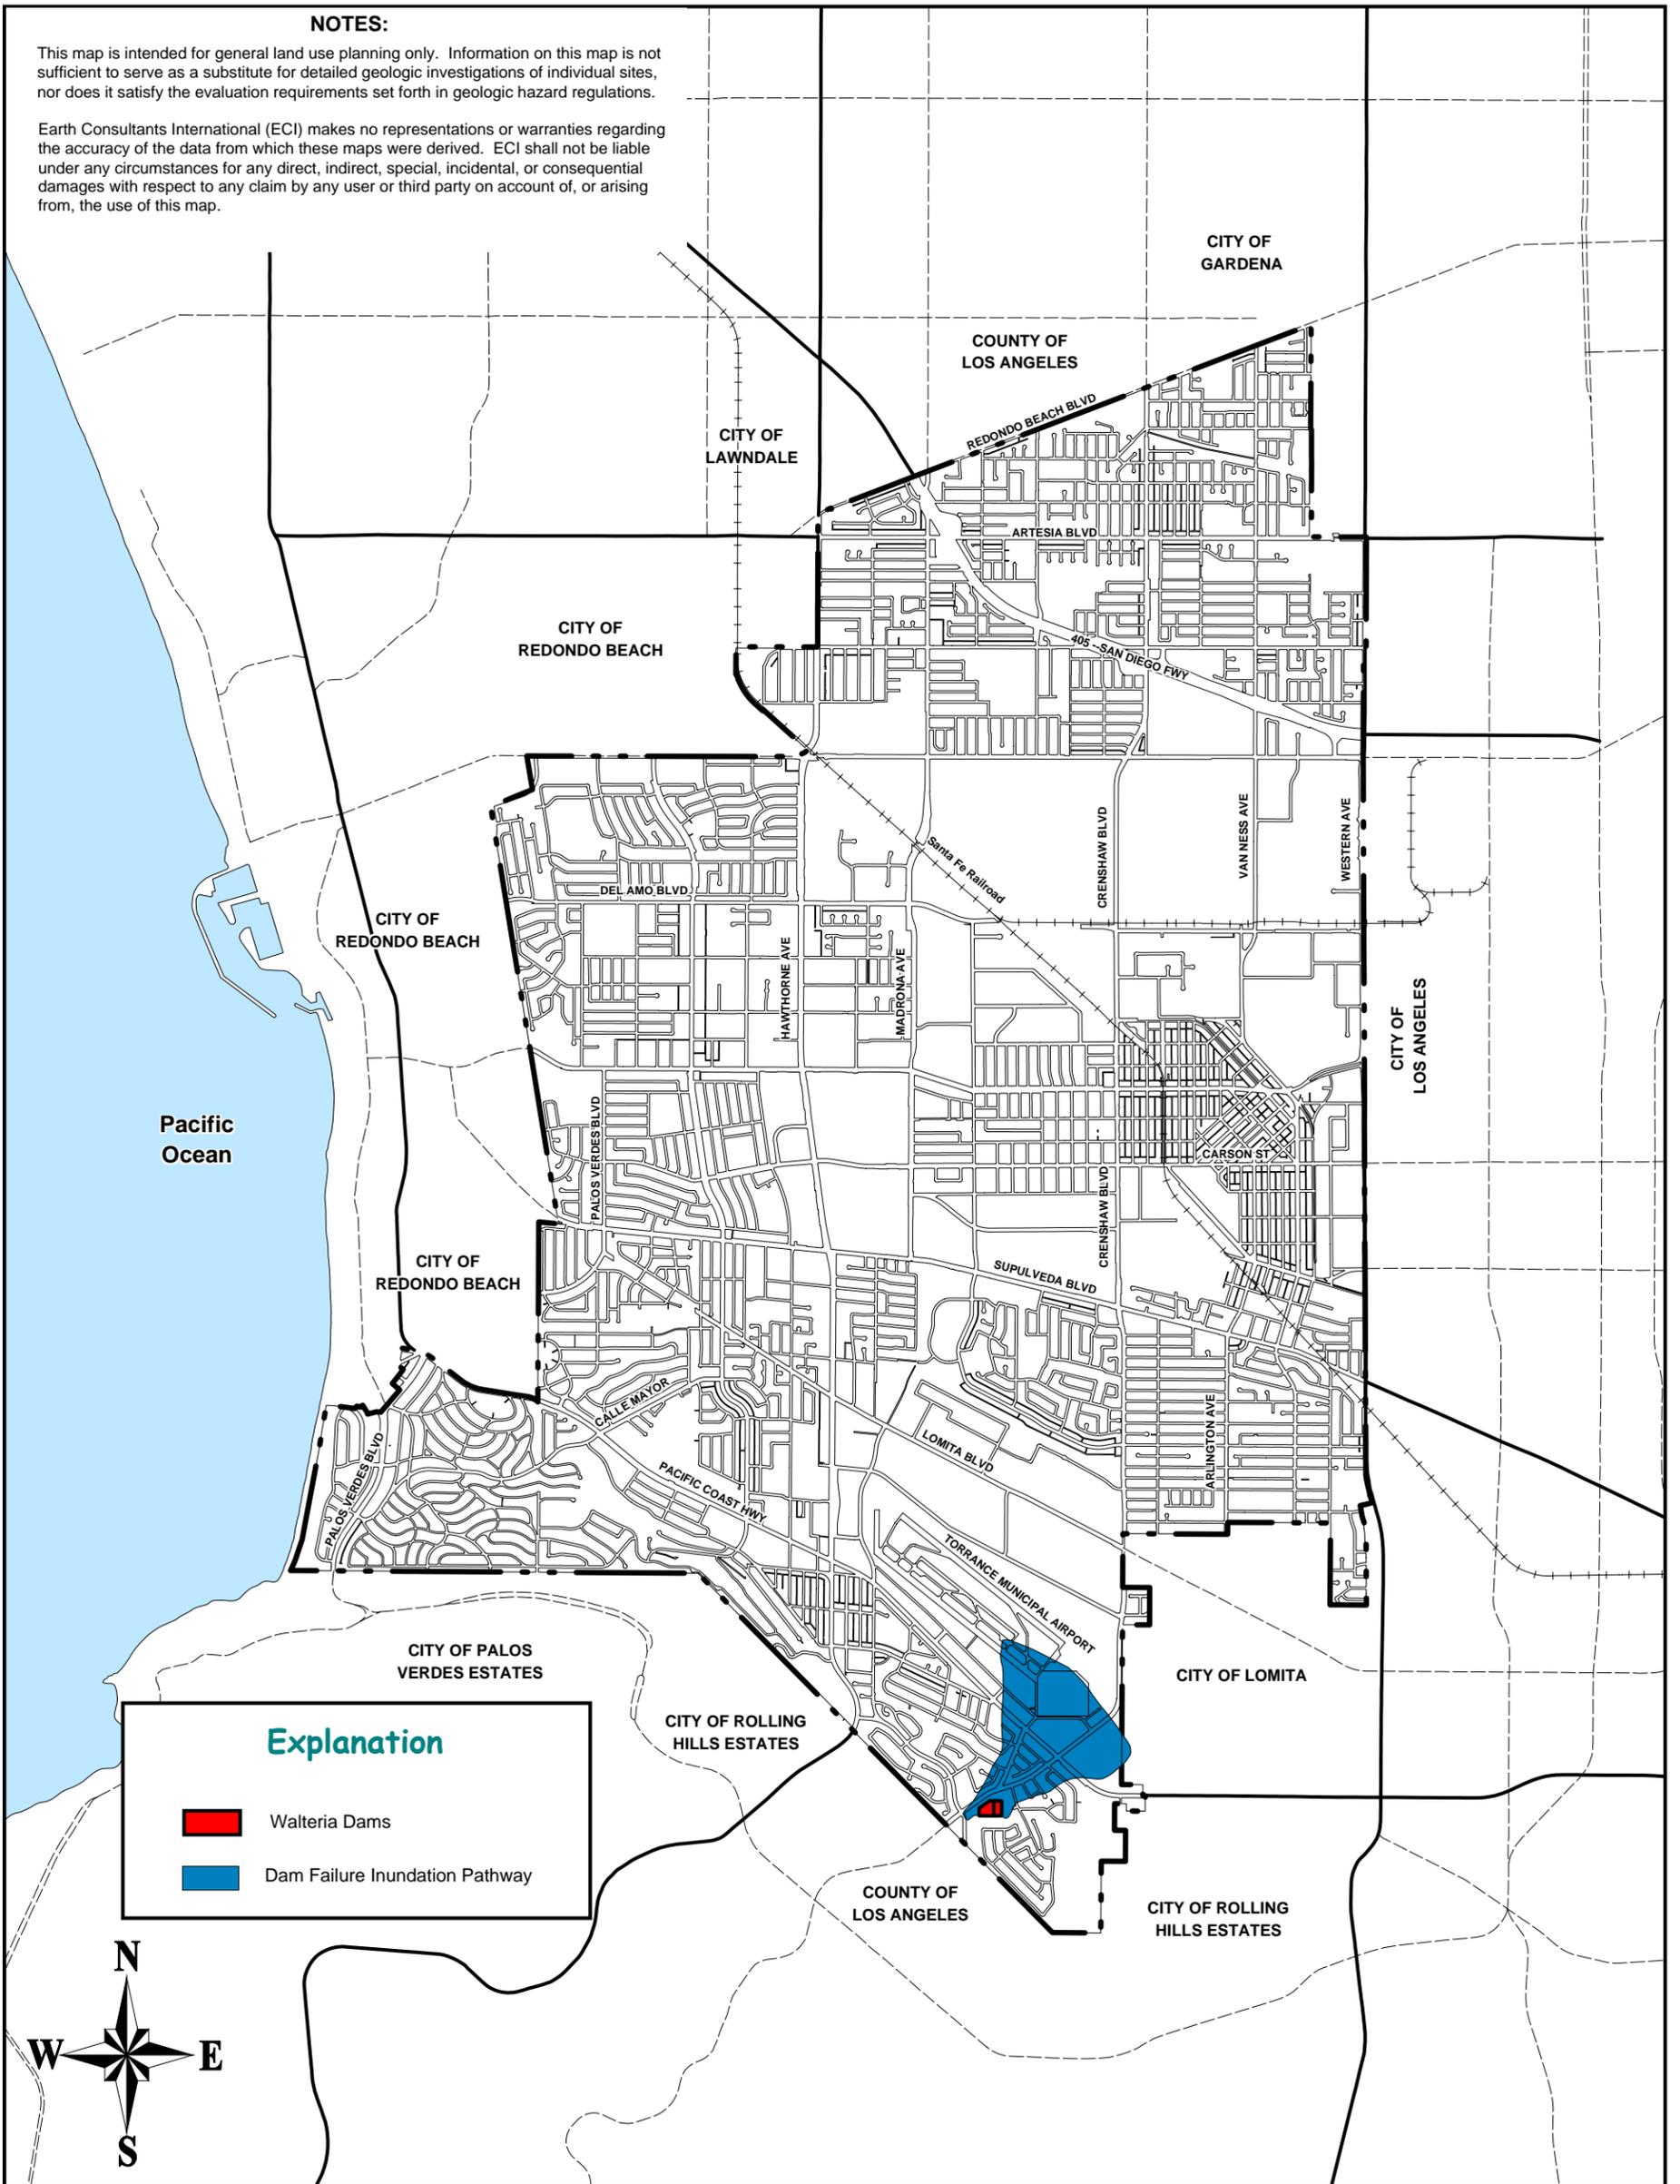
Explanation

- Waleria Dams
- Dam Failure Inundation Pathway

Base Map: City of Torrance (2005)
Source: Governor's Office of Emergency Services

gravity. According to the City's Natural Hazards Mitigation Plan (2004), if these reservoirs fail catastrophically as a result of earthquake-induced damage, they could empty in as little as 18 minutes. This would allow little time to evacuate the areas immediately down-gradient from the reservoirs, with the potential for significant loss of life and damage to property. The inundation pathway for these reservoirs has been mapped (JMM, 1984), as required by the California Division of Dam Safety, and is shown on Plate 3-3. Inundation from these reservoirs, with an estimated maximum discharge of 7,300 cubic feet per second (cfs), would impact both residential and commercial areas near Crenshaw Boulevard and Pacific Coast Highway, and would spill onto the southeastern edge of the Torrance Airport.

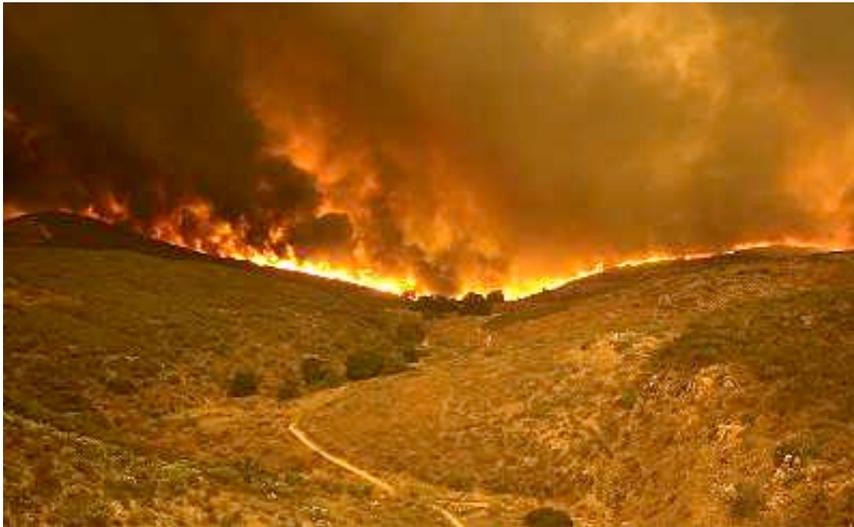
Figure 4-1: View of the Cedar Fire of October 2003 moving down Oak Canyon, toward the 52 Freeway, in San Diego County. This fire burned more than 270,000 acres, destroyed 2,820 structures, damaged 63 others, and caused 14 fatalities. A signal flare set off by a lost hunter caused the fire.

As the 2003 fires in southern California showed, wildfires that consume hundreds of thousands of acres of vegetated property overwhelm local emergency response resources (Figures 4-1 and 4-2). Under the right wind conditions, multiple ignitions can develop as a result of the wind transport of burning cinders (called brands) over distances of a mile or more. Wildfires in those areas where the wildland approaches or interfaces with the urban environment (referred to as the urban-wildland interface area or UWI area) can be particularly dangerous and complex, posing a severe threat to public and firefighter safety, and causing devastating losses of life and property. This is because when a wildland fire encroaches onto the built environment, ignited structures can then sustain and transmit the fire from one building to the next. It has become increasingly clear that continuous planning, preparedness, and education are required to reduce the fire hazard potential, and to limit the destruction caused by fires. This is discussed in detail in this document.

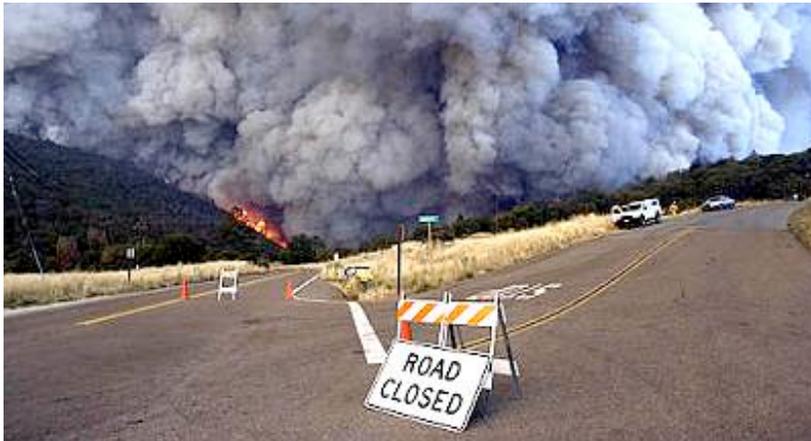
Figure 4-2: View of one of the many fires that ravaged the southern California area in the fall of 2003, forcing the evacuation of entire neighborhoods, and the closing of roads.
