**TECHNICAL BACKGROUND REPORT to the
SAFETY ELEMENT of the GENERAL PLAN
for the CITY of TORRANCE,
LOS ANGELES COUNTY, CALIFORNIA**

**SEISMIC HAZARDS
GEOLOGIC HAZARDS
FLOODING HAZARDS
FIRE HAZARDS
HAZARDOUS MATERIALS MANAGEMENT
AVIATION HAZARDS**

August 2005

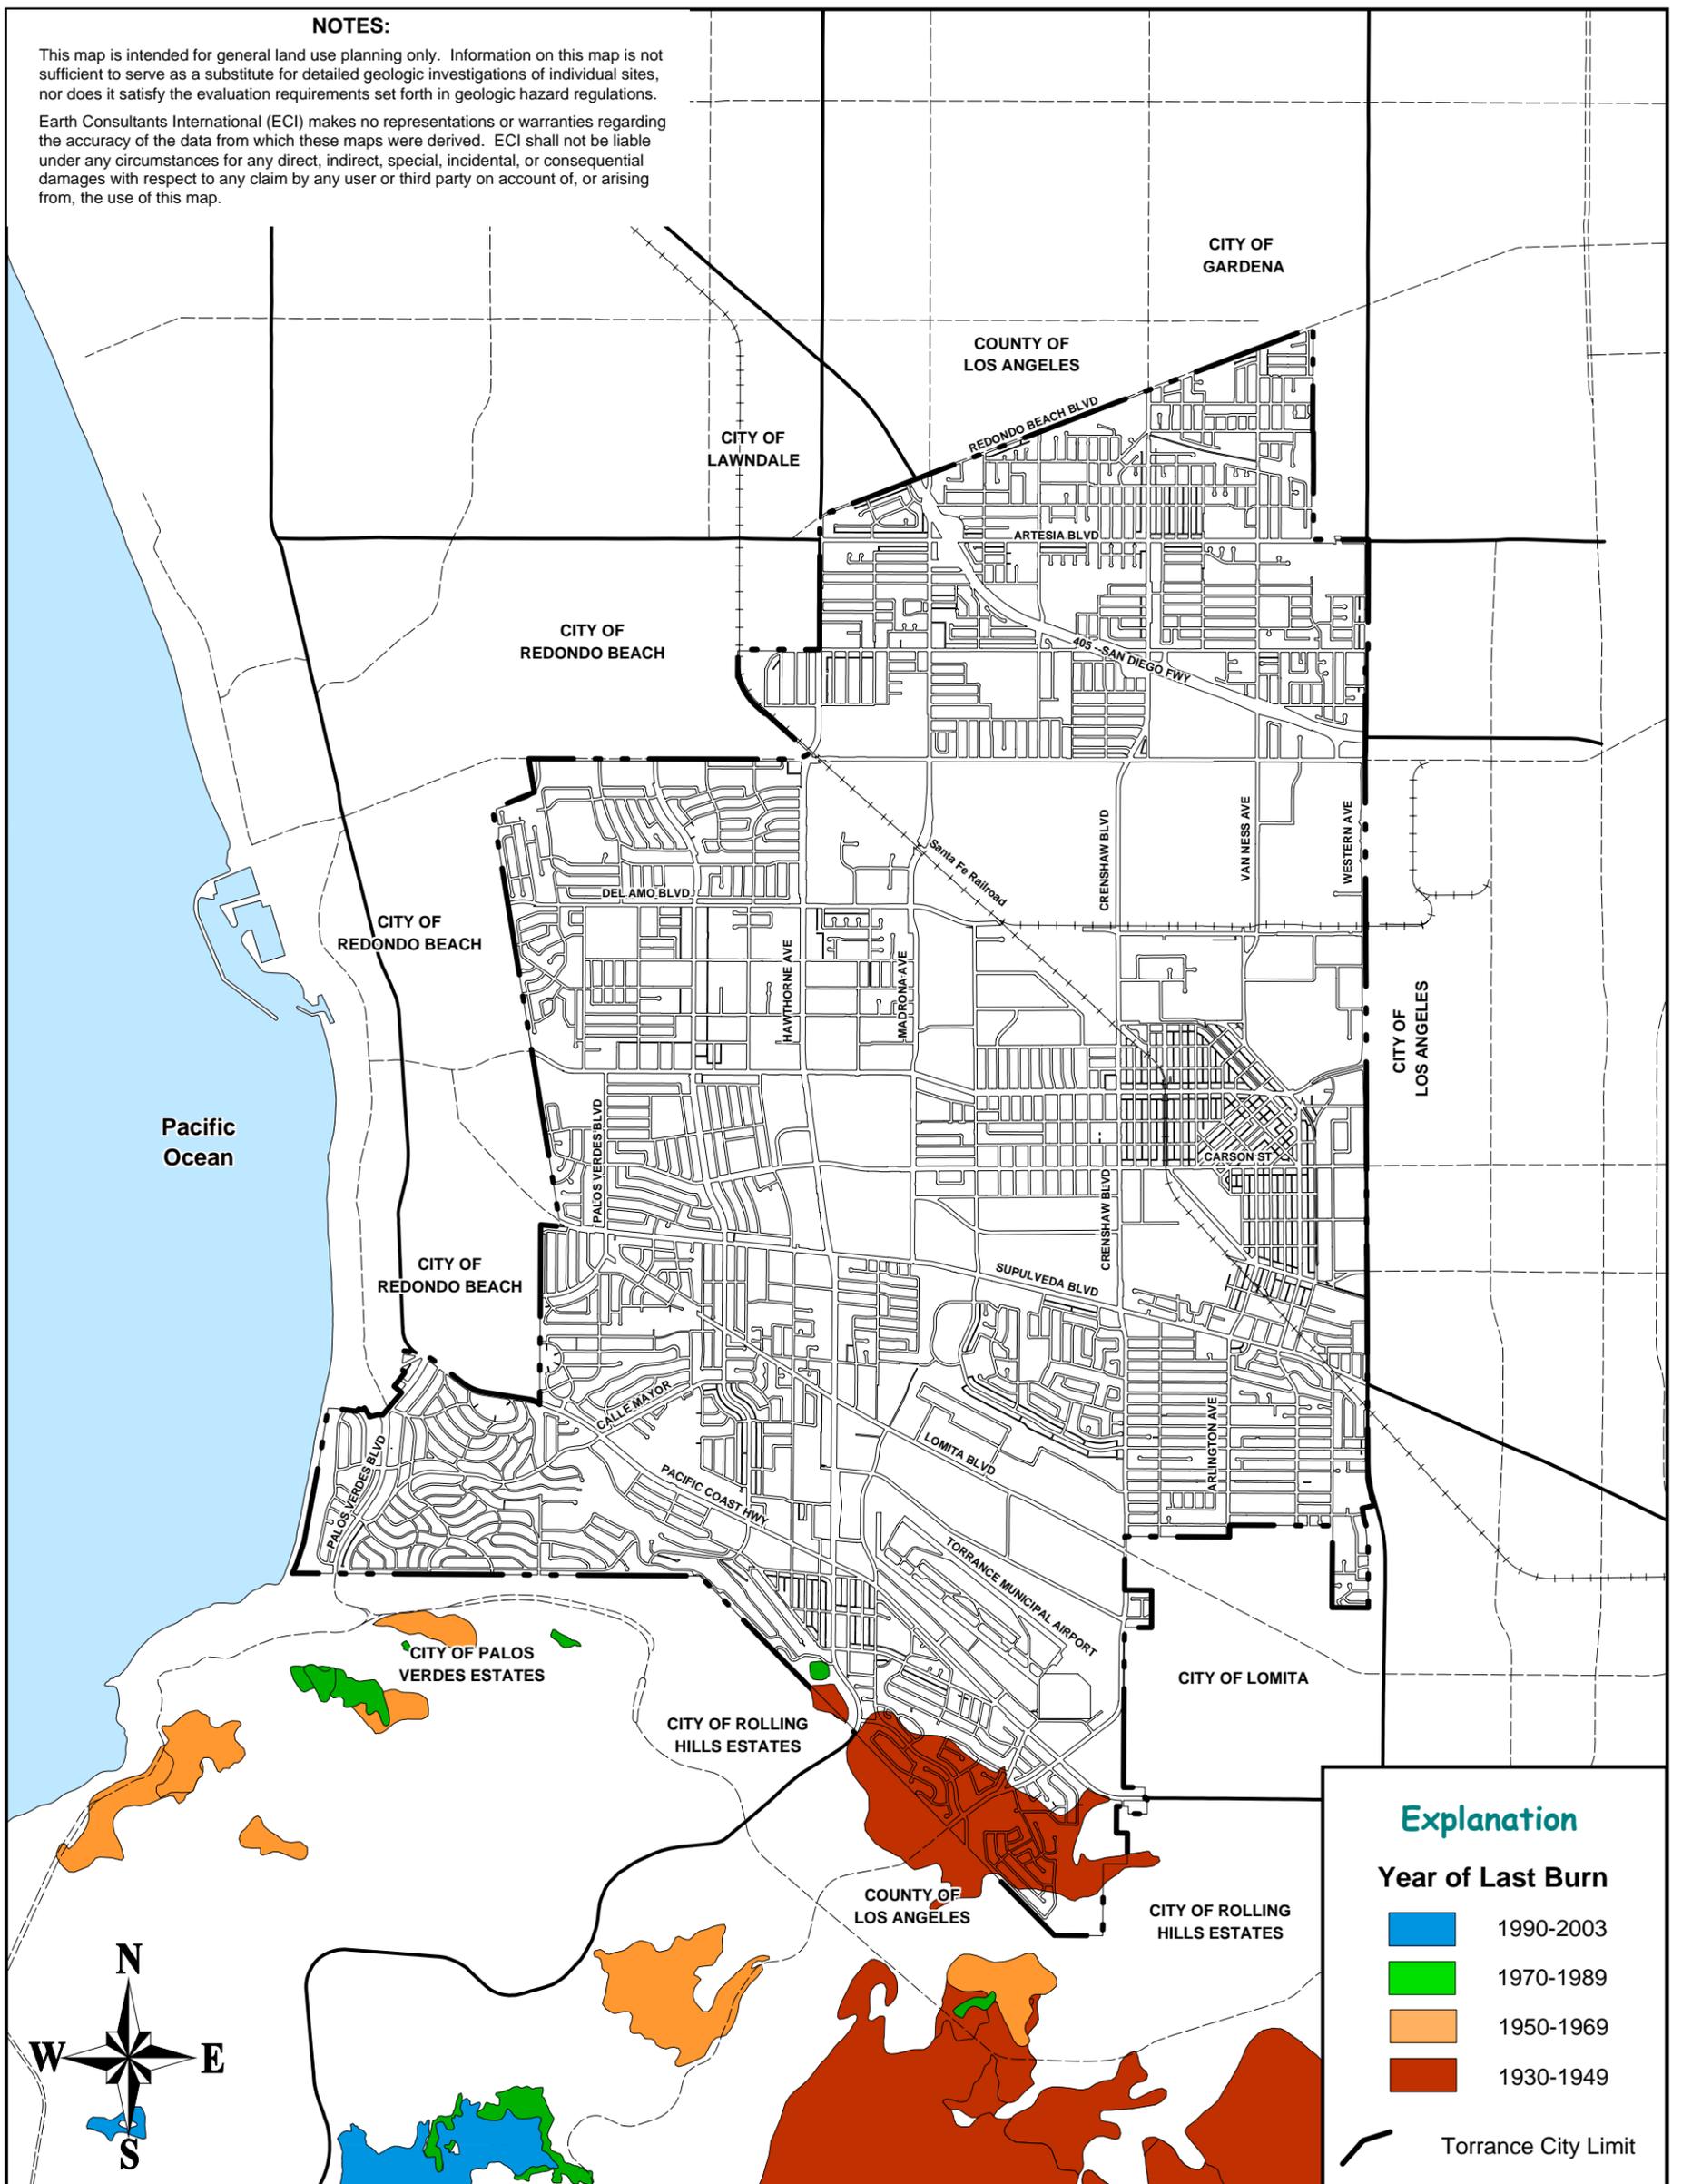
Year of Last Burn

- 1990-2003
- 1970-1989
- 1950-1969
- 1930-1949

Base Map: City of Torrance (2005).
 Source: California Fire and Resource Assessment Program (FRAP) @
<http://frap.cdf.ca.gov/data/frapgisdata/select.asp>

This map shows areas in Torrance and the northern Palos Verdes Hills that have burned between 1930 and 2003.

high wildland fire susceptibility include Malibu, Glendale, Burbank, and the mountainous regions of Altadena, La Canada Flintridge and Pasadena, to mention a few. Wildland fires have also occurred historically in the Palos Verdes Hills, in the southern portion of Torrance, and to the south of the city, in what is now Rolling Hills, Rolling Hills Estates and Palos Verdes Estates. Plate 4-1 shows those areas in the northern Palos Verdes Hills that have reportedly burned at least once between 1930 and 2003, the year for which the most recent data are available from the California Department of Forestry (<http://frap.cdf.ca.gov/data/frapgisdata/select.asp>). The graphic shows areas that reportedly burned at least once during a 20-year period. Overlap of some of these burnt areas indicates that wildland fire has impacted the same area more than once during the time period covered by the graphic. Most of the burnt areas in Plate 4-1 are south of Torrance, with three exceptions: wildland fires ignited two areas in the southernmost portion of the city sometime between 1930 and 1949, and a more recent but significantly smaller fire was reported in the undeveloped slope north of Via Valmonte and west of Hawthorne Boulevard sometime between 1970 and 1989. In fact, according to personnel from the City's Fire Department, small vegetation fires occasionally still occur on this slope, but these are not considered to pose a concern to the adjacent structures (Fire Department, personal communication, 2005).

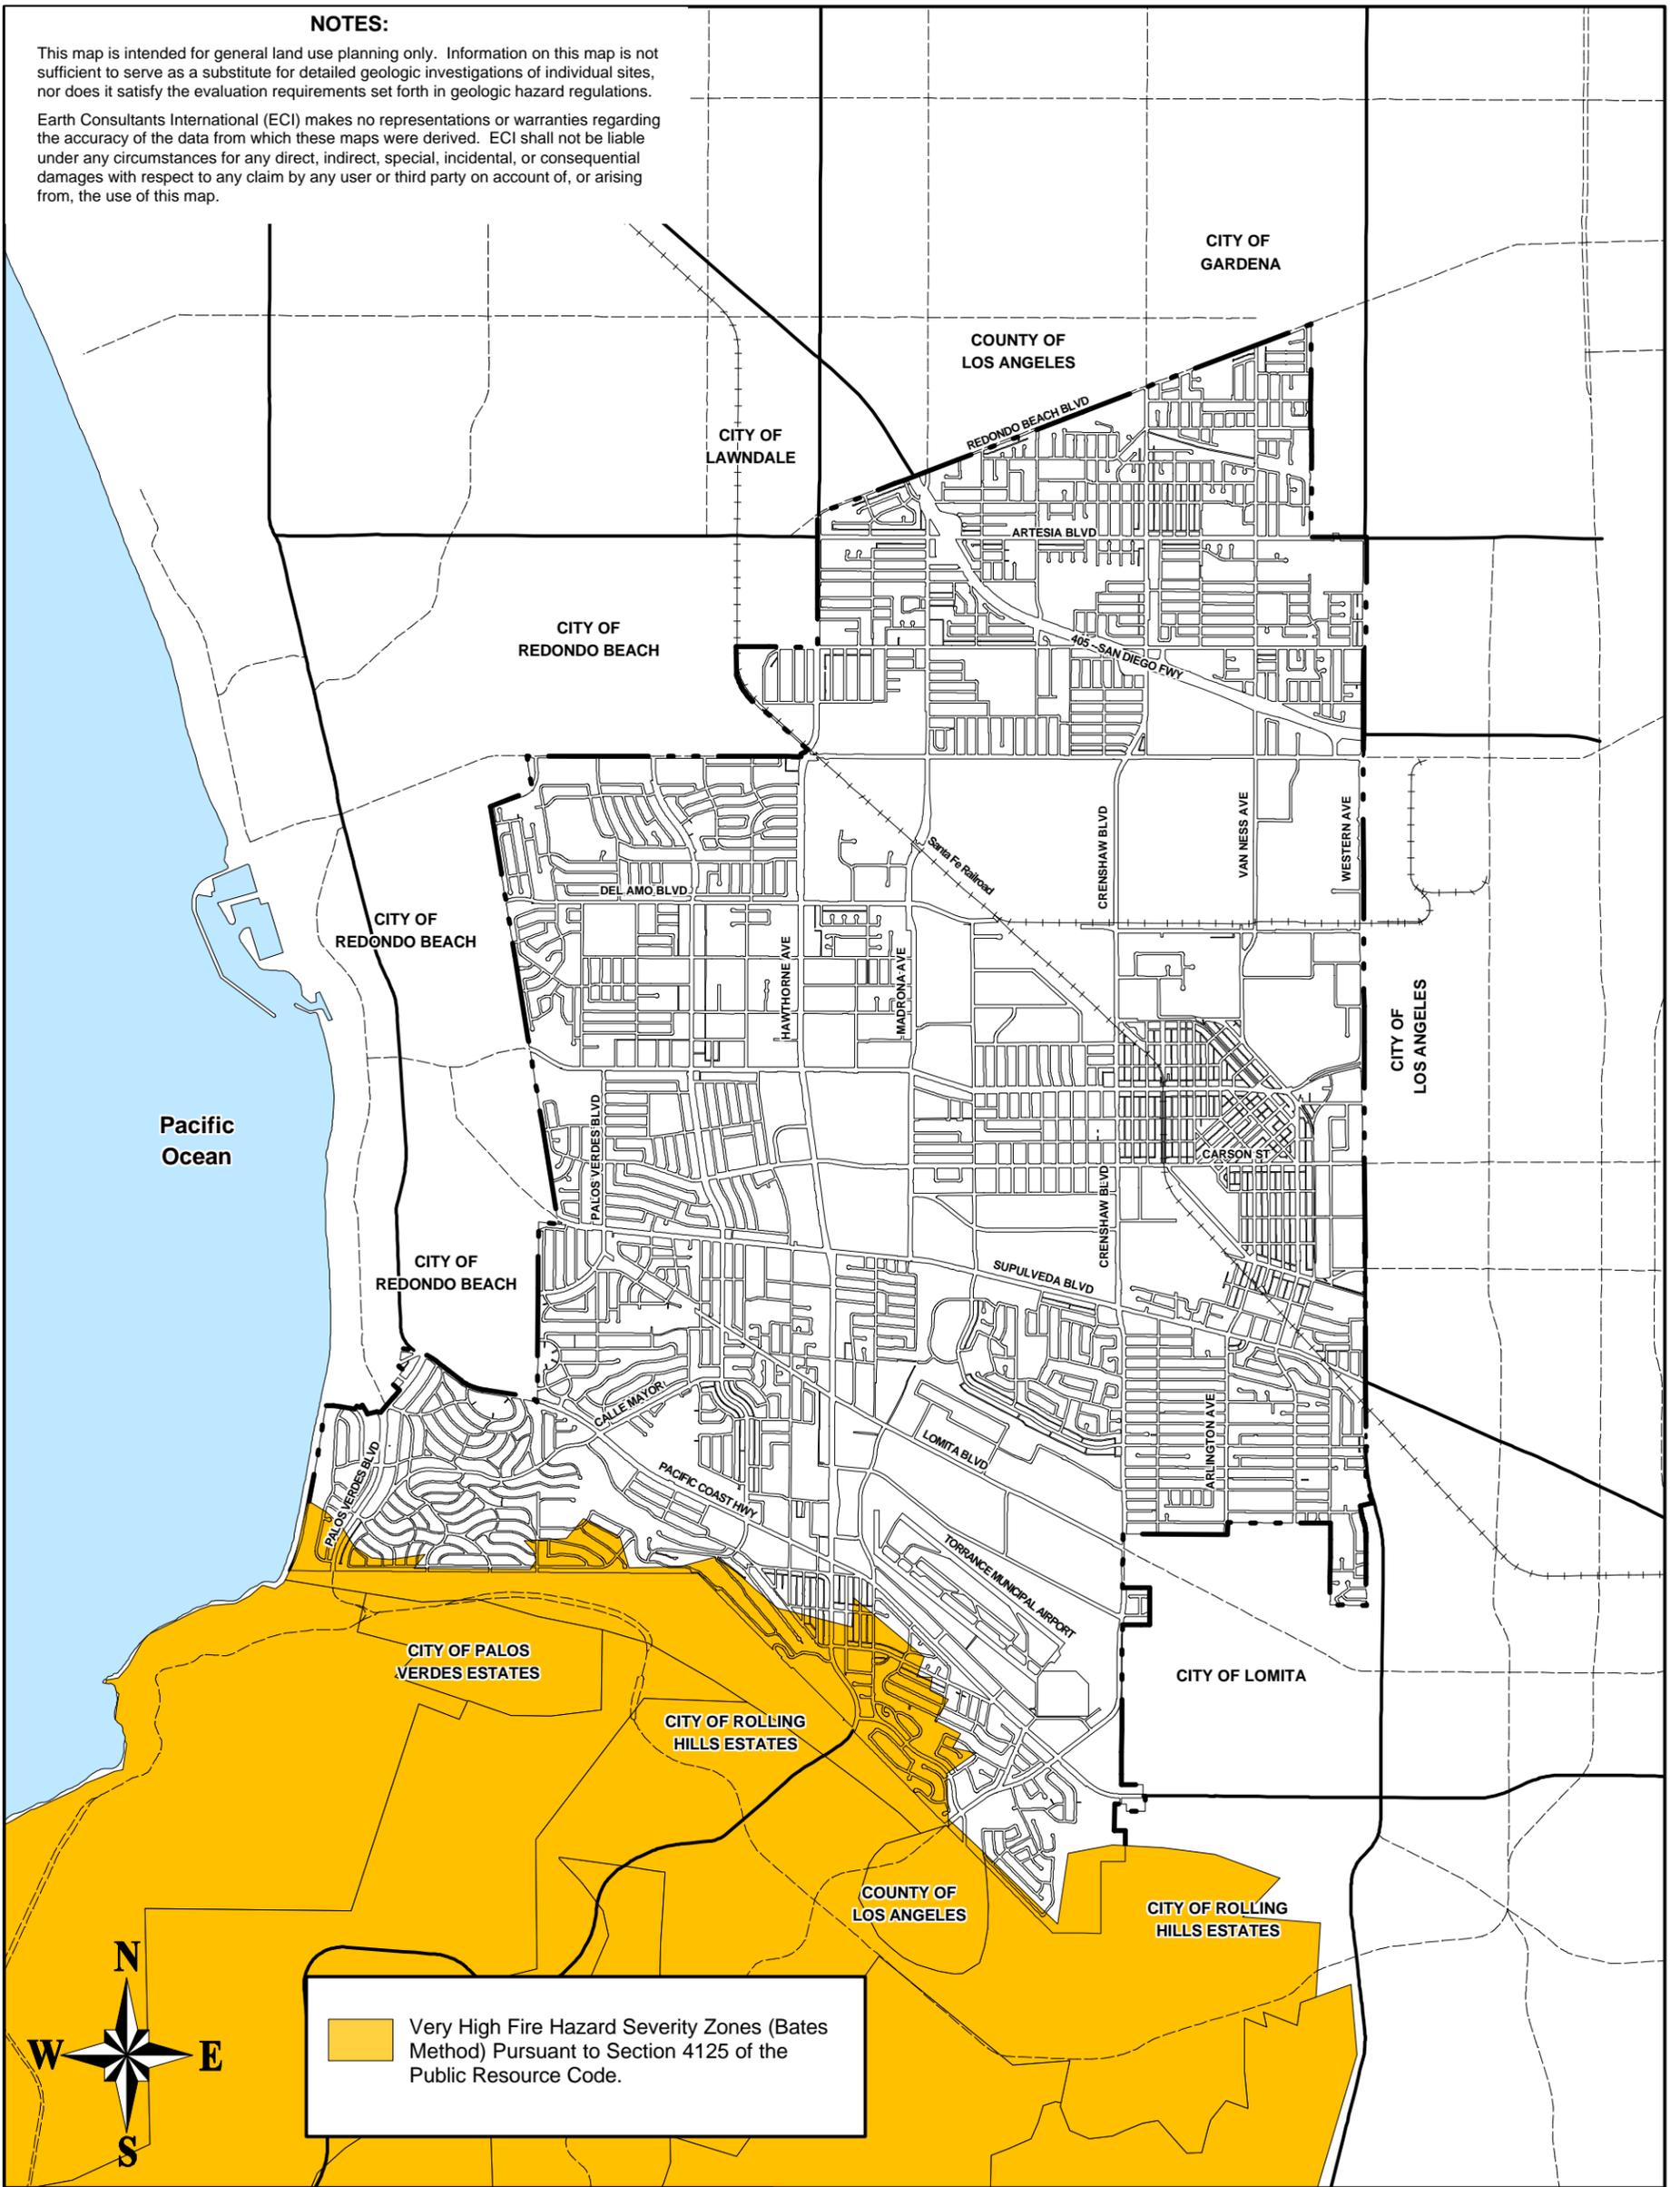
**Plate
4-2**

Very High Fire Hazard Severity Zones (Bates Method) Pursuant to Section 4125 of the Public Resource Code.

Base Map: City of Torrance
Sources: Fire and Resource Assessment Program, California Department of Forestry and Fire Protection (2001)

Once the boundaries of a VHFHSZ have been delineated, the CDF notifies the local fire authorities that are responsible for fire prevention and suppression within that area. Since the State is not financially responsible for Local Responsibility Areas, local jurisdictions have final say regarding whether or not an area should be included in a VHFHSZ (Government Code Section 50022). The VHFHSZ mapped in and near Torrance by the CDF (2001) are shown in yellow on Plate 4-2. The map shows that some areas along the southernmost edge of Torrance are considered by the State to have a very high fire hazard. The City of Torrance, however, considers their wildland fire risk to be insignificant, and since the City ultimately has financial responsibility for these areas, future versions of this map will likely not include these neighborhoods of Torrance. If and when the State issues a new VHFHSZ Map for this area, Plate 4-2 should be updated.

In the developed, relatively flat areas of the city, vegetation fires are not considered a hazard, as the topography, lack of fuel loading (due to carefully maintained and regularly watered landscaping), and effective fire suppression services combine to mitigate the potential for wildland fires. This is reflected in the Very High Fire Hazard Severity Zones Map for Torrance and vicinity that shows no fire hazard in most of the city. The southern portion of the city, adjacent to the Palos Verdes Hills, however, is, given its topography and past fire history, still classified by the State of California as a Very High Fire Hazard Severity Zone (see yellow zones on Plate 4-2).

California state law [Assembly Bill 6; Civil Code Section 1103(c)(6)] requires that fire hazard areas be disclosed in real estate transactions; that is, real-estate sellers are required to inform prospective buyers whether or not a property is located within a wildland area that could contain substantial fire risks and hazards, such as a Very High Fire Hazard Severity Zone (see Plate 4-2), or in a State Responsibility Area.

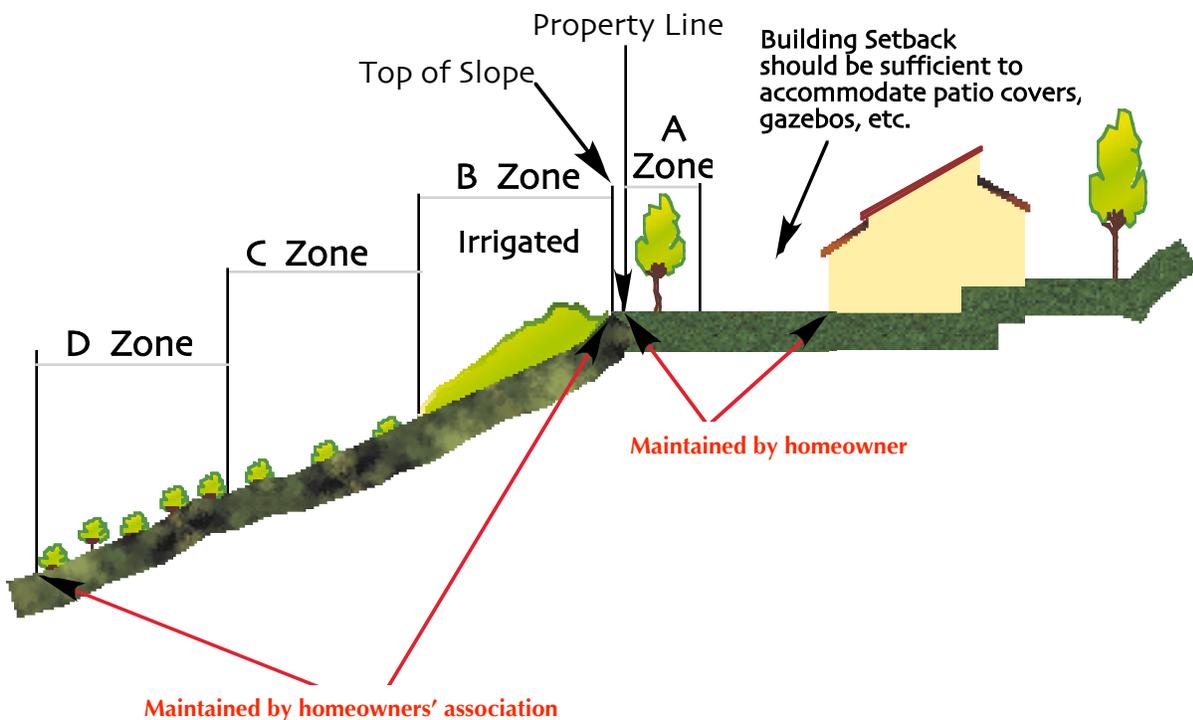
Figure 4-3: Fuel Modification Zones that can be Used in Very High Fire Hazard Severity Areas

Fuel modification zones are typically divided into four areas referred to as the A, B, C and D zones. The A Zone is the closest to the homes, and is the last 20-feet of the backyard of the private residences. The B, C and D zones lie outside the fence line and are within the common area typically owned by an association. Any dead or dying vegetation in these zones should be removed, and certain fire-prone species of vegetation are required to be removed when found in any of the four fuel modification zones. Each of these zones is described further below and shown graphically on Figure 4-3.

- The **C and D zones** are the next 100 feet away from the homes. Each of these zones is a minimum of 50 feet in width. These zones are called the thinning zones. Natural vegetation is reduced by 50 percent in the C zone, and by 30 percent in the D zone. A way to imagine this thinning principle is as follows: in the 50-percent thinning zone (C zone) two people can walk side by side around clumps of vegetation. In a 30 percent thinning zone (D Zone), two people would have to walk single file between clumps of natural vegetation. These areas are not irrigated.

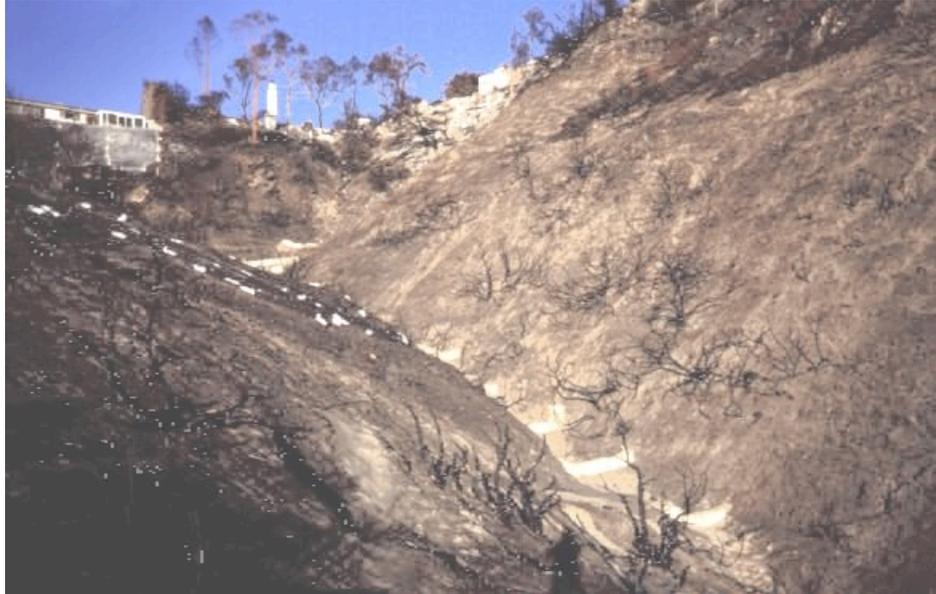
Figure 4-4: Photograph Showing Denudation of Slopes Following the 1993 Laguna Beach Fire. Sandbags, plastic covers, hay bales, and other measures were implemented as soon as possible to reduce the potential for slope instability during the winter following the fire.

However, this does not need to happen if remedial measures following a wildfire are taken in anticipation of the next winter. Studies (Cannon, 2001) suggest that in addition to rainfall and slope steepness, other factors that contribute to the formation of post-fire debris flows include the underlying rock type, the shape of the drainage basin, and the presence or absence of water-repellant soils (during a fire, the organic material in the soil may be burned away or decompose into water-repellent substances that prevents water from percolating into the soil.)

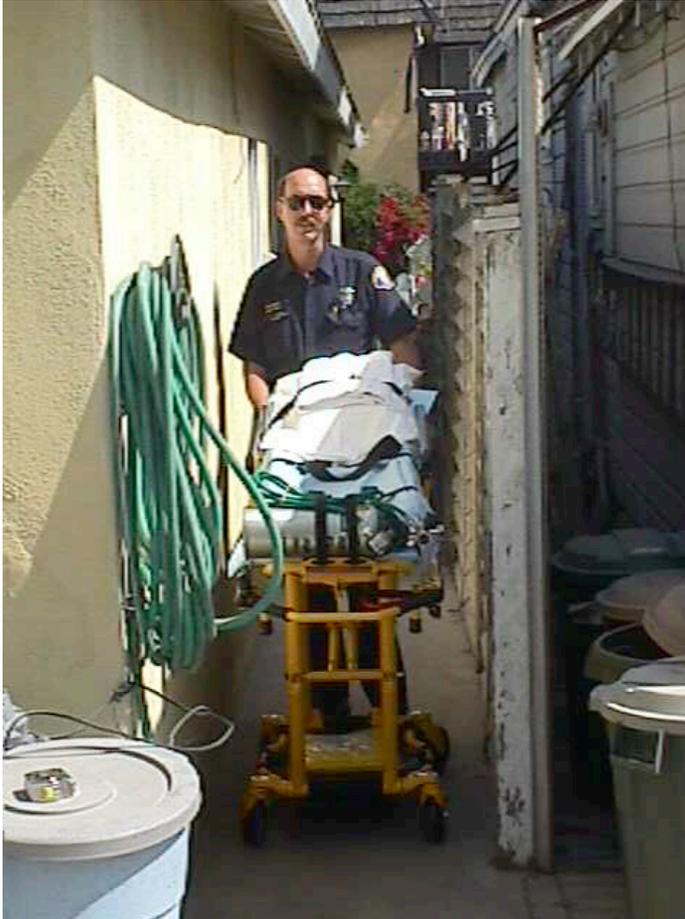
Figure 4-5: Photograph illustrating the difficulty of maneuvering emergency equipment and victims through a narrow building setback, especially if non-structural additions project into this area. Dumpsters and other things stored in this area can also make access to the back of a residence difficult, if not impossible. Residents should maintain this area free of obstructions. (Courtesy of the Newport Beach Fire Department).

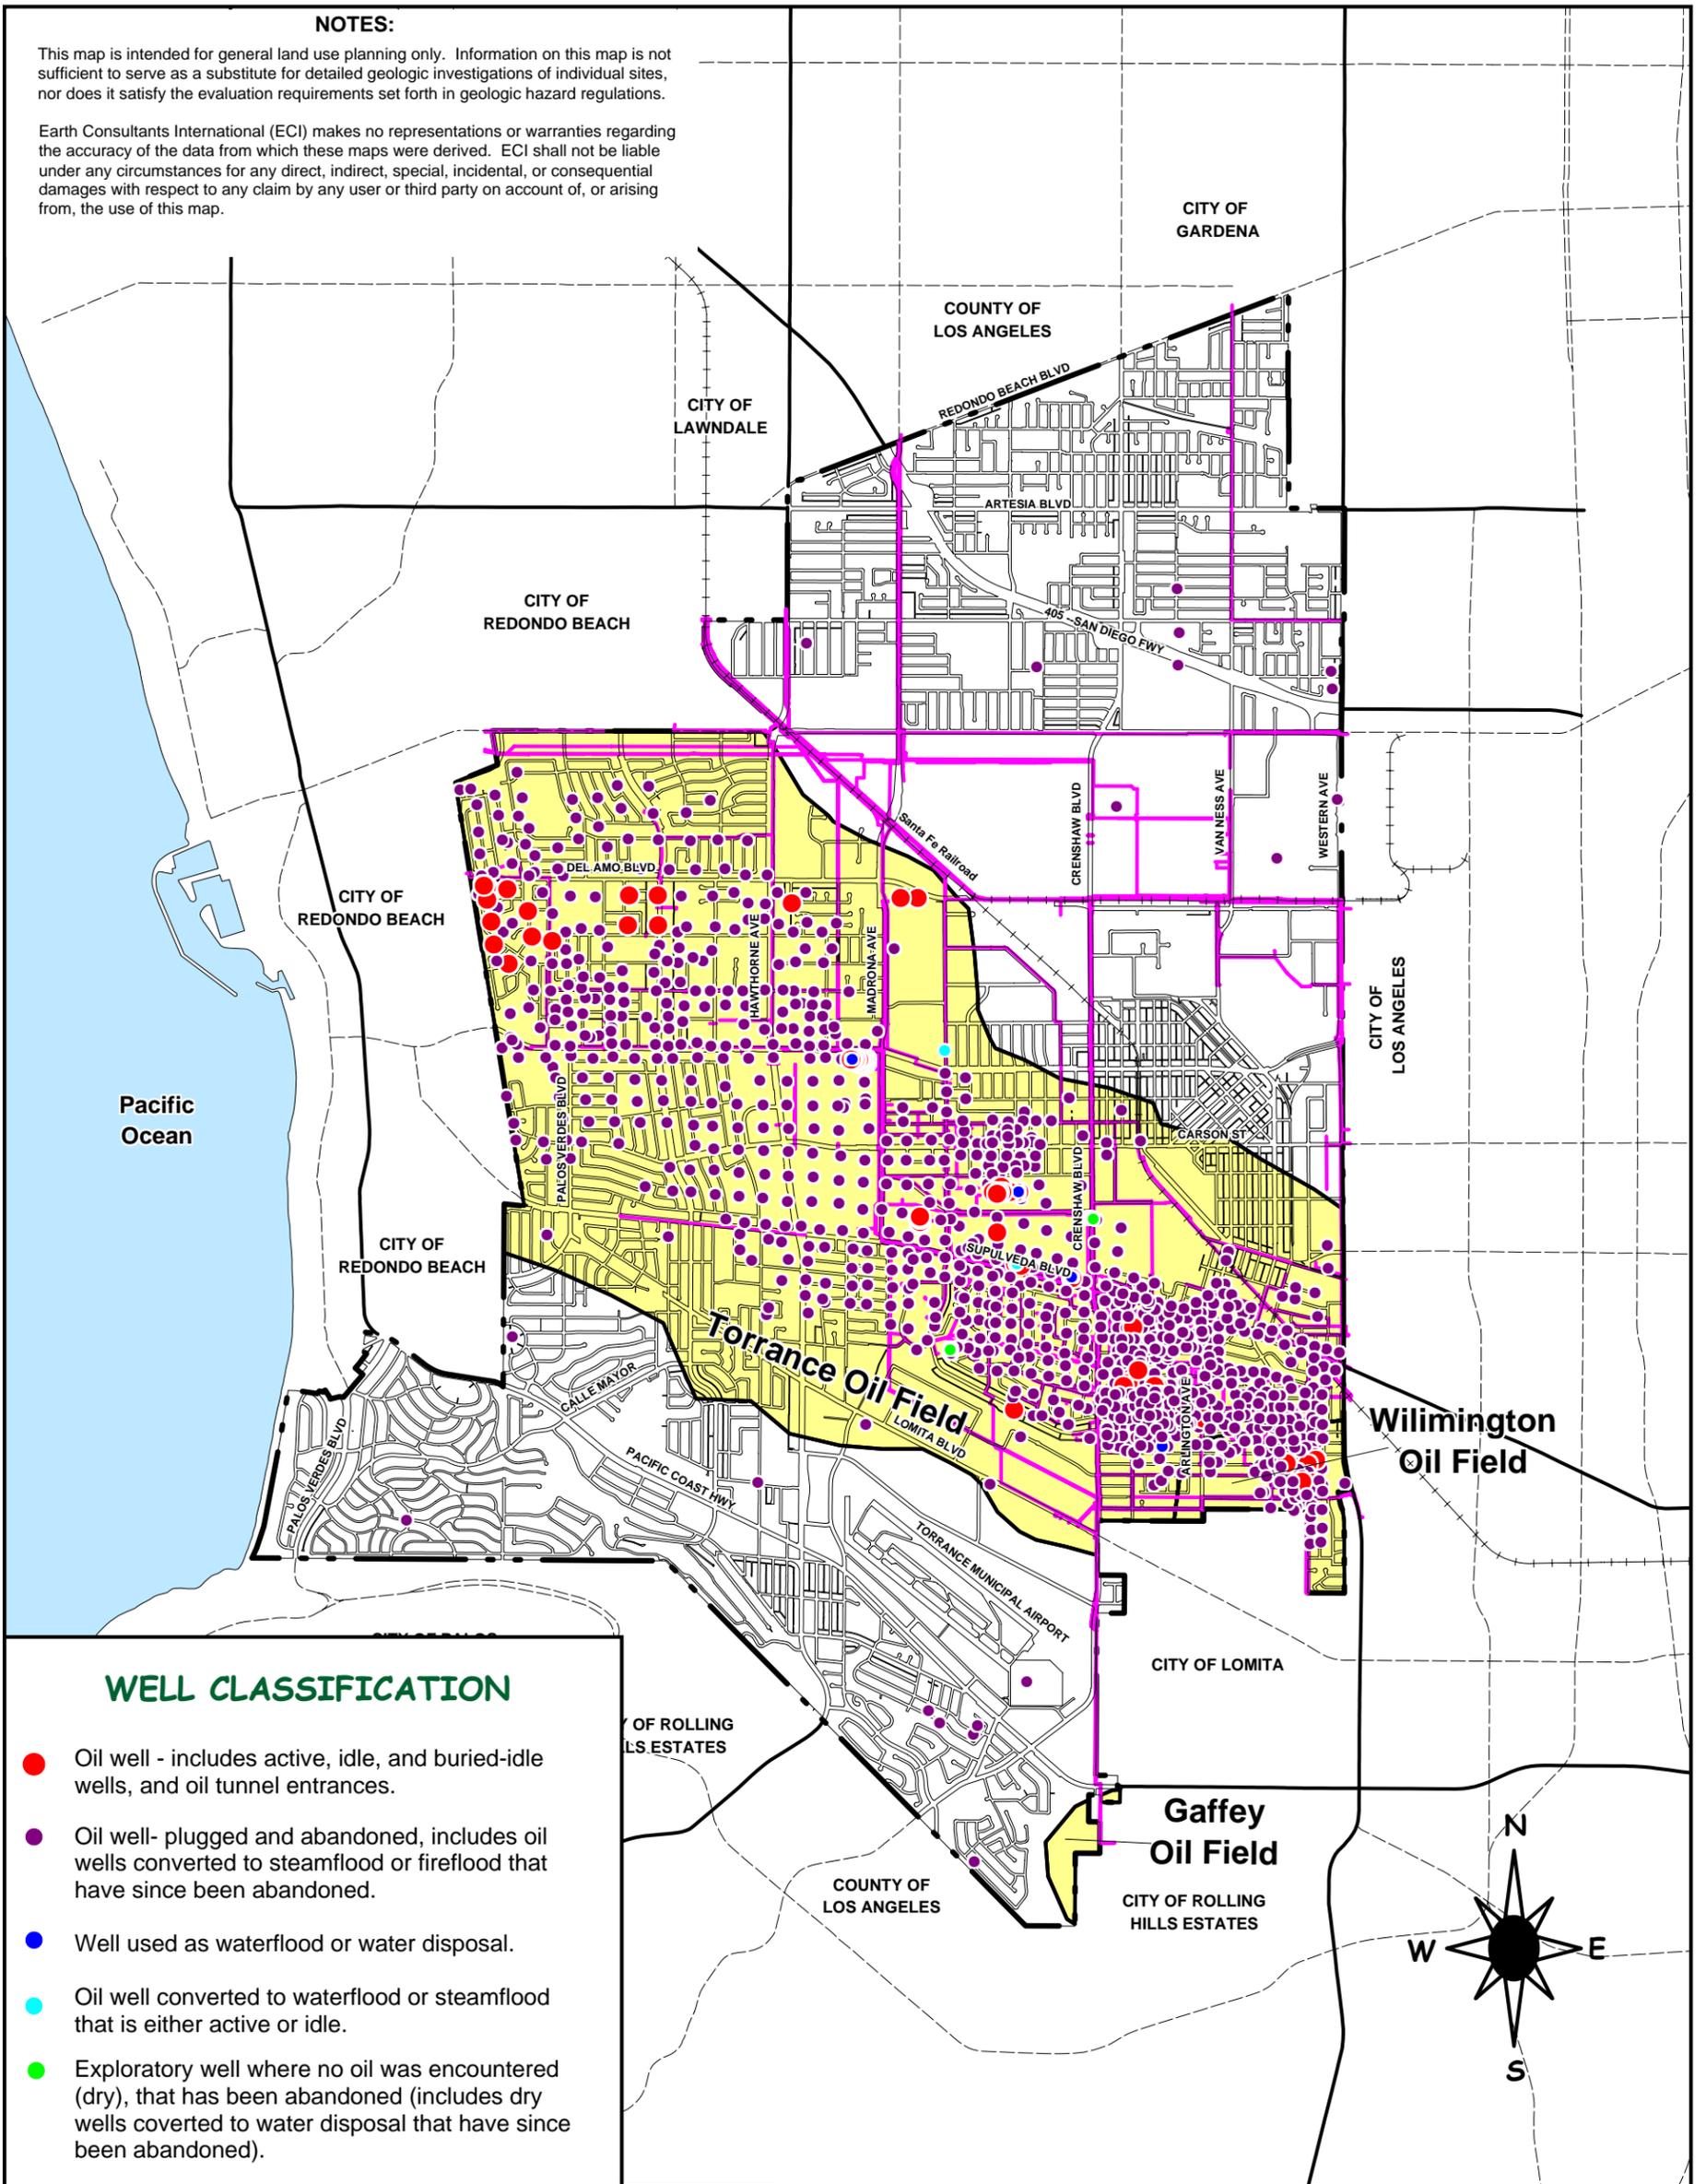
WELL CLASSIFICATION

- Oil well - includes active, idle, and buried-idle wells, and oil tunnel entrances.
- Oil well- plugged and abandoned, includes oil wells converted to steamflood or fireflood that have since been abandoned.
- Well used as waterflood or water disposal.
- Oil well converted to waterflood or steamflood that is either active or idle.
- Exploratory well where no oil was encountered (dry), that has been abandoned (includes dry wells converted to water disposal that have since been abandoned).

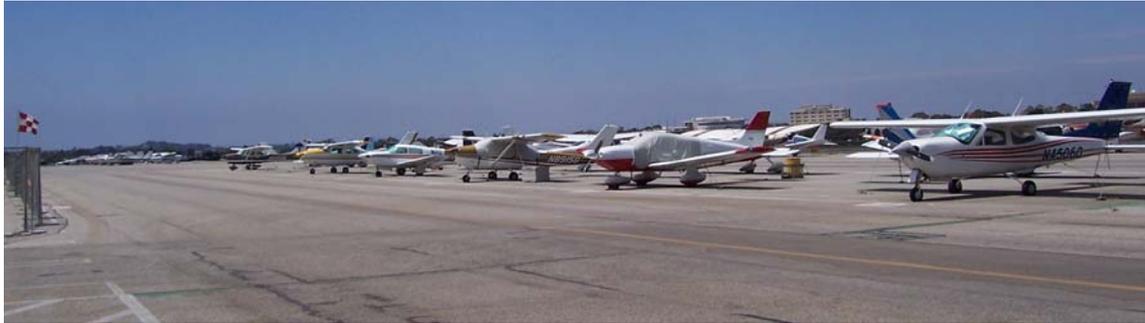
**Airplanes parked at the southwestern apron,
view towards the Northwestern take-off direction**

Torrance Airport can handle planes with a maximum per wheel weight of 20,000 lbs. However the majority of airplanes are light, single-, sometimes twin-engine models, used mainly for recreational purposes, limited in size and seating capacity (usually 2 to 8), with a small amount of fuel carried (less than 200 gallons on average), and with a typical gross weight not exceeding 12,500 lbs.

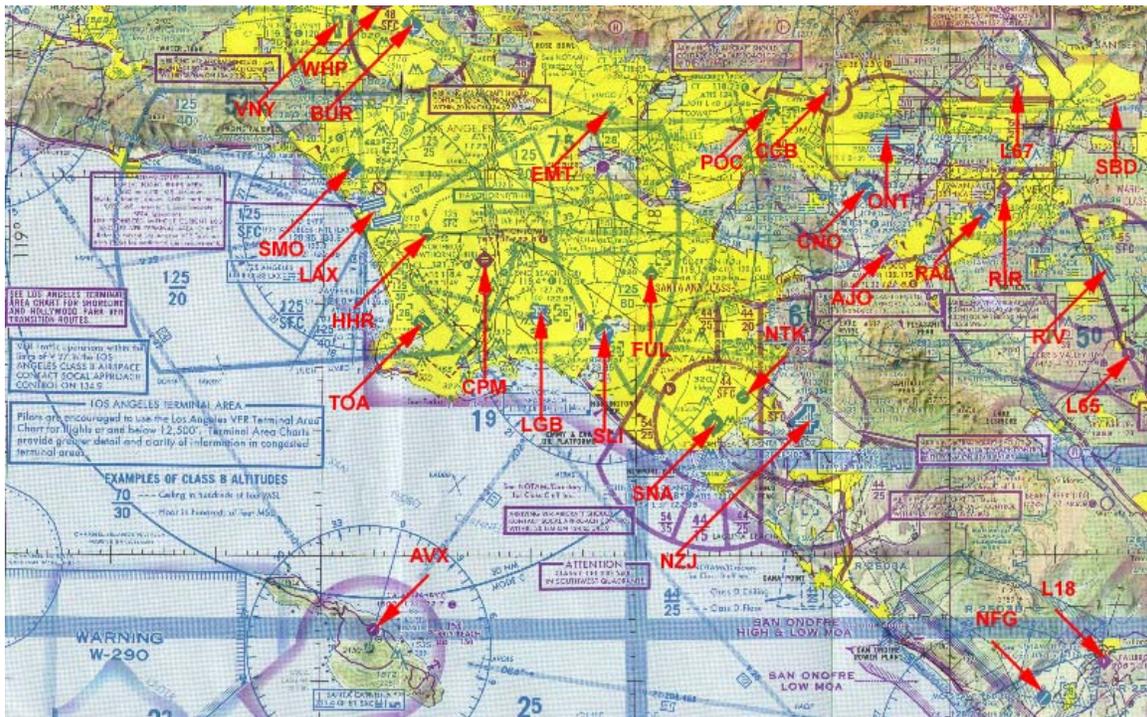
Air Traffic and Airports in the Greater Los Angeles Area

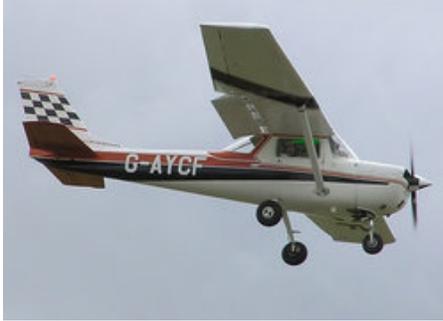
Cessna 150

- 2 seats
- 123 mph (196 Km/h) cruising speed
- 100 hp engine
- 1,600 lb max gross weight

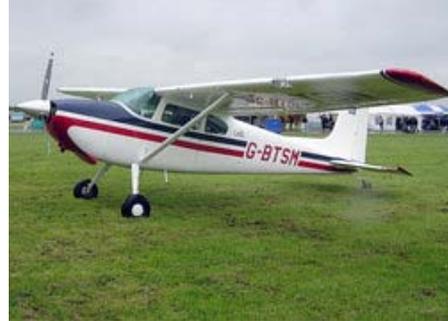
Cessna 180

- 4 seats
- 167 mph (267km/h) top speed
- 230 hp engine
- 2,550 lb max gross weight

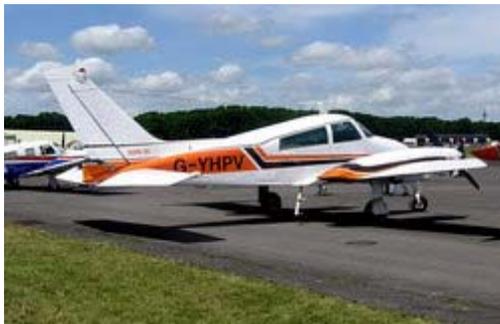
Cessna 310

- 6 seats
- 238 mph (383 km/h) top speed
- Combined 570 hp in 2 engines
- 5,500 lbs max gross weight

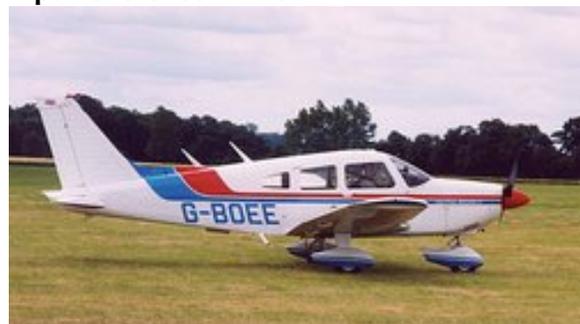
Piper Cherokee PA 28

- 4 seats
- 141 mph (235 km/h) cruise speed
- 160 hp engine
- 2,440 lb max gross weight

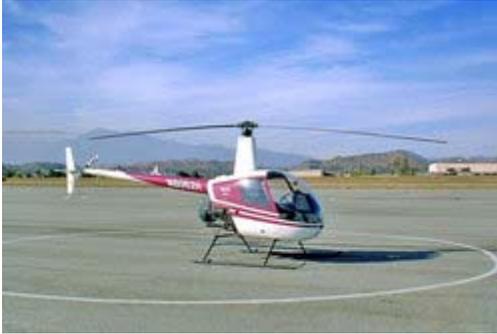
Robinson R22

- 2 seats
- 113 mph (180 km/h) top speed
- 124 hp engine
- 1,300 lb max gross weight

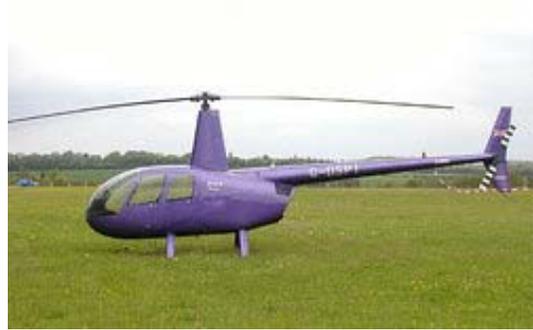
Robinson R44

- 4 seats
- 149 mph (209 km/h) top speed
- 225 hp engine
- 2,400 lb max gross weight

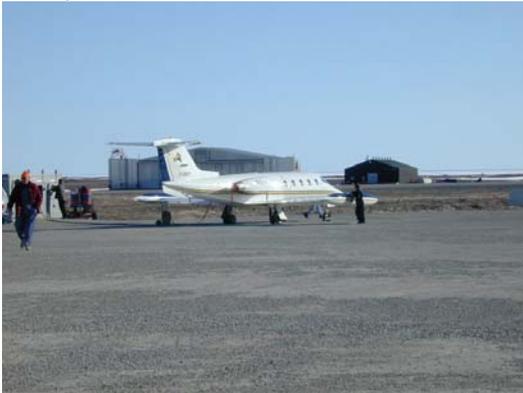
Lear Jet 25

- 2 pilot crew, 8 passenger capacity
- 545 mph (877 km/h) top speed
- 2 jet engines
- 15,000 lbs max gross weight

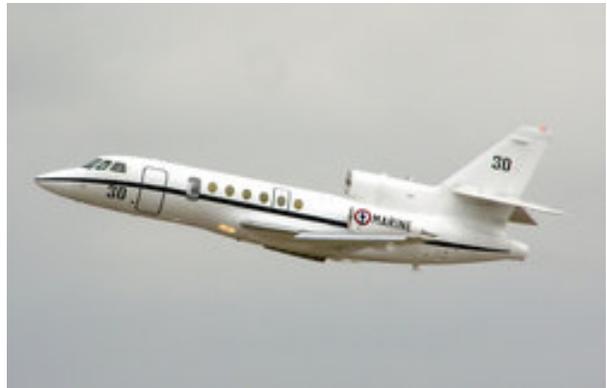
Dassault Falcon

- 2 pilot crew, 14 passengers
- 690 mph (1,100 km/h) top speed
- 3 turbofan engines
- 63,000 lbs max gross weight

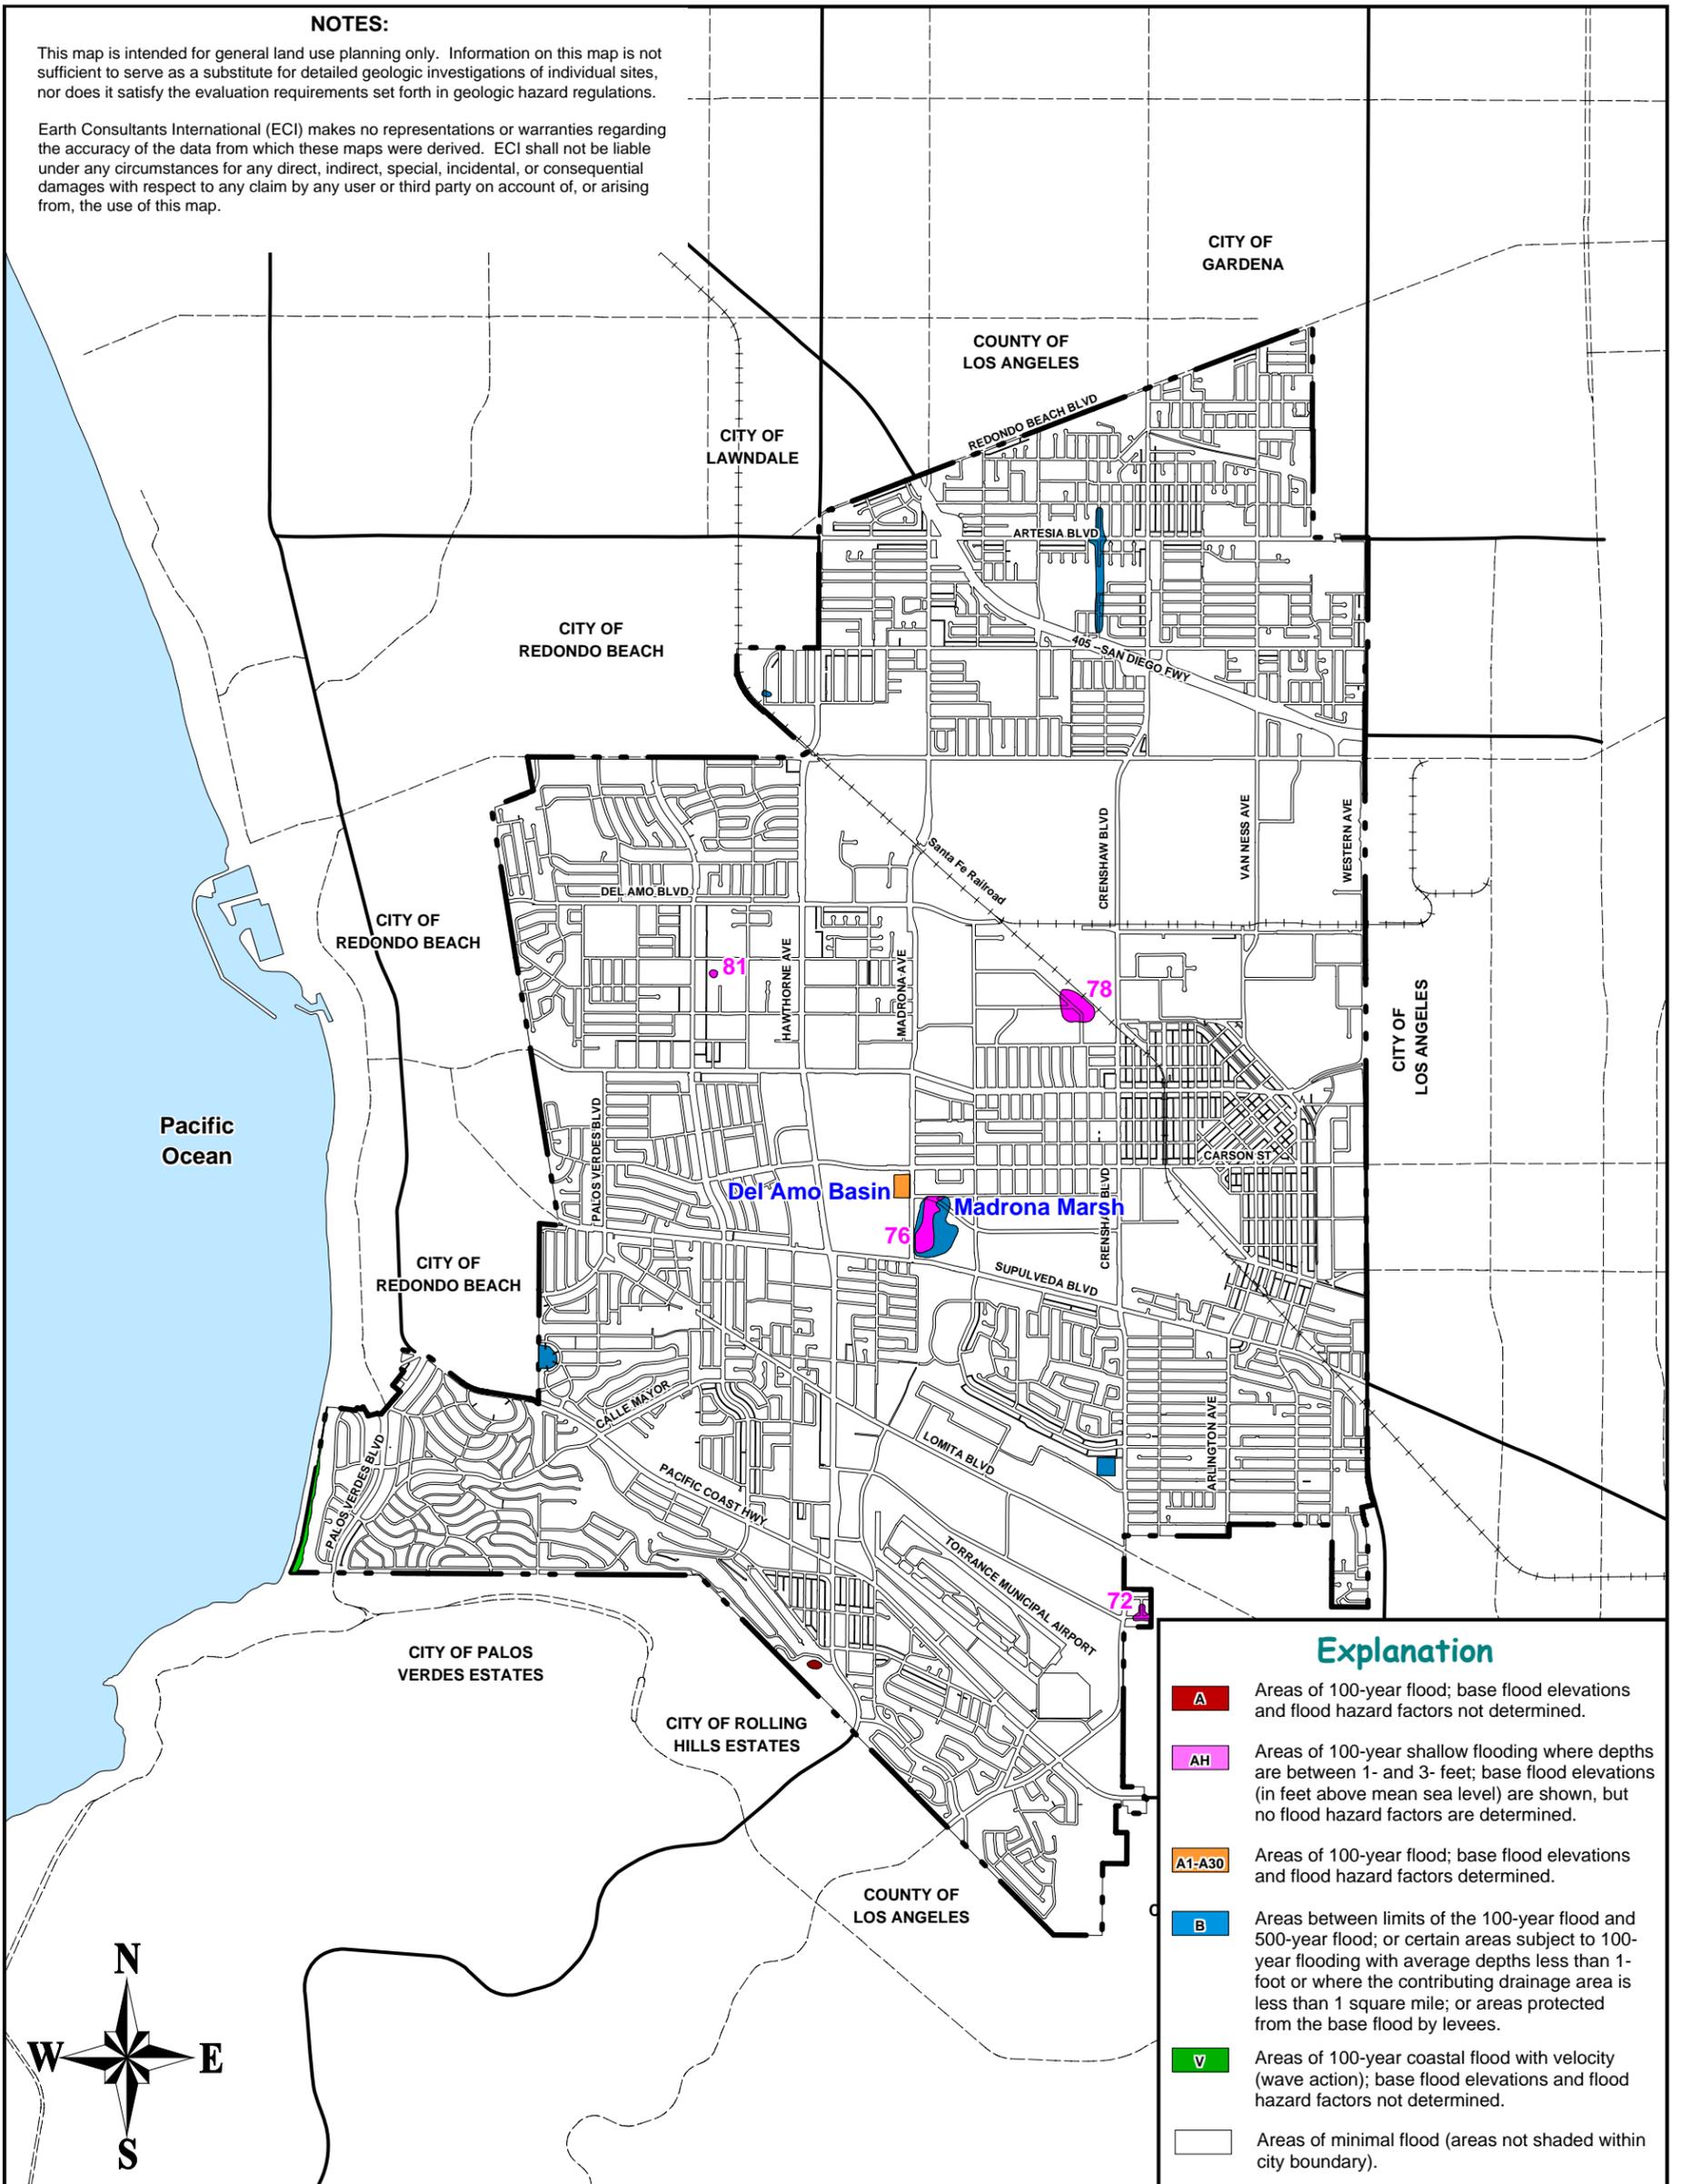
- A** Areas of 100-year flood; base flood elevations and flood hazard factors not determined.
- AH** Areas of 100-year shallow flooding where depths are between 1- and 3- feet; base flood elevations (in feet above mean sea level) are shown, but no flood hazard factors are determined.
- A1-A30** Areas of 100-year flood; base flood elevations and flood hazard factors determined.
- B** Areas between limits of the 100-year flood and 500-year flood; or certain areas subject to 100-year flooding with average depths less than 1-foot or where the contributing drainage area is less than 1 square mile; or areas protected from the base flood by levees.
- V** Areas of 100-year coastal flood with velocity (wave action); base flood elevations and flood hazard factors not determined.
- Areas of minimal flood (areas not shaded within city boundary).

Base Map: City of Torrance (2005)
 Source: Federal Emergency Management Agency, 1979, Flood Insurance Rate Map (Panel Numbers: 060165 0001B, 060165 0003B, 060165 0004B, and 060165 0005B).
